**CONSERVATION WORKS OF
THIRUMALAI NAYAKKAR
MAHAL**

**Published by
DEPARTMENT OF ARCHAEOLOGY
GOVERNMENT OF TAMIL NADU
CHENNAI.**

Name of the book : Conservation Works of Thirumalai Nayakkar Mahal

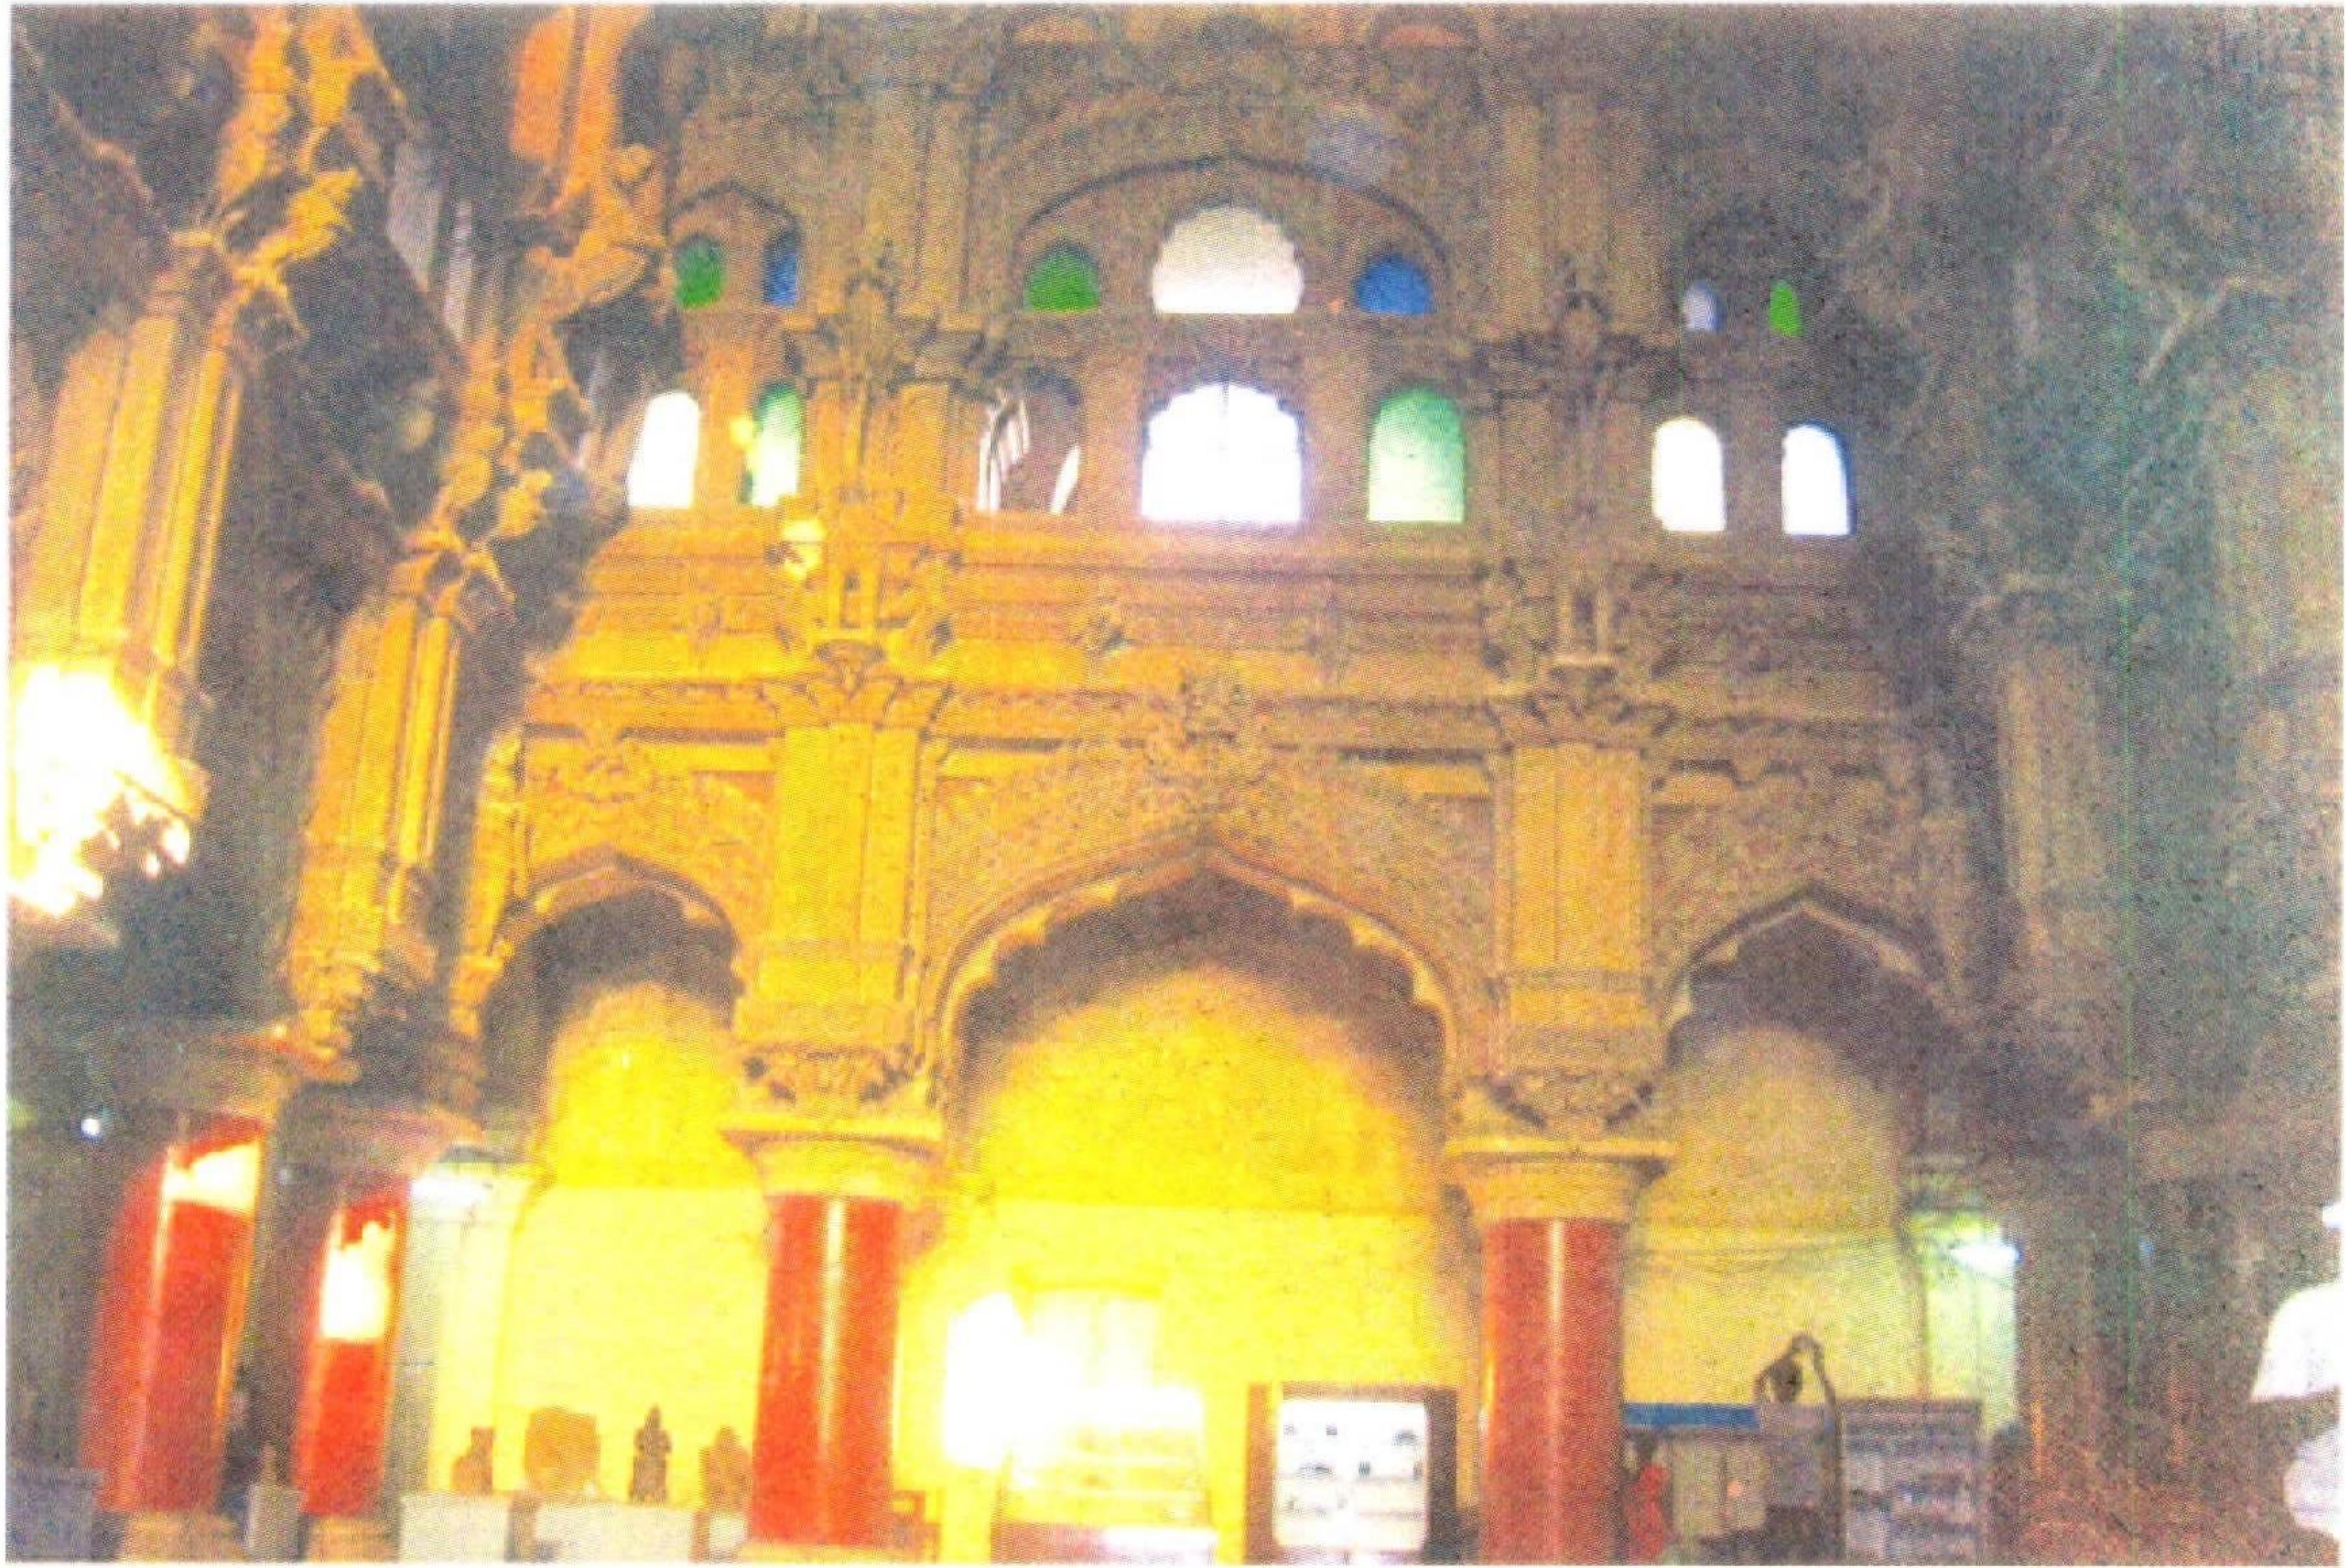
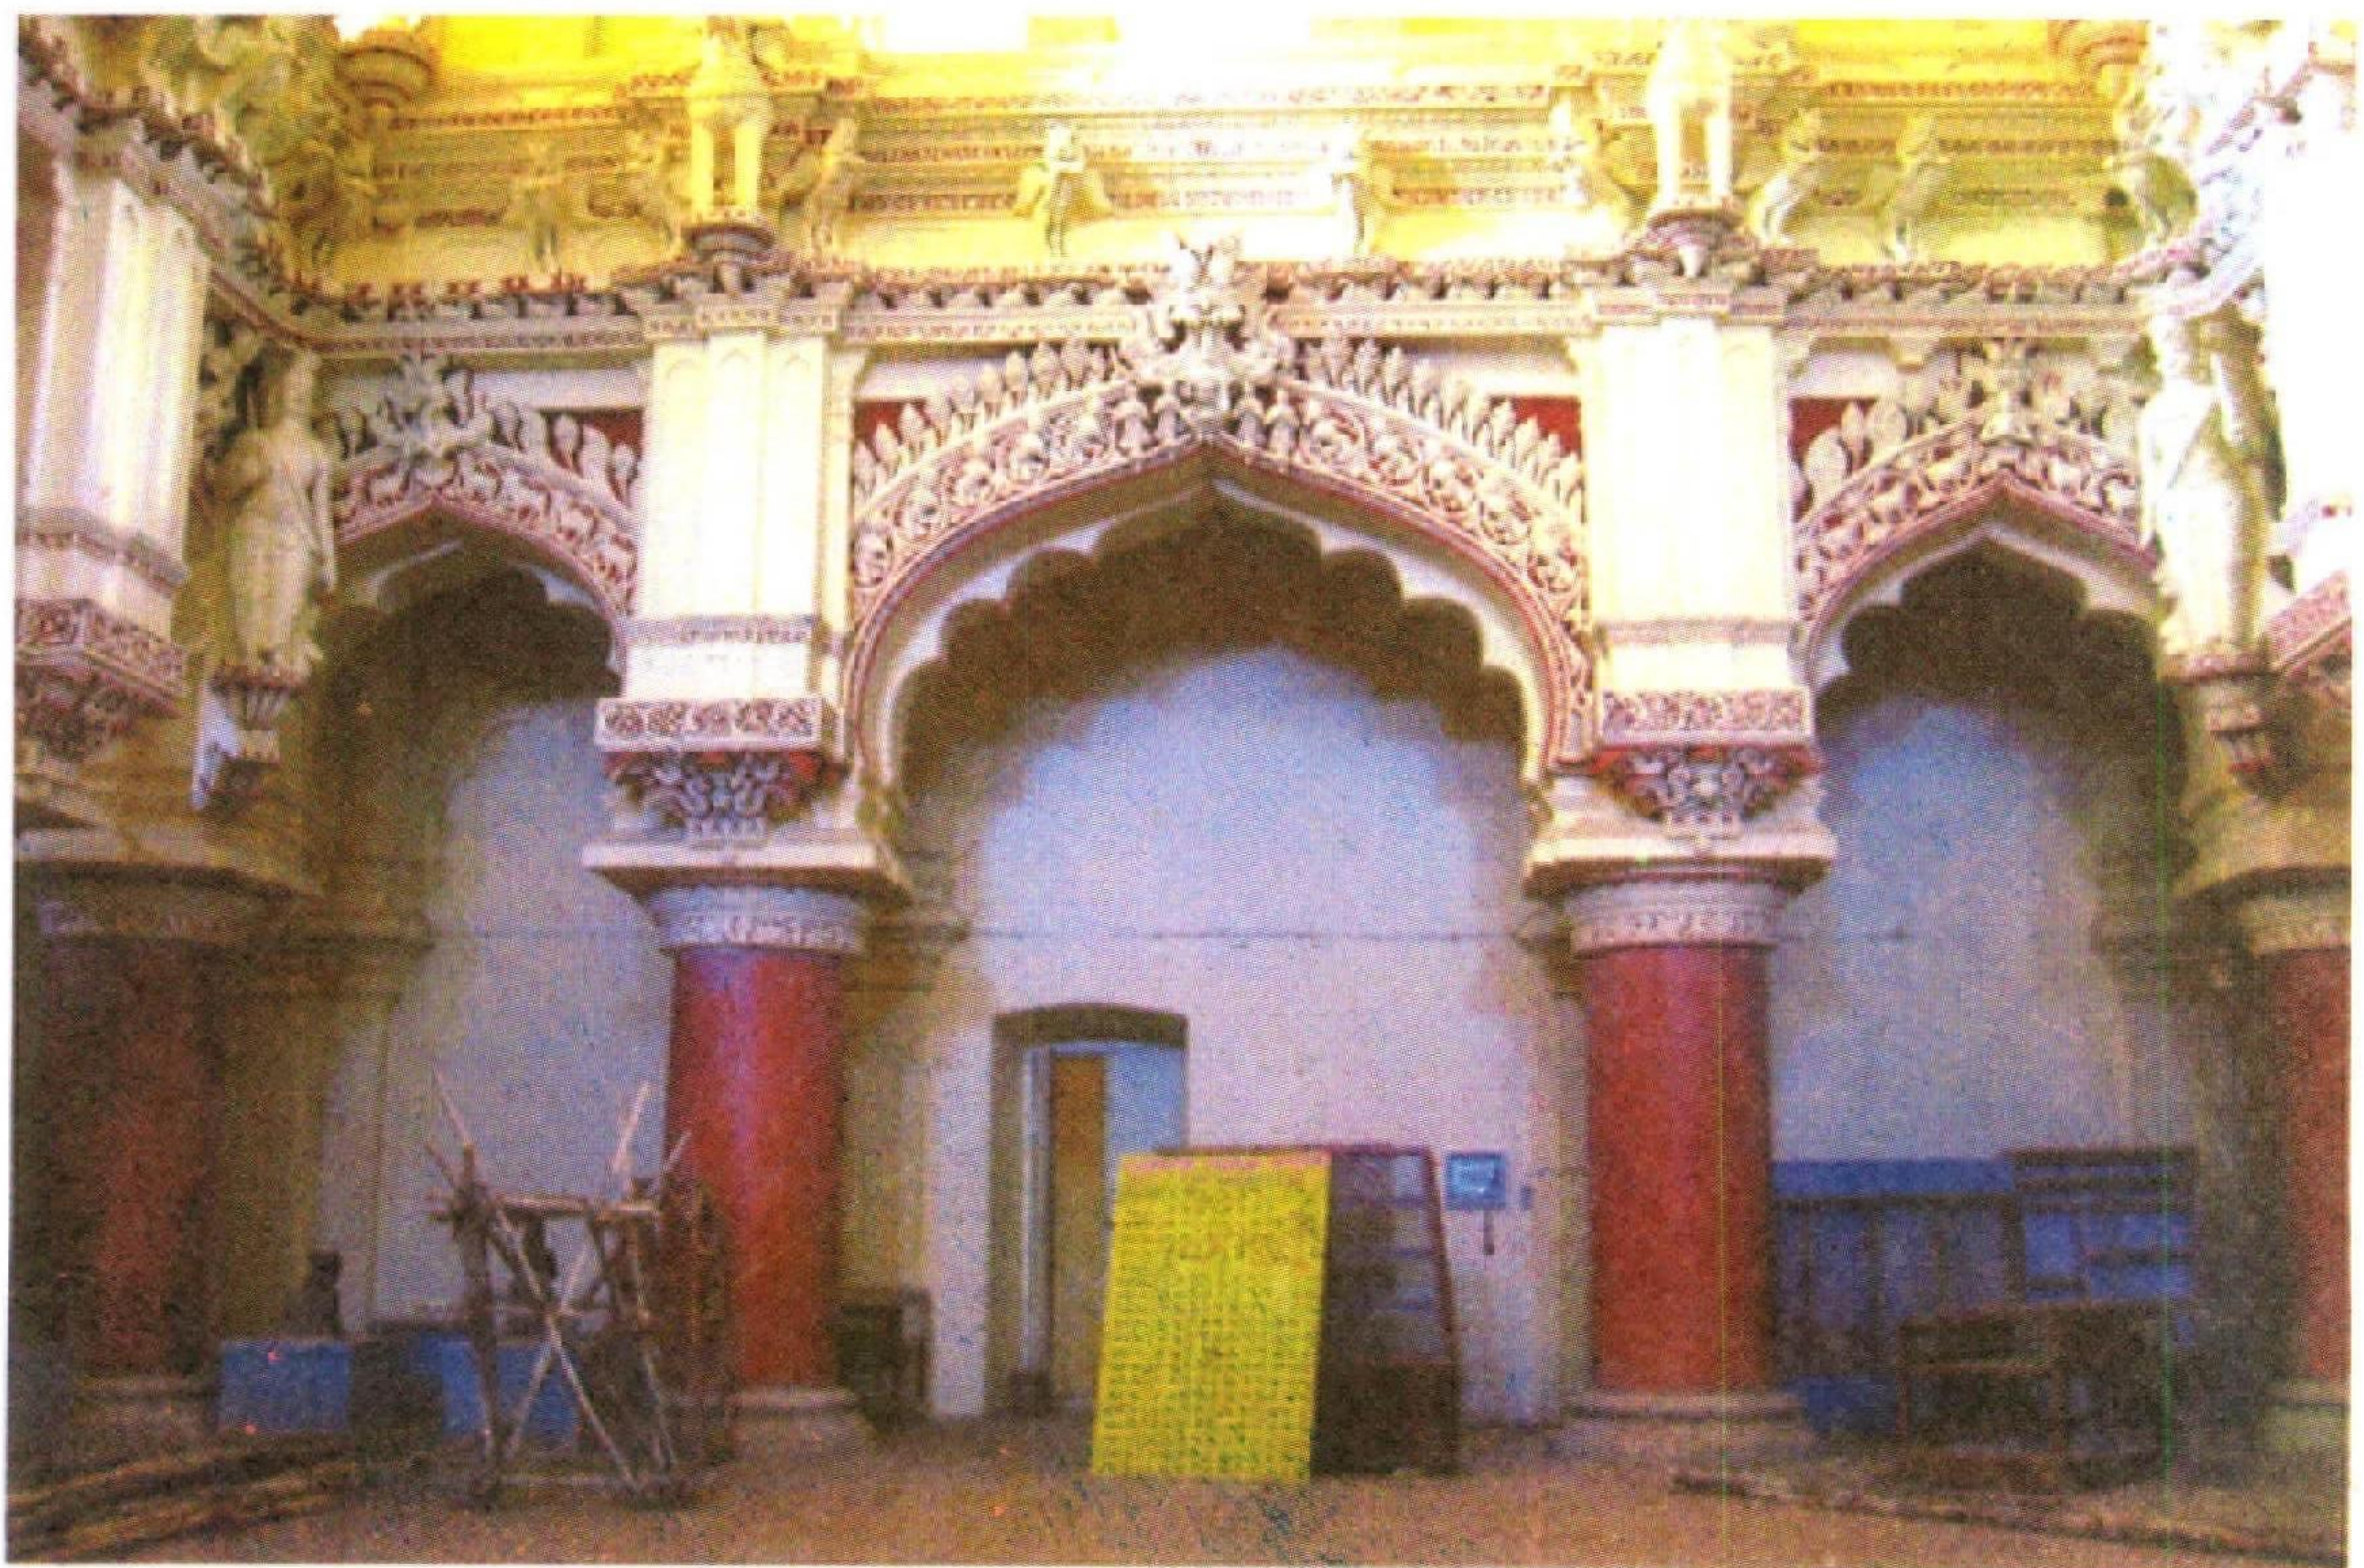
NATAKASALAI

BEFORE

AFTER

- Replacing damaged teak wood doors, windows and iron grills.
- Repairs to Natagasalai (where site museum is located)
- Repairs to side additional building.

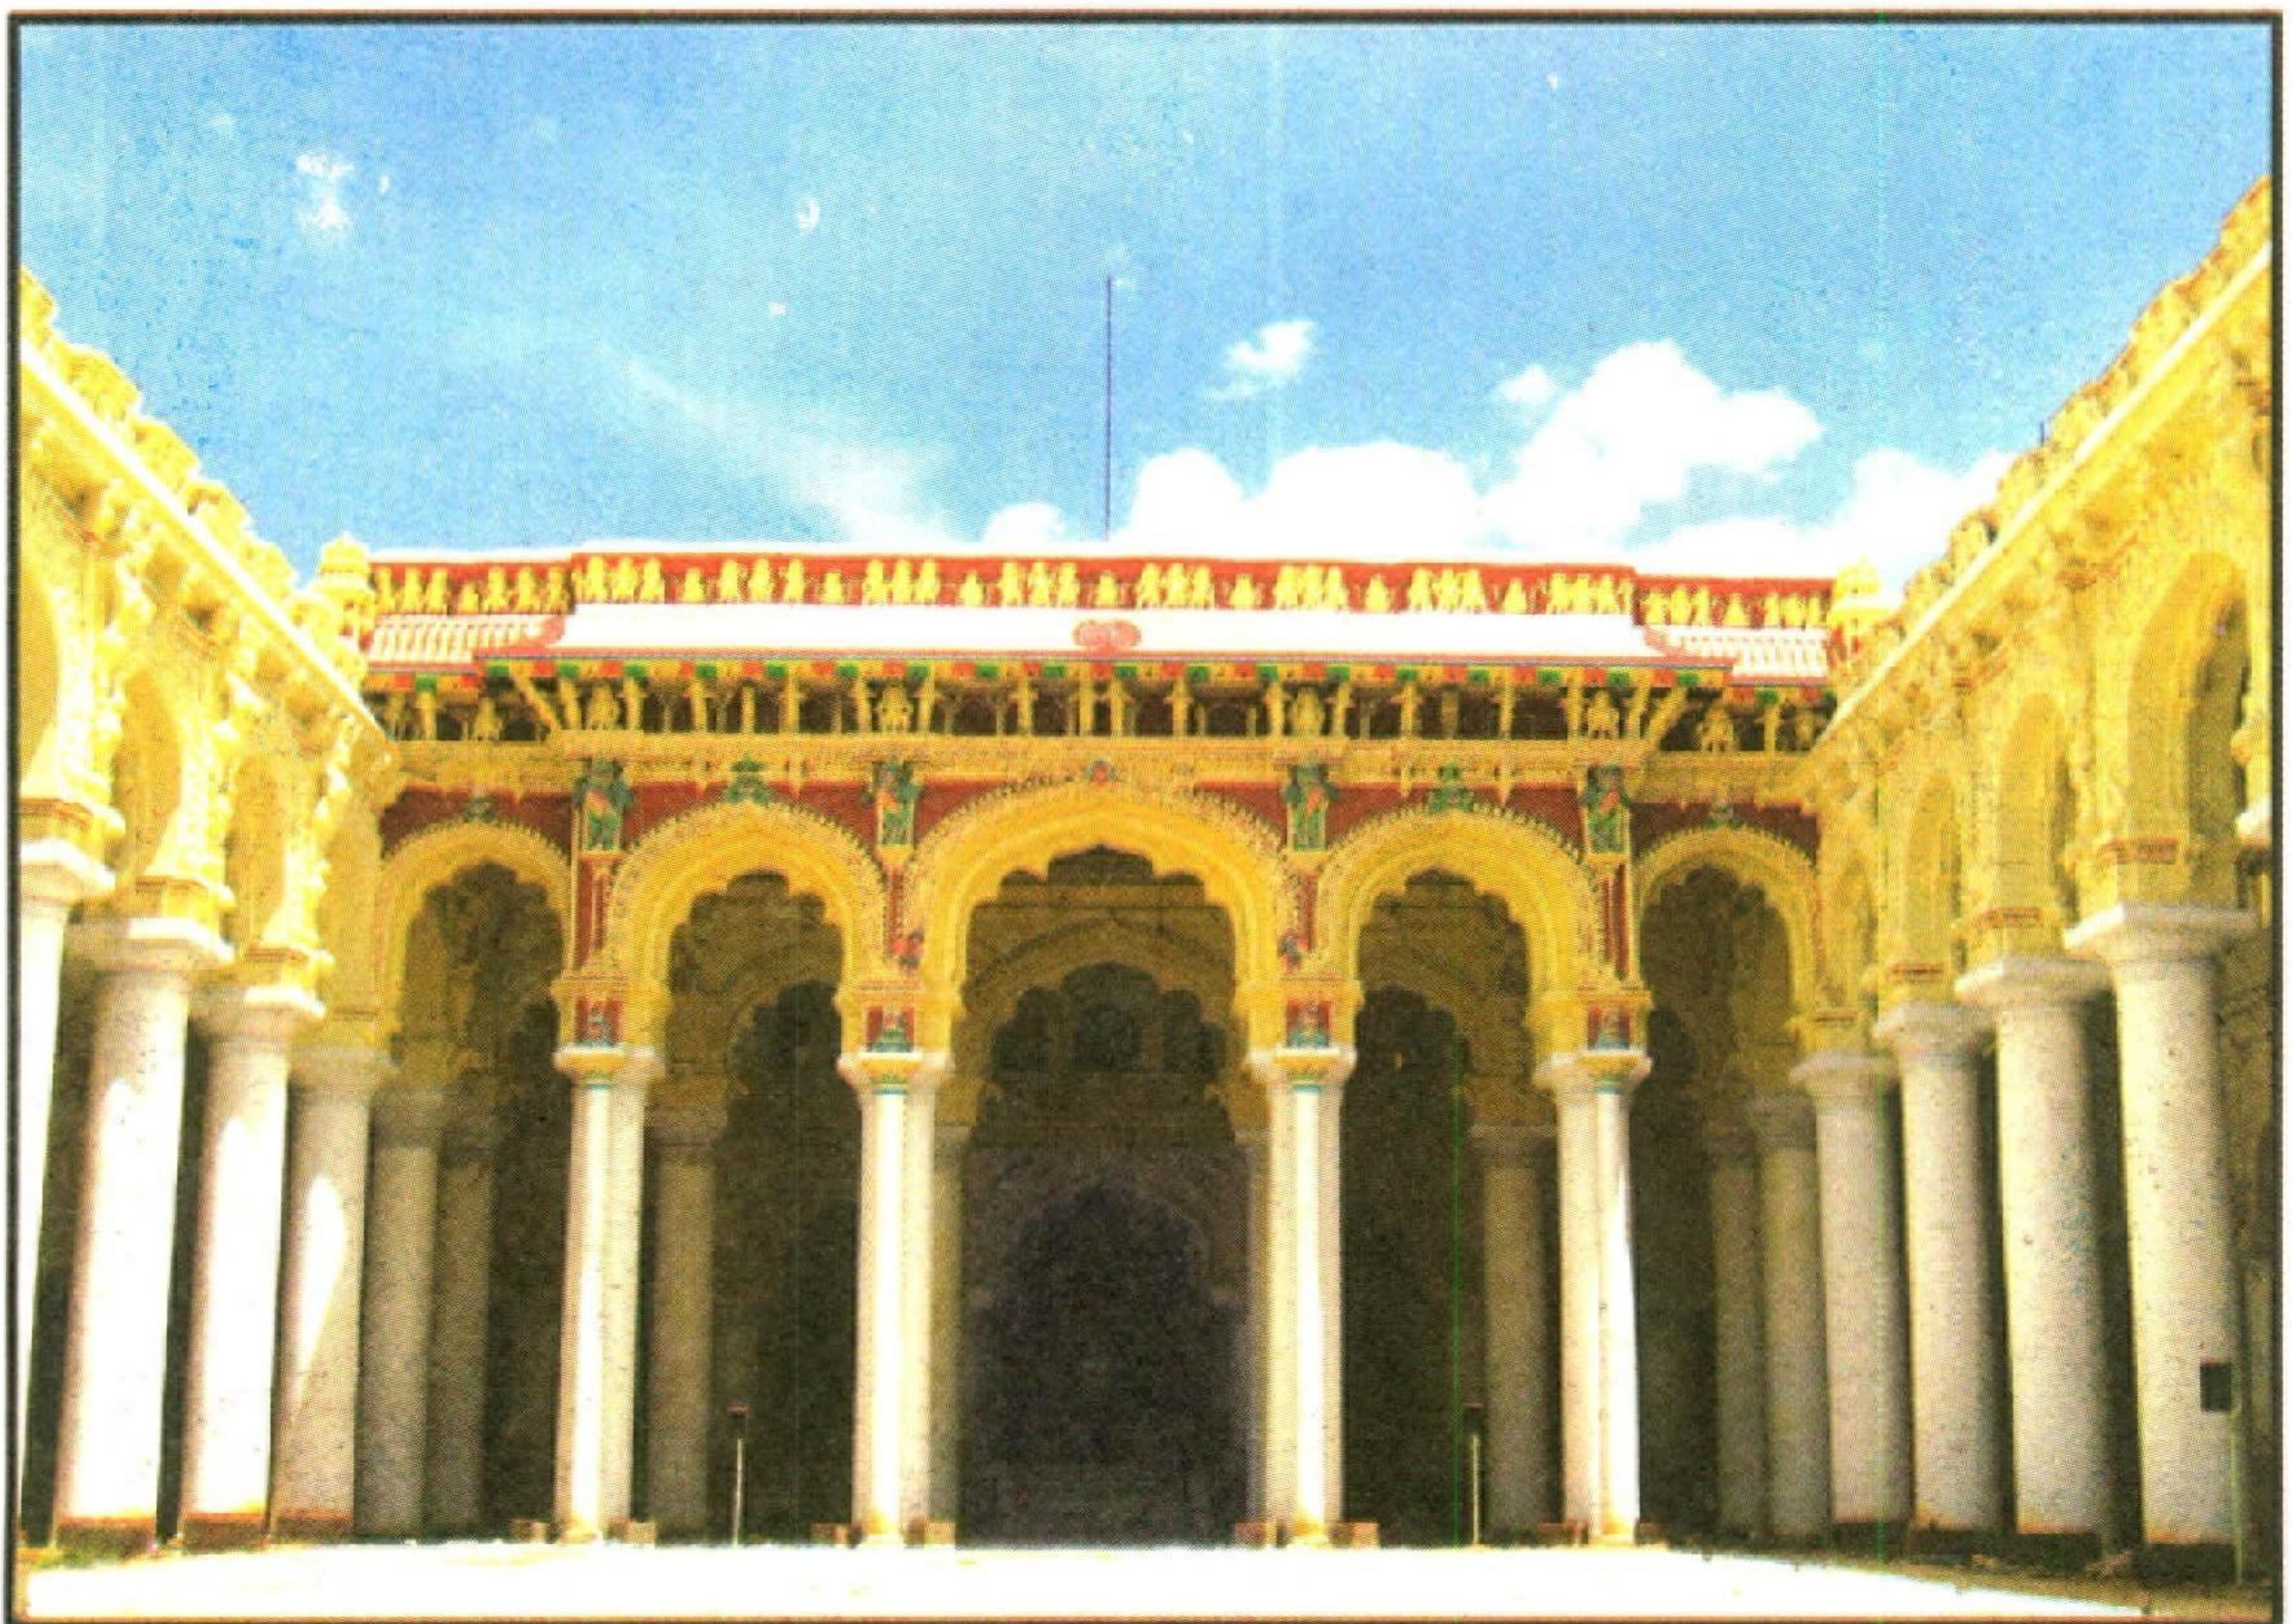
MINISTER'S DOME

BEFORE

AFTER

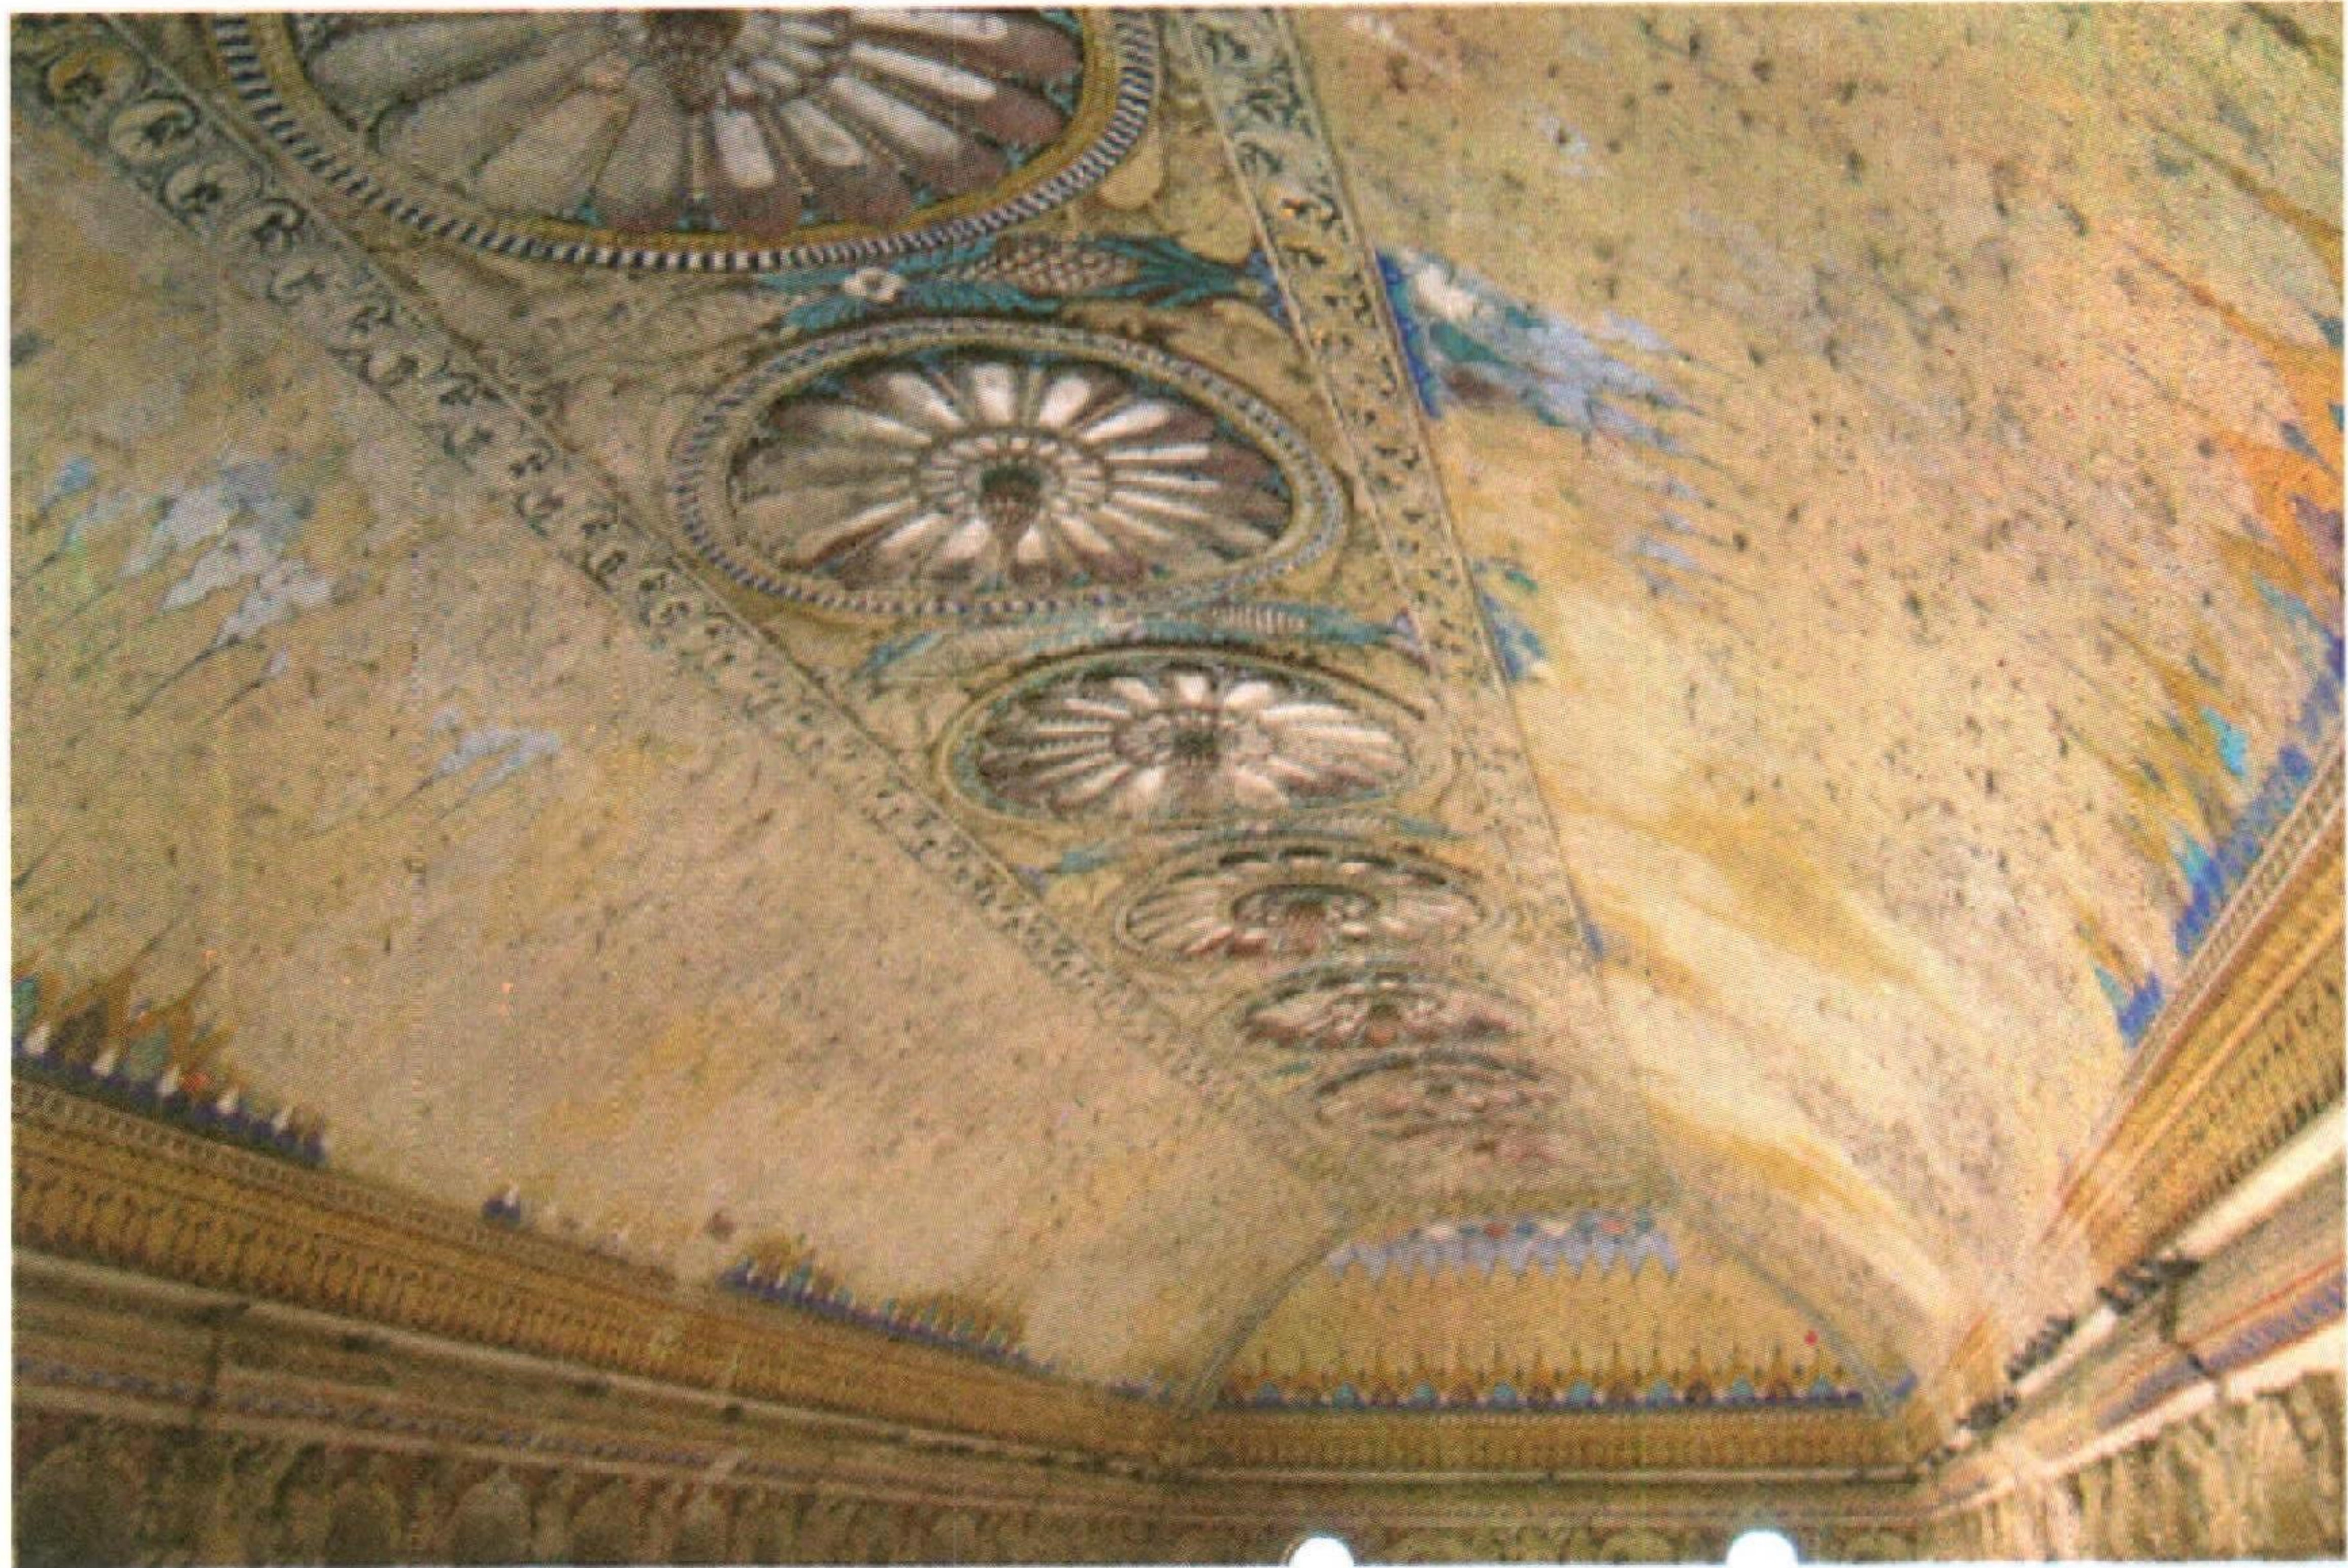
SWARGAVILASAM DOME

BEFORE

AFTER

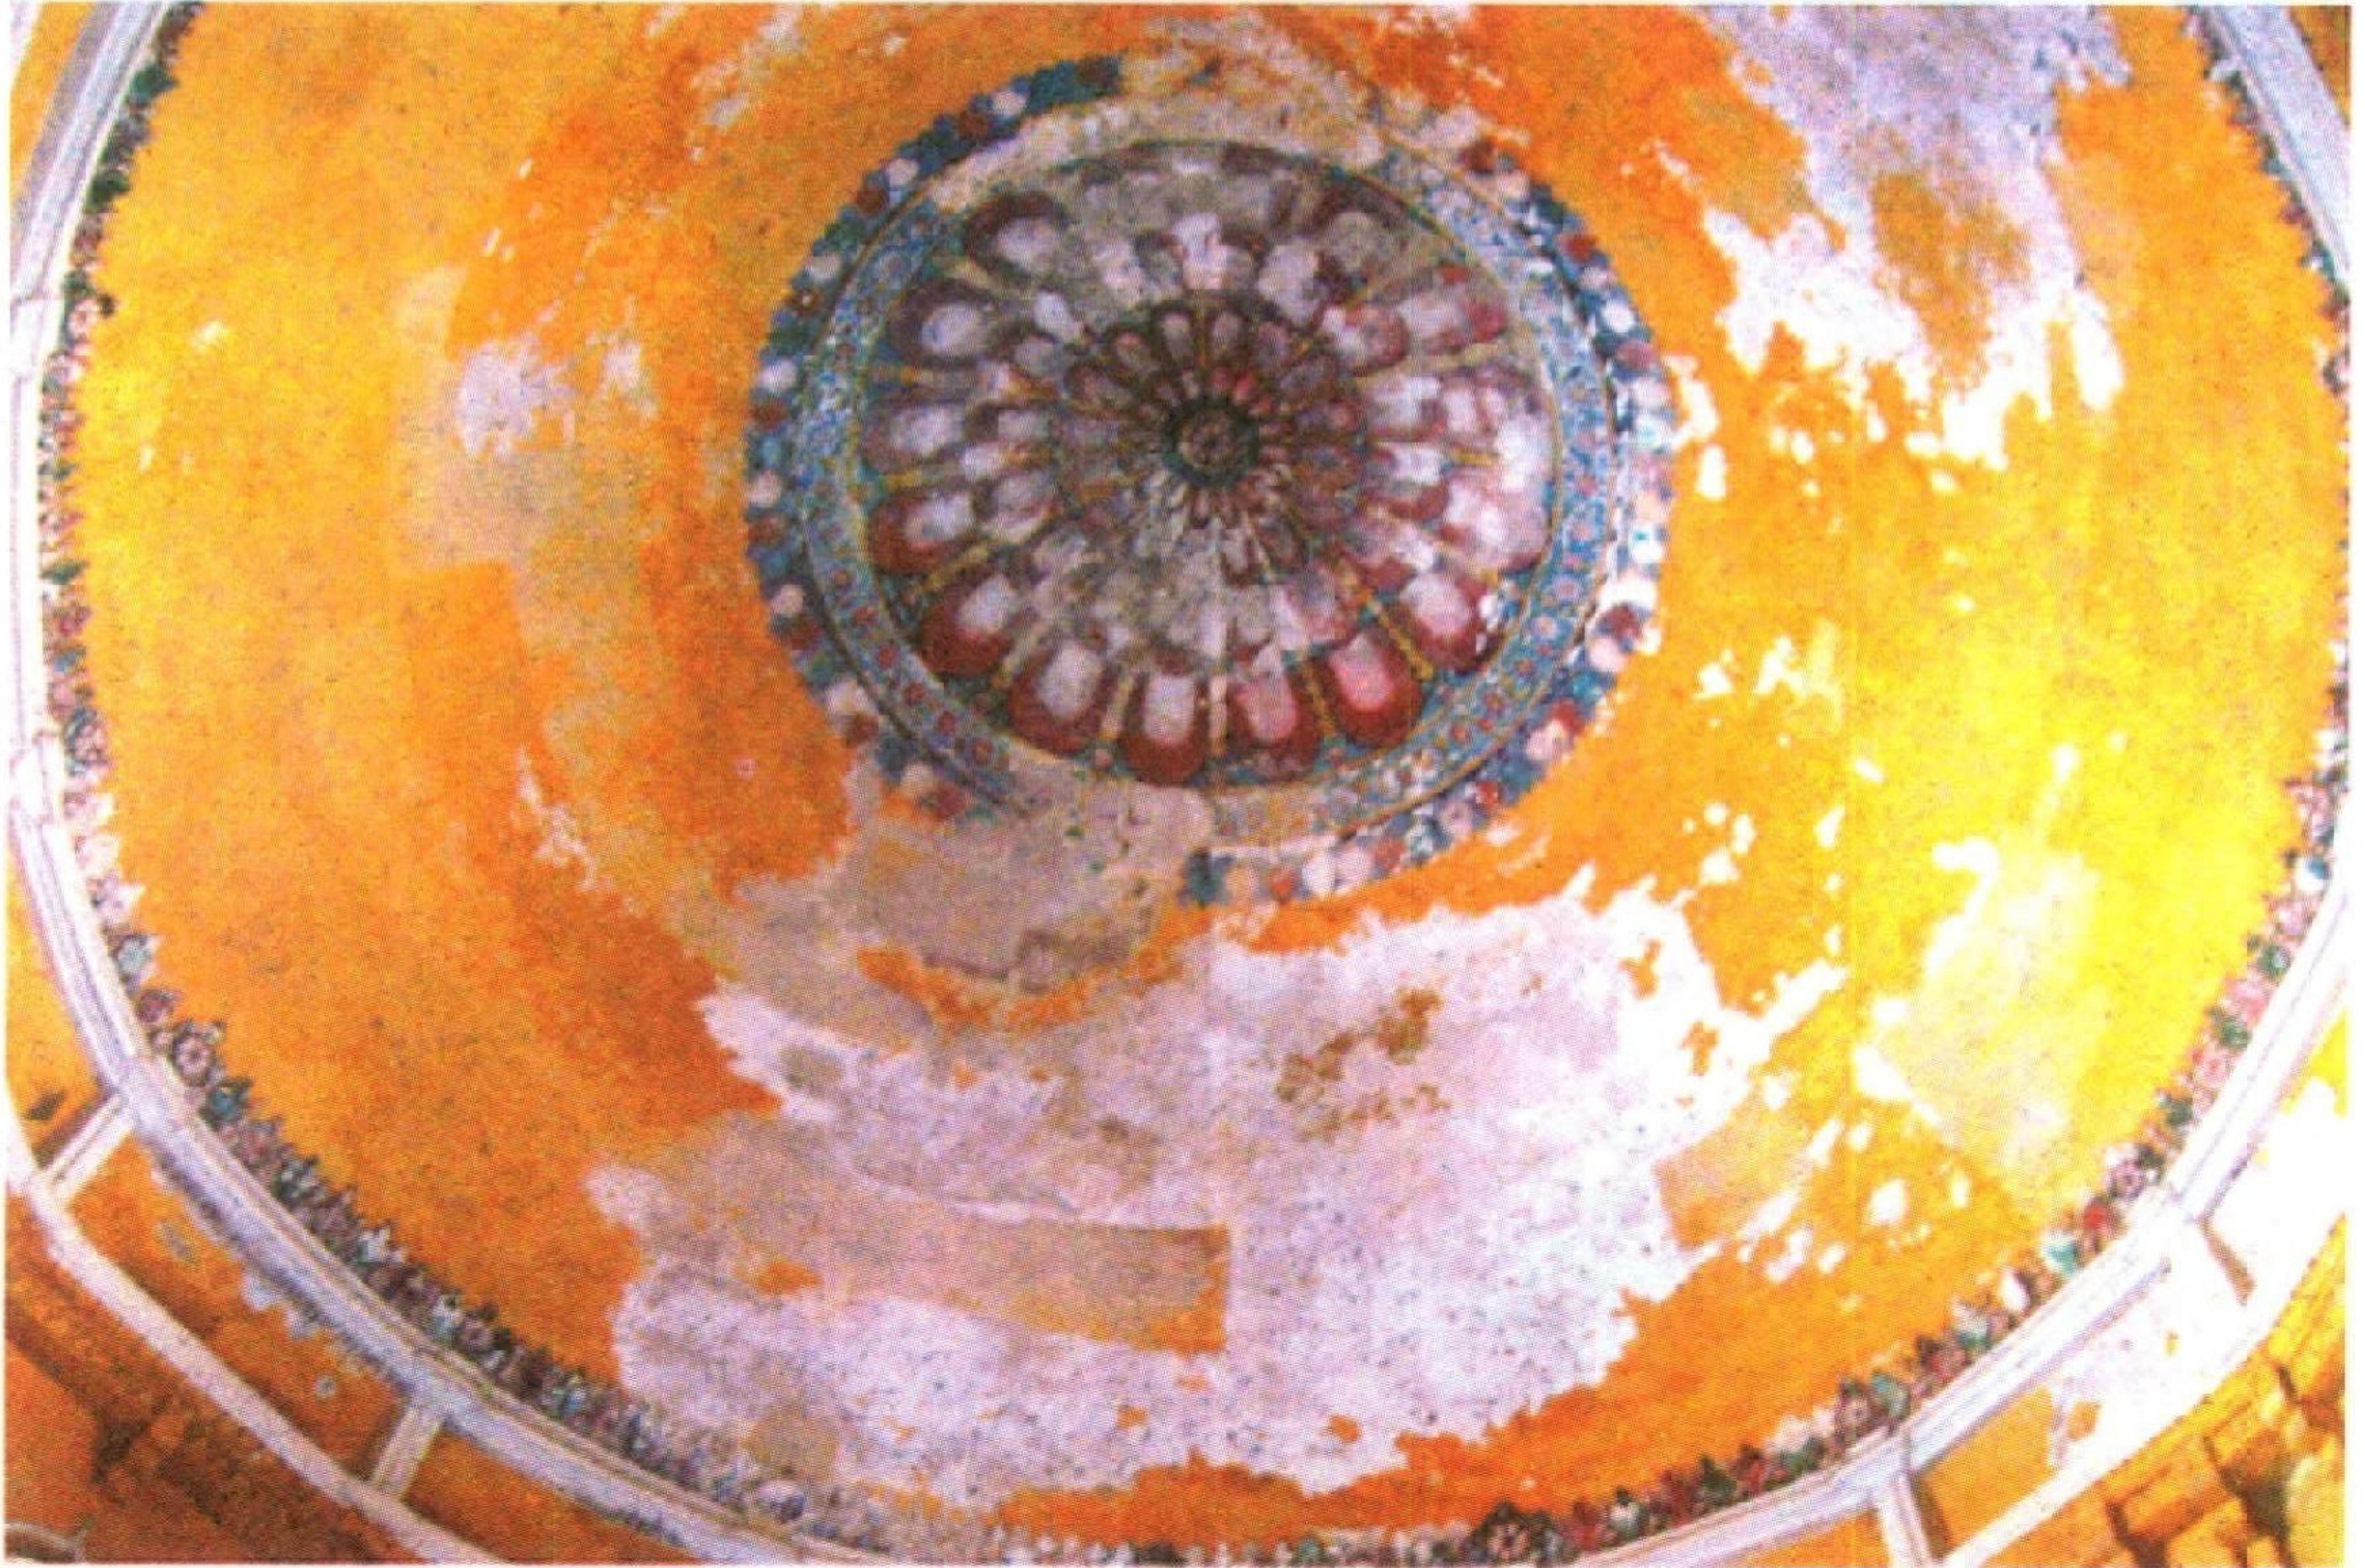
CORRIDOR CEILING

BEFORE

AFTER

- Cleaning of the stucco works and the ceiling, minor repairs to the stucco works where necessary, and colour washing of the stucco works and ceiling of the entire building- need to be done.
