# **Conservation works of Monuments**

**2006 - 2010**

**DEPARTMENT OF ARCHAEOLOGY**  
**GOVERNMENT OF TAMIL NADU**  
**CHENNAI.**

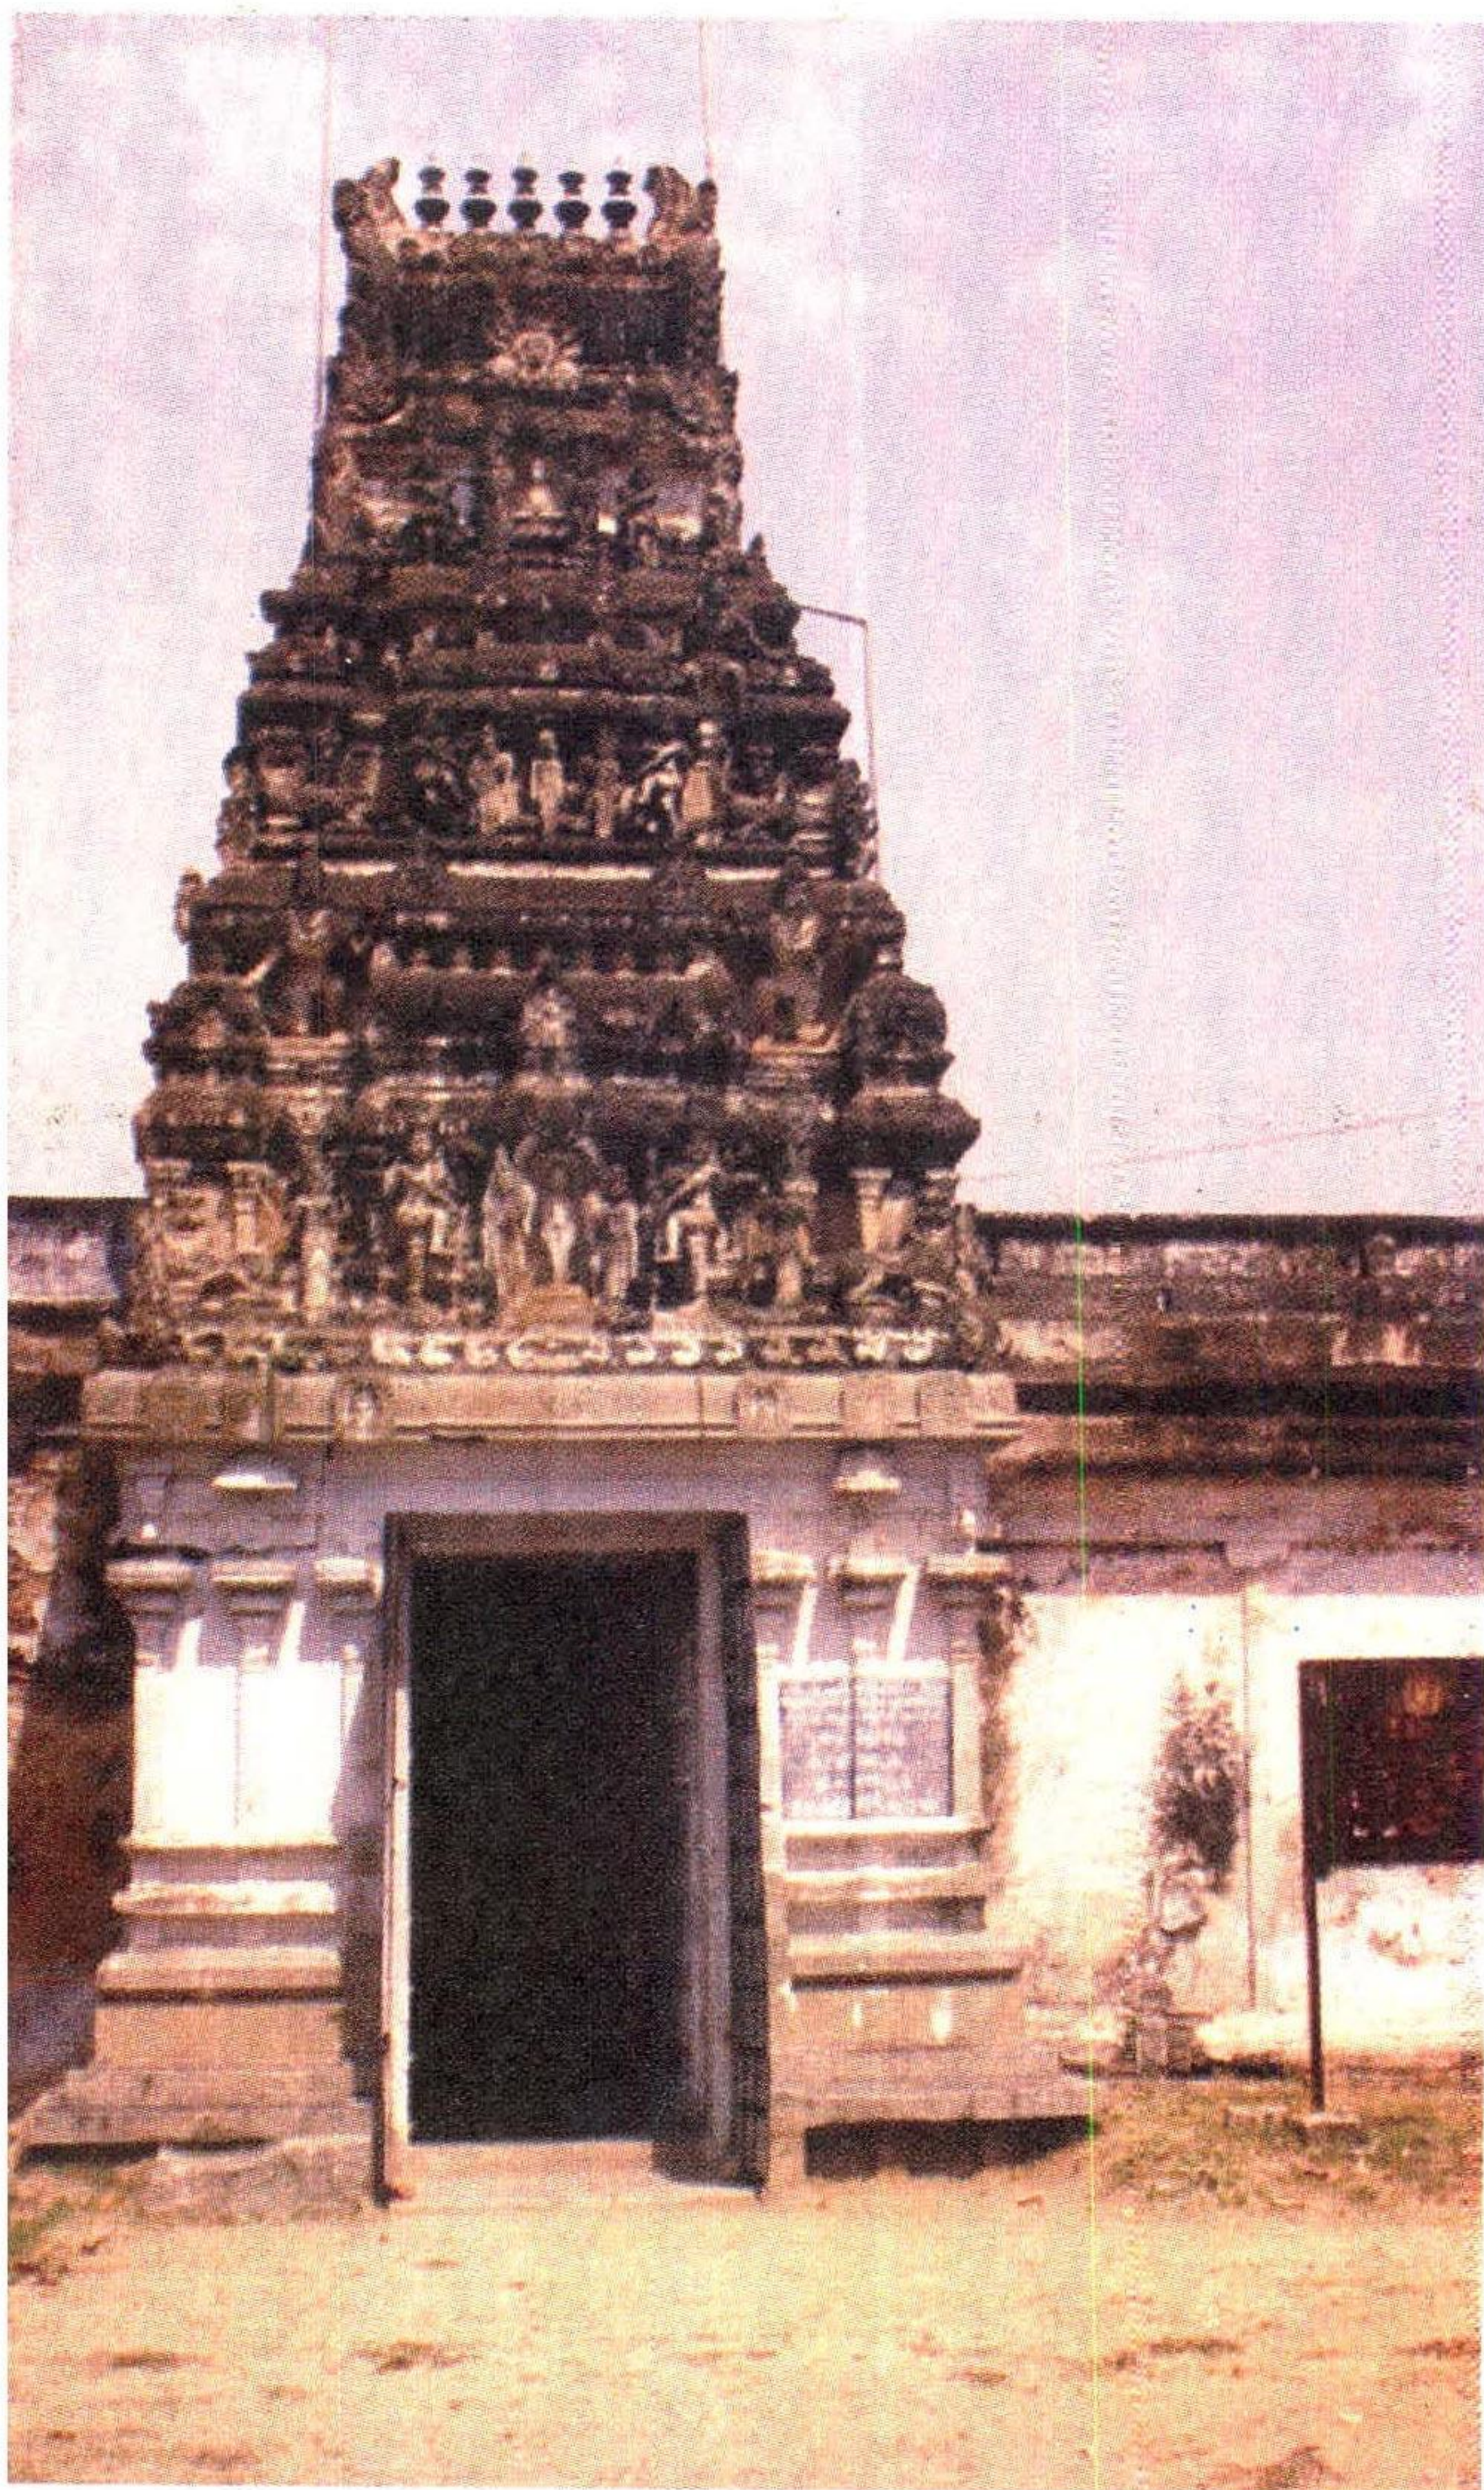
## POONDI ARUGARKOIL, ERUMPEDU

**Before Conservation**

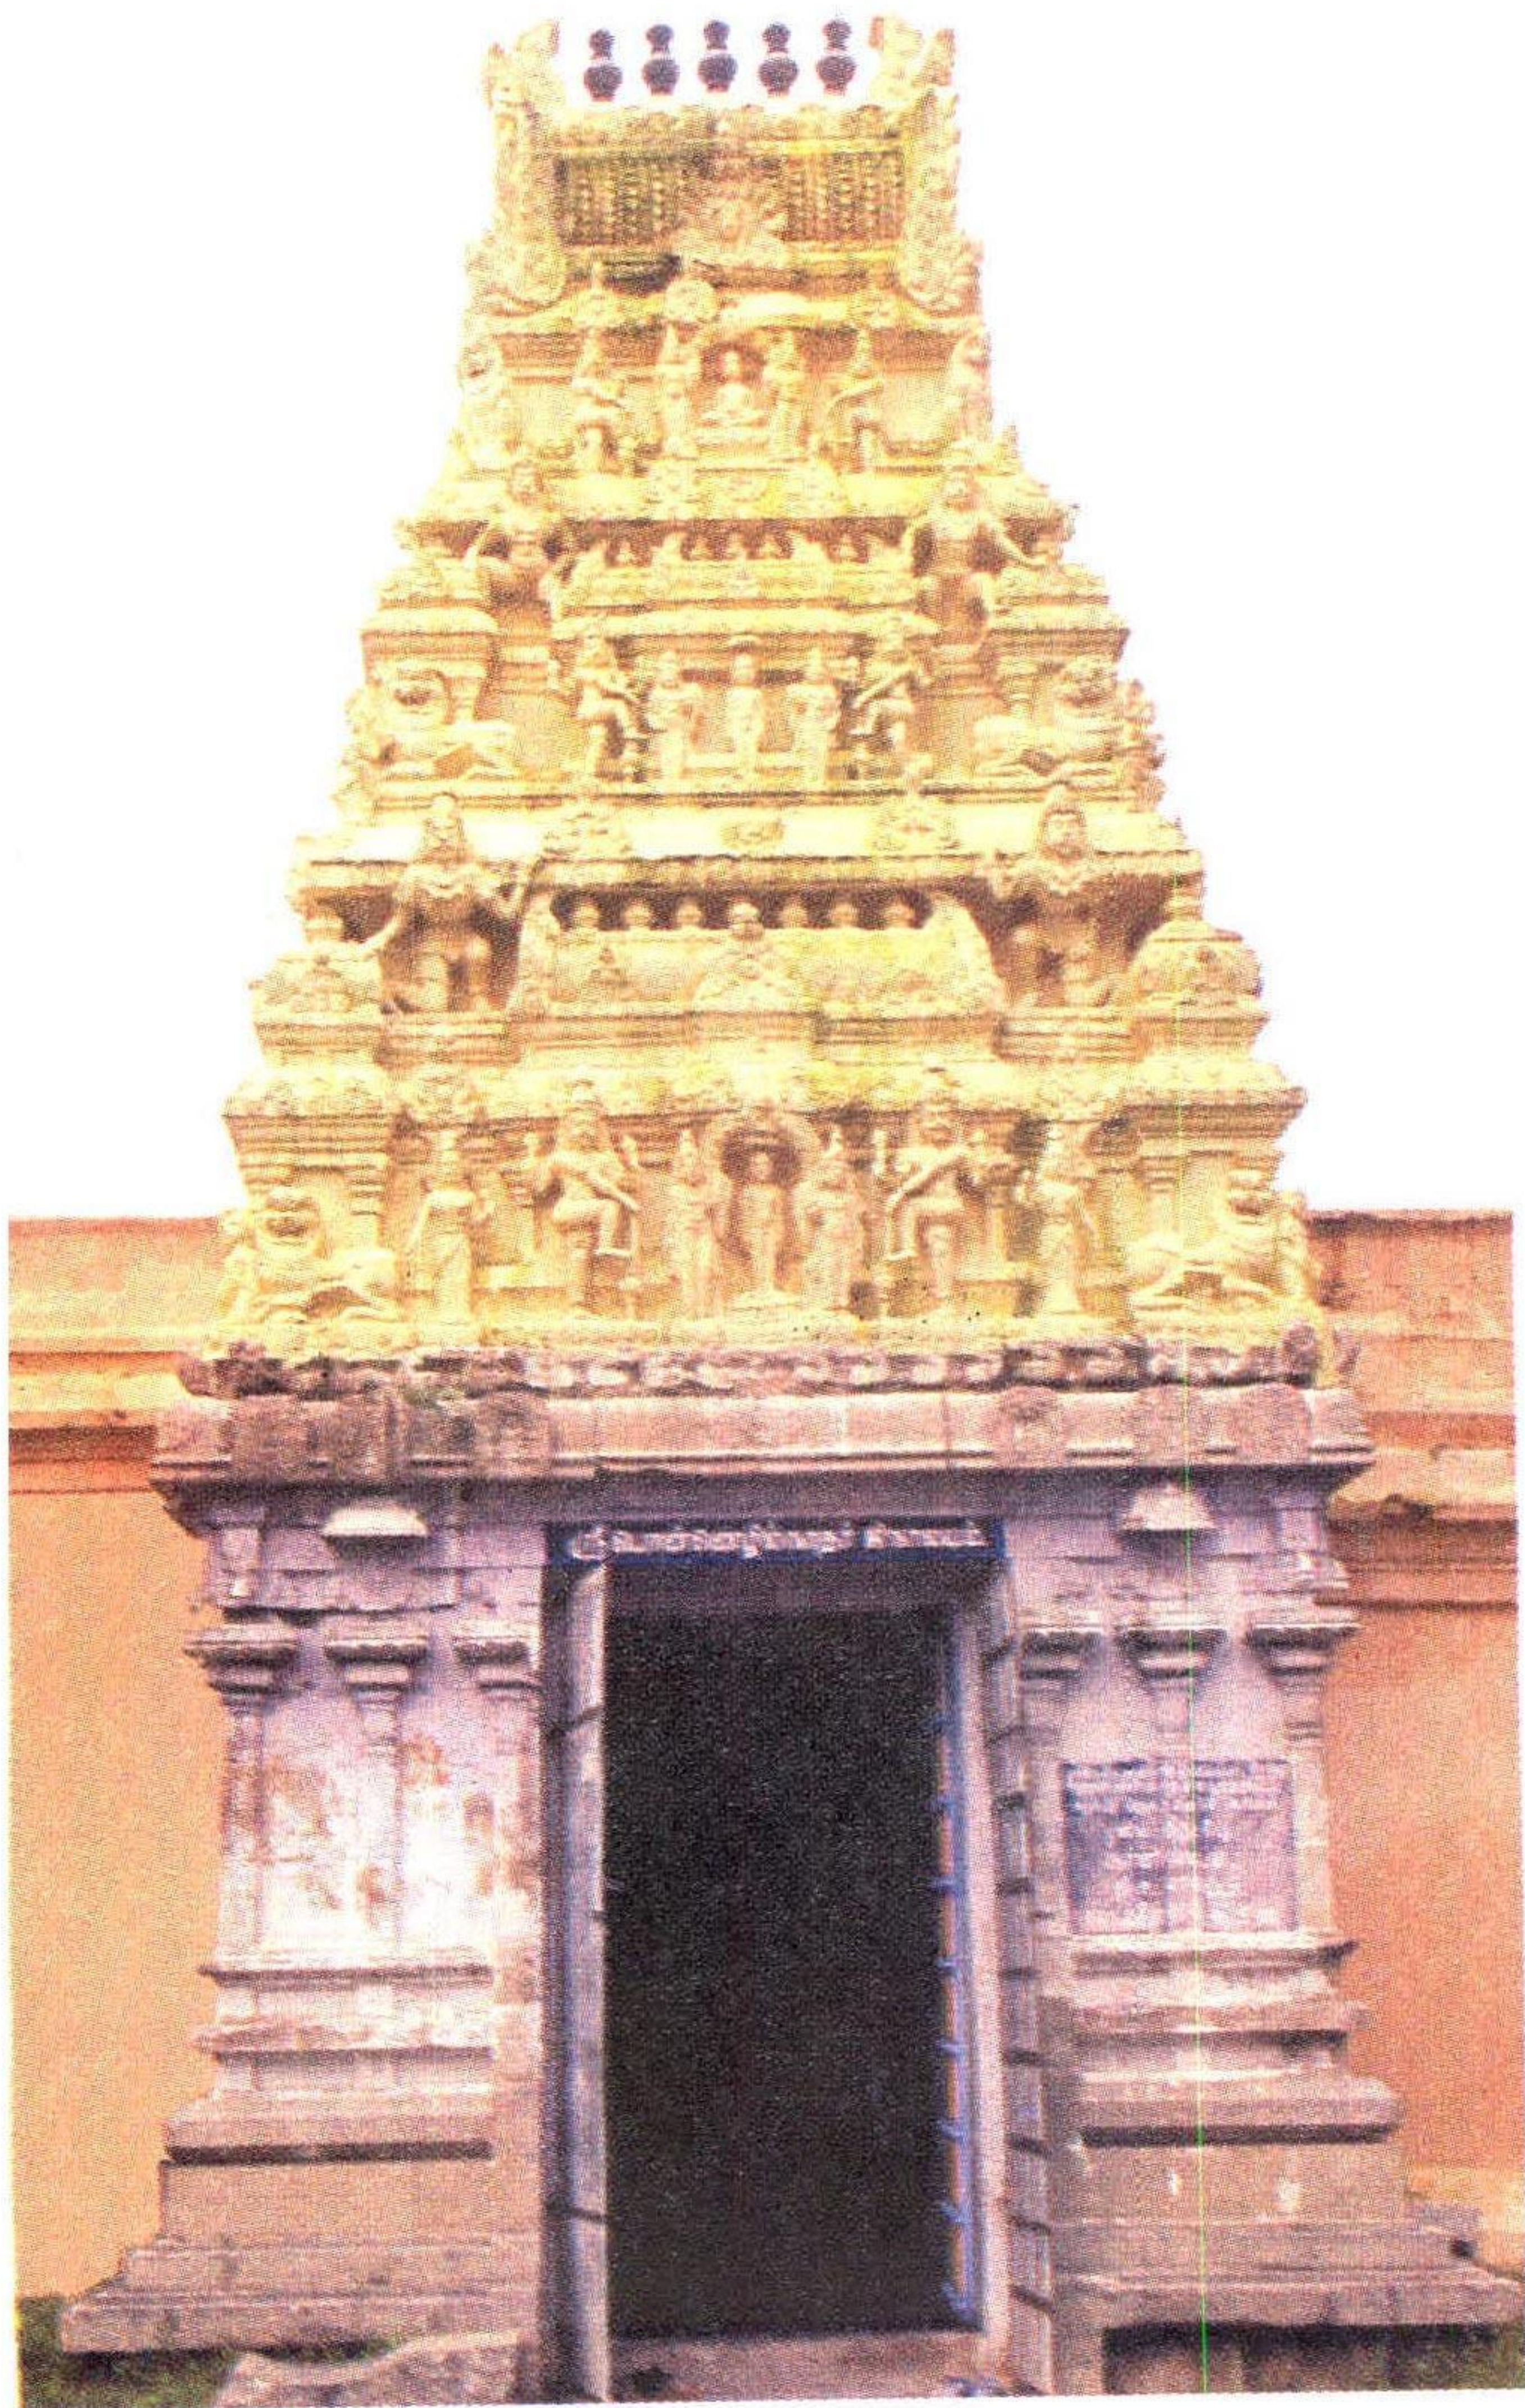
## **POONDI ARUGARKOIL, ERUMPEDU**

**After Conservation**

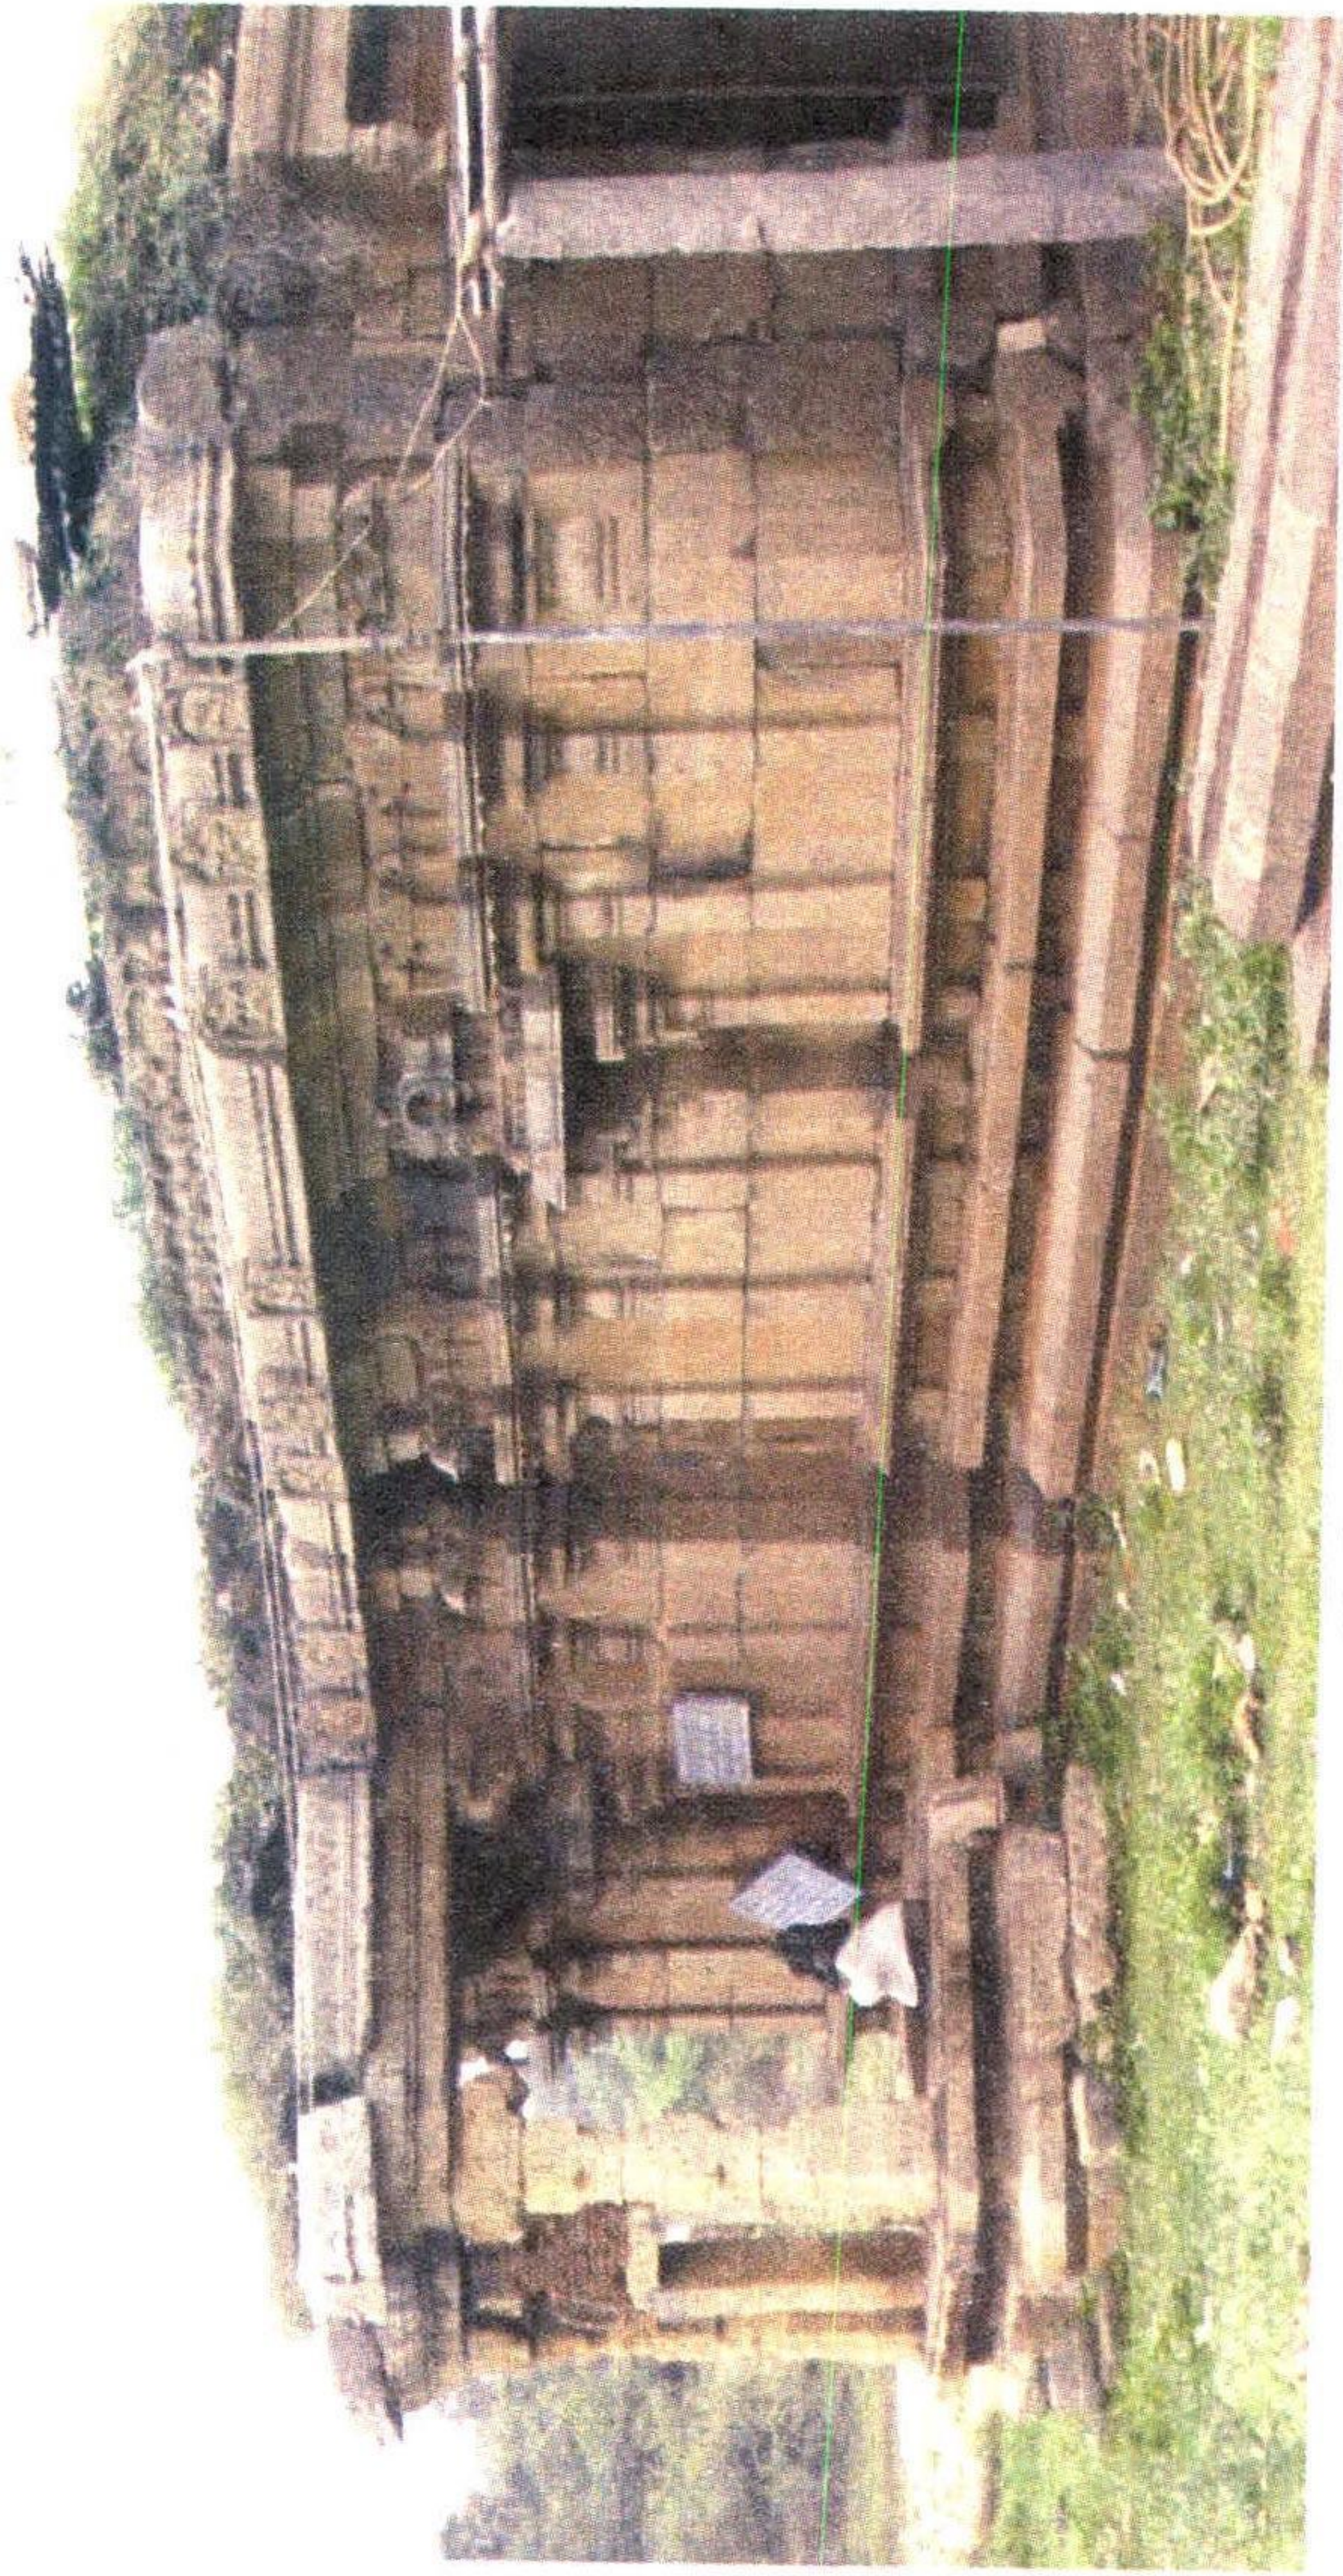
## SIVAN KOIL AYYAPATTI

At present top of the roof is covered with the tin sheets by the local devotees. Temporary entrance door is found at the Artha Mandapam of the Main Shrine. No settlement was found at anywhere. Main electrical service connection is hanging without support. Vegetation growth found at the inner boundary. All-round of Sanctum Sanctorum in the Ambal shrine and sub-shrines; stone courses of outer veneer with core filling have fallen from Adhithanam to Vuthiram portion. Except the Artha Mandapam of the Main Shrine; no roof Pavukkal is found. Certain fallen stone courses were found scattered within the boundary, and certain course stones were dumped at the boundary side. Hence special care has to be taken for classifying the required sizes to merge with the missing places by engaging the services of experienced Sthapathies. Kabothagam, Vyalum courses and roof Pavukkal stones are also not traceable. Additional mandapam has been constructed for koshta Dhakshinamoorthy by closing the inscriptions.

**Before Conservation**

- Outer wall stone courses are found partially hanging and fallen features may be interned in the earth on a spot as near as possible below the position it originally occupied. While falling due to its age and weathering action, there may be a chances to be broken in to pieces. By engaging experienced Sthapathy, rough sketch elevation by showing the courses of each side is to be drawn manually and available individual stones,

- Balipeedam and Nandhi mandapam may be completely removed and resetted after strengthening the foundation.

- Without ornamental works, new stones of Kabhothagam and Eluthagam may be provided in the missing places. In all reconstruction, care must be taken that the new stone work to be match with existing texture and colour and it may be dressed in the same way.

- Undulated flooring found at Artha Mandapam and sub-shrines are to be removed completely and resetted.

- Inscriptions found at Adhistanam level was completely closed by constructing the later addition mandapam at the south west corner of the outer main shrine. Without damaging the adjacent main structure, the additional encroachment may be evicted very carefully.

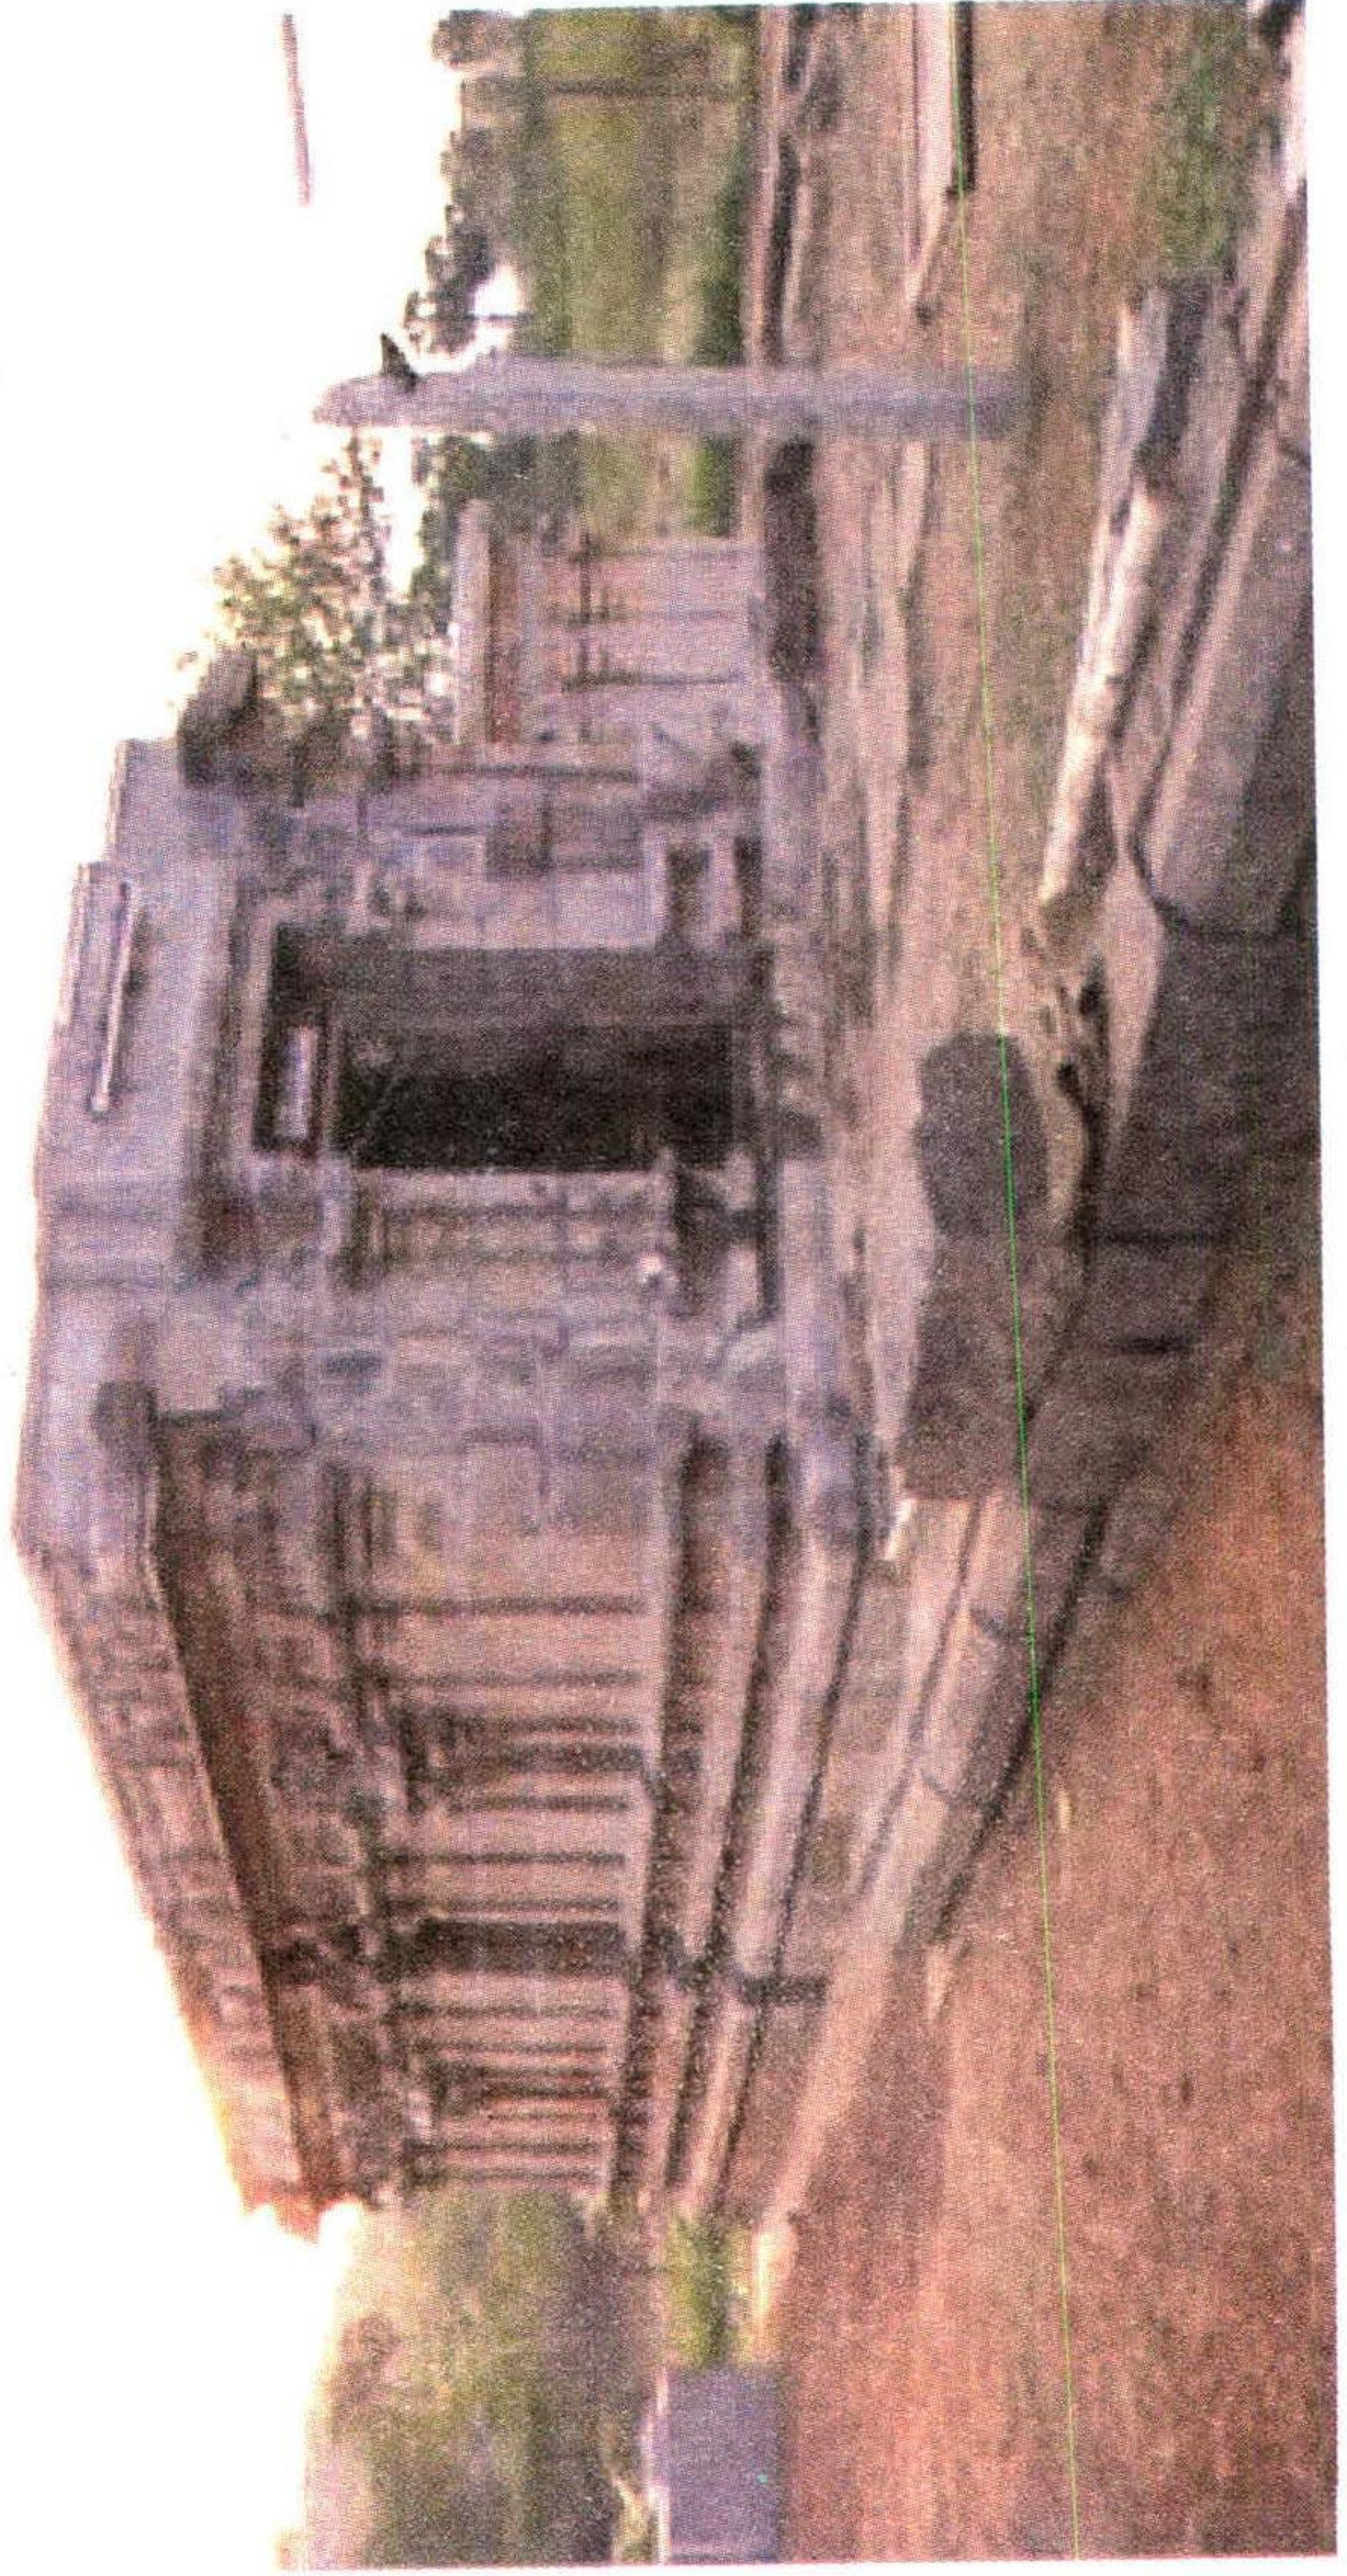
## **SIVAN KOIL AYYAPATTI**

**After Conservation**

Outer wall stone courses are found partially hanging and fallen features interned in the earth on a spot were removed carefully to use the same at the missing portion.

- After strengthening the foundation outer veneer stones were replaced in their original positions by providing necessary core filling as per the existing..

- Palipeedam and Nandhi mandapam were completely removed and resetted after strengthening the foundation.

- Without ornamental works, new stones of Kabhothagam and Eluthagam provided in the missing places were bedded in combination mortar 1:1:5 and pointed with same mortar.

- Undulated flooring found at Artha Mandapam and sub-shrines were removed completely by Aressing.

- Later addition mandapam at the south west corner of the outer main shrine. evicted and inscriptions found at Adhistanam level was brought to the light.

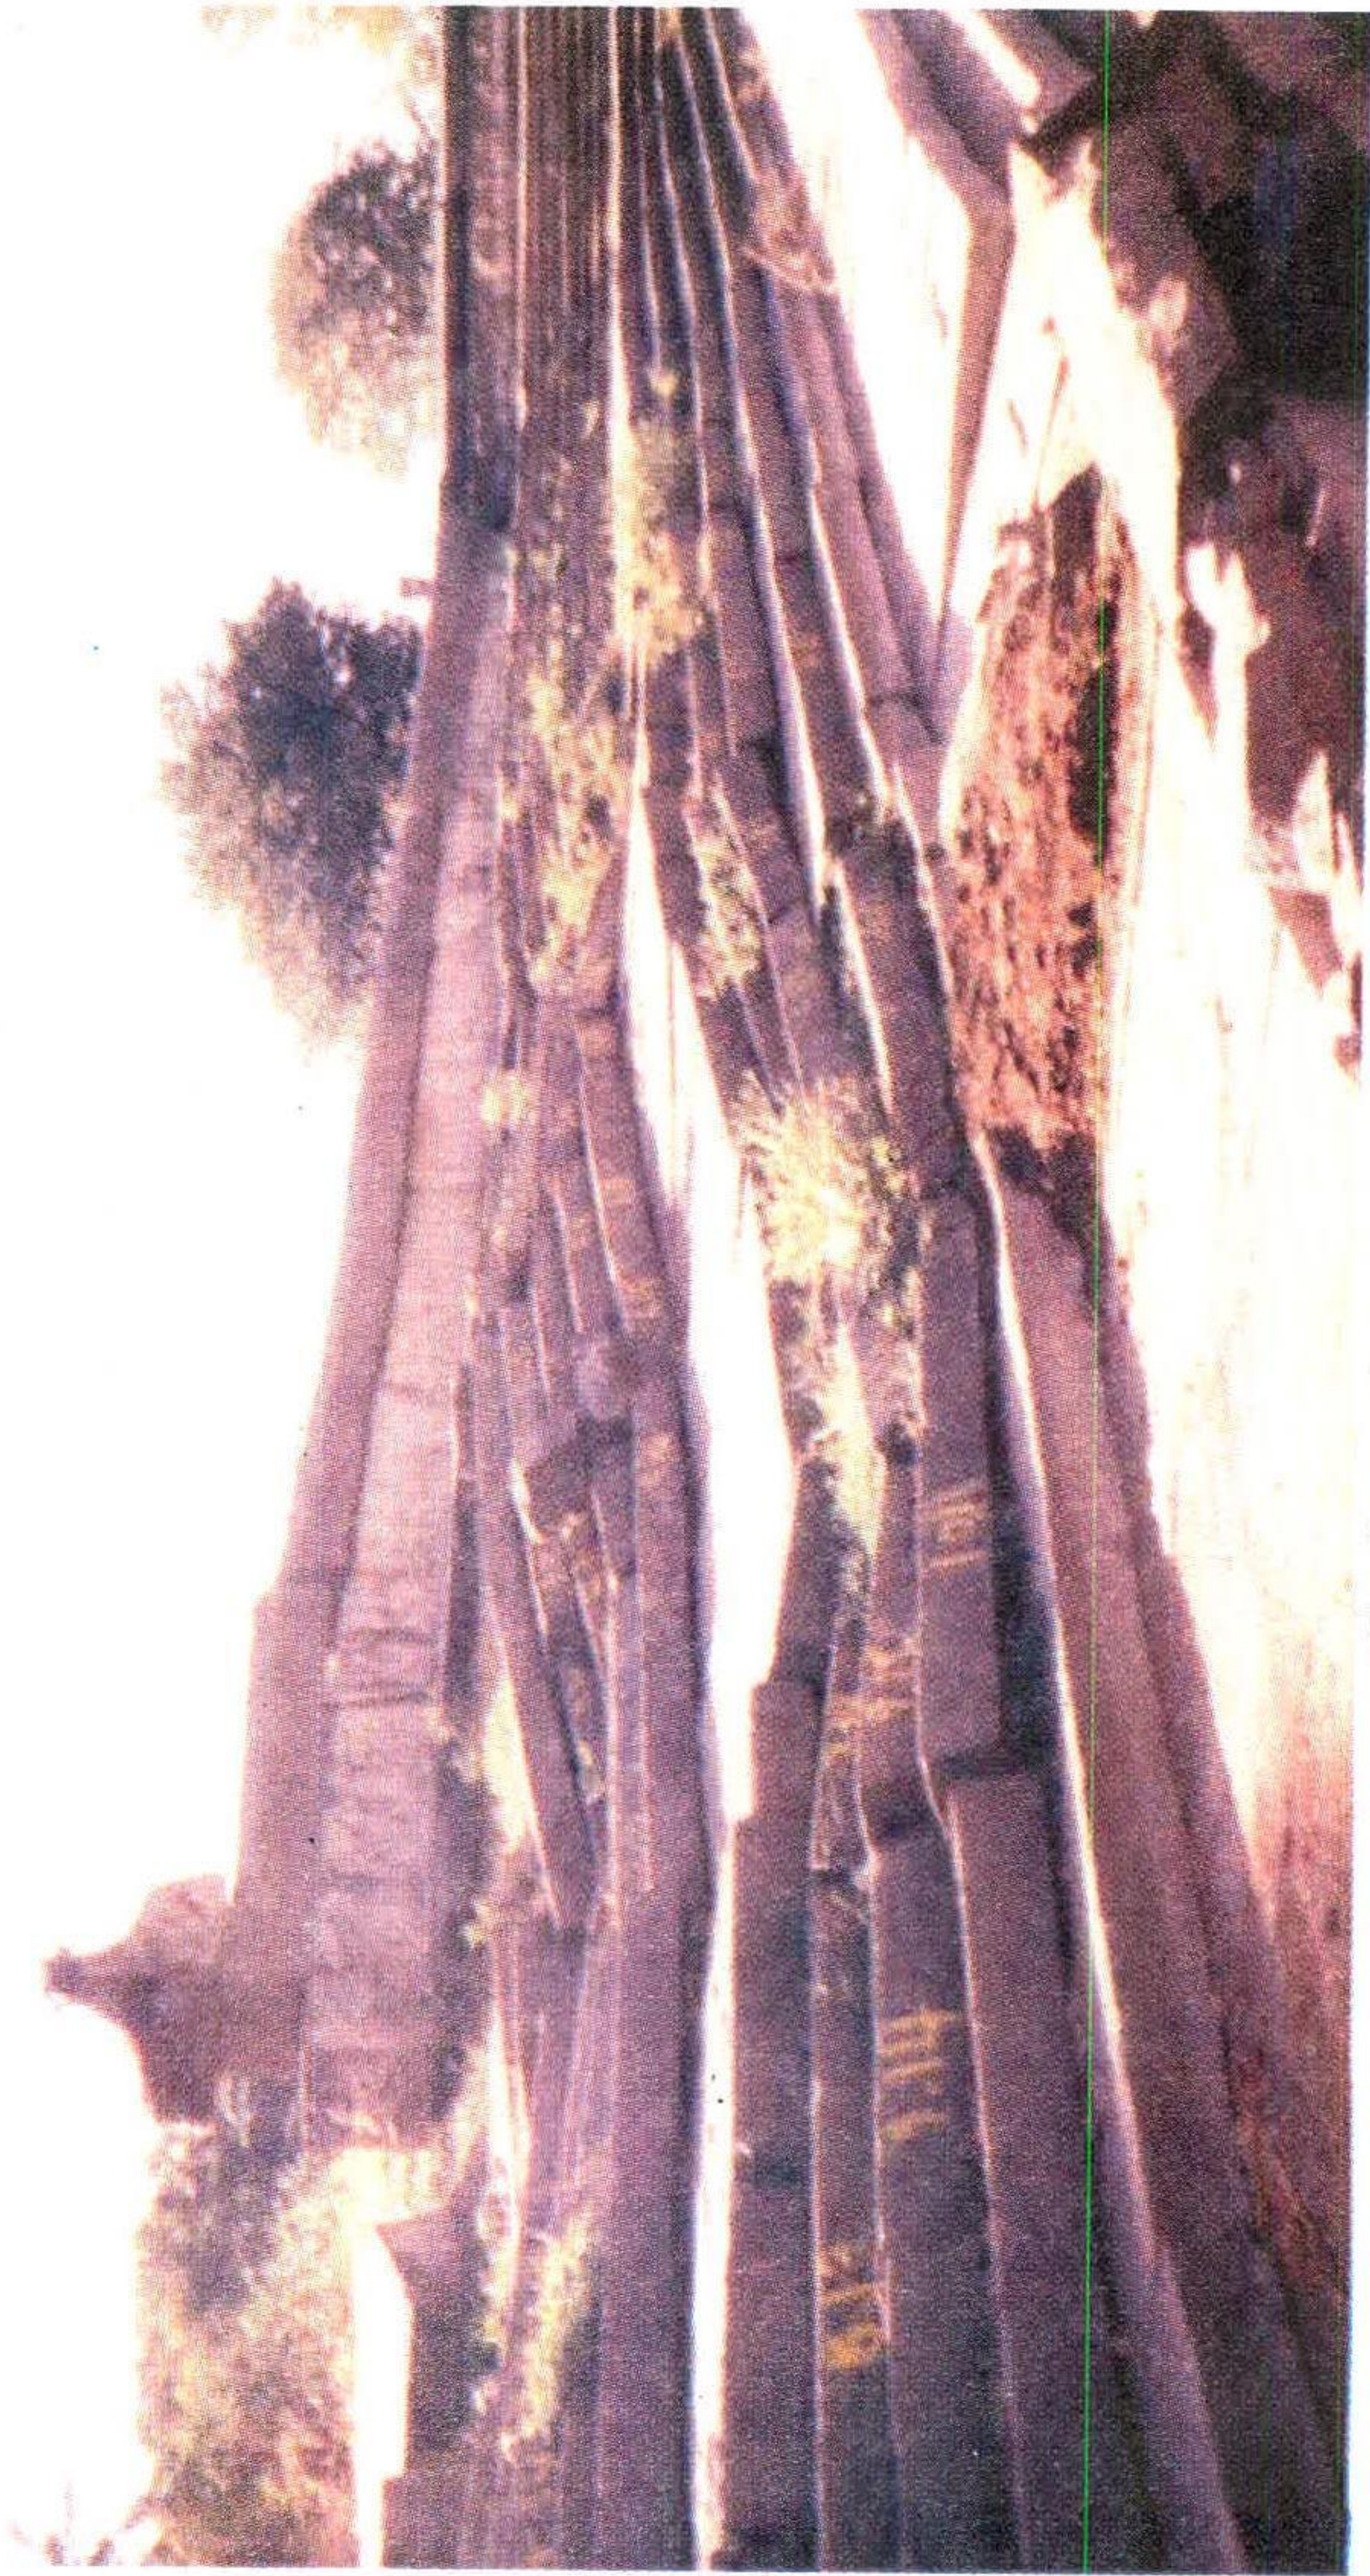
## **CHINAYANKULAM, CHINNAYAMPET**

**Before Conservation**

- Disturbed steps found from the top to the possibility level of the steps at northern & southern side to be rectified.
- Uprooting the thorny vegetations growth found within the fencing area.
- PCC platform to be extended up to the fencing.
- Blocked earth and debris to be removed from the out-let and in-let channels of the tank.

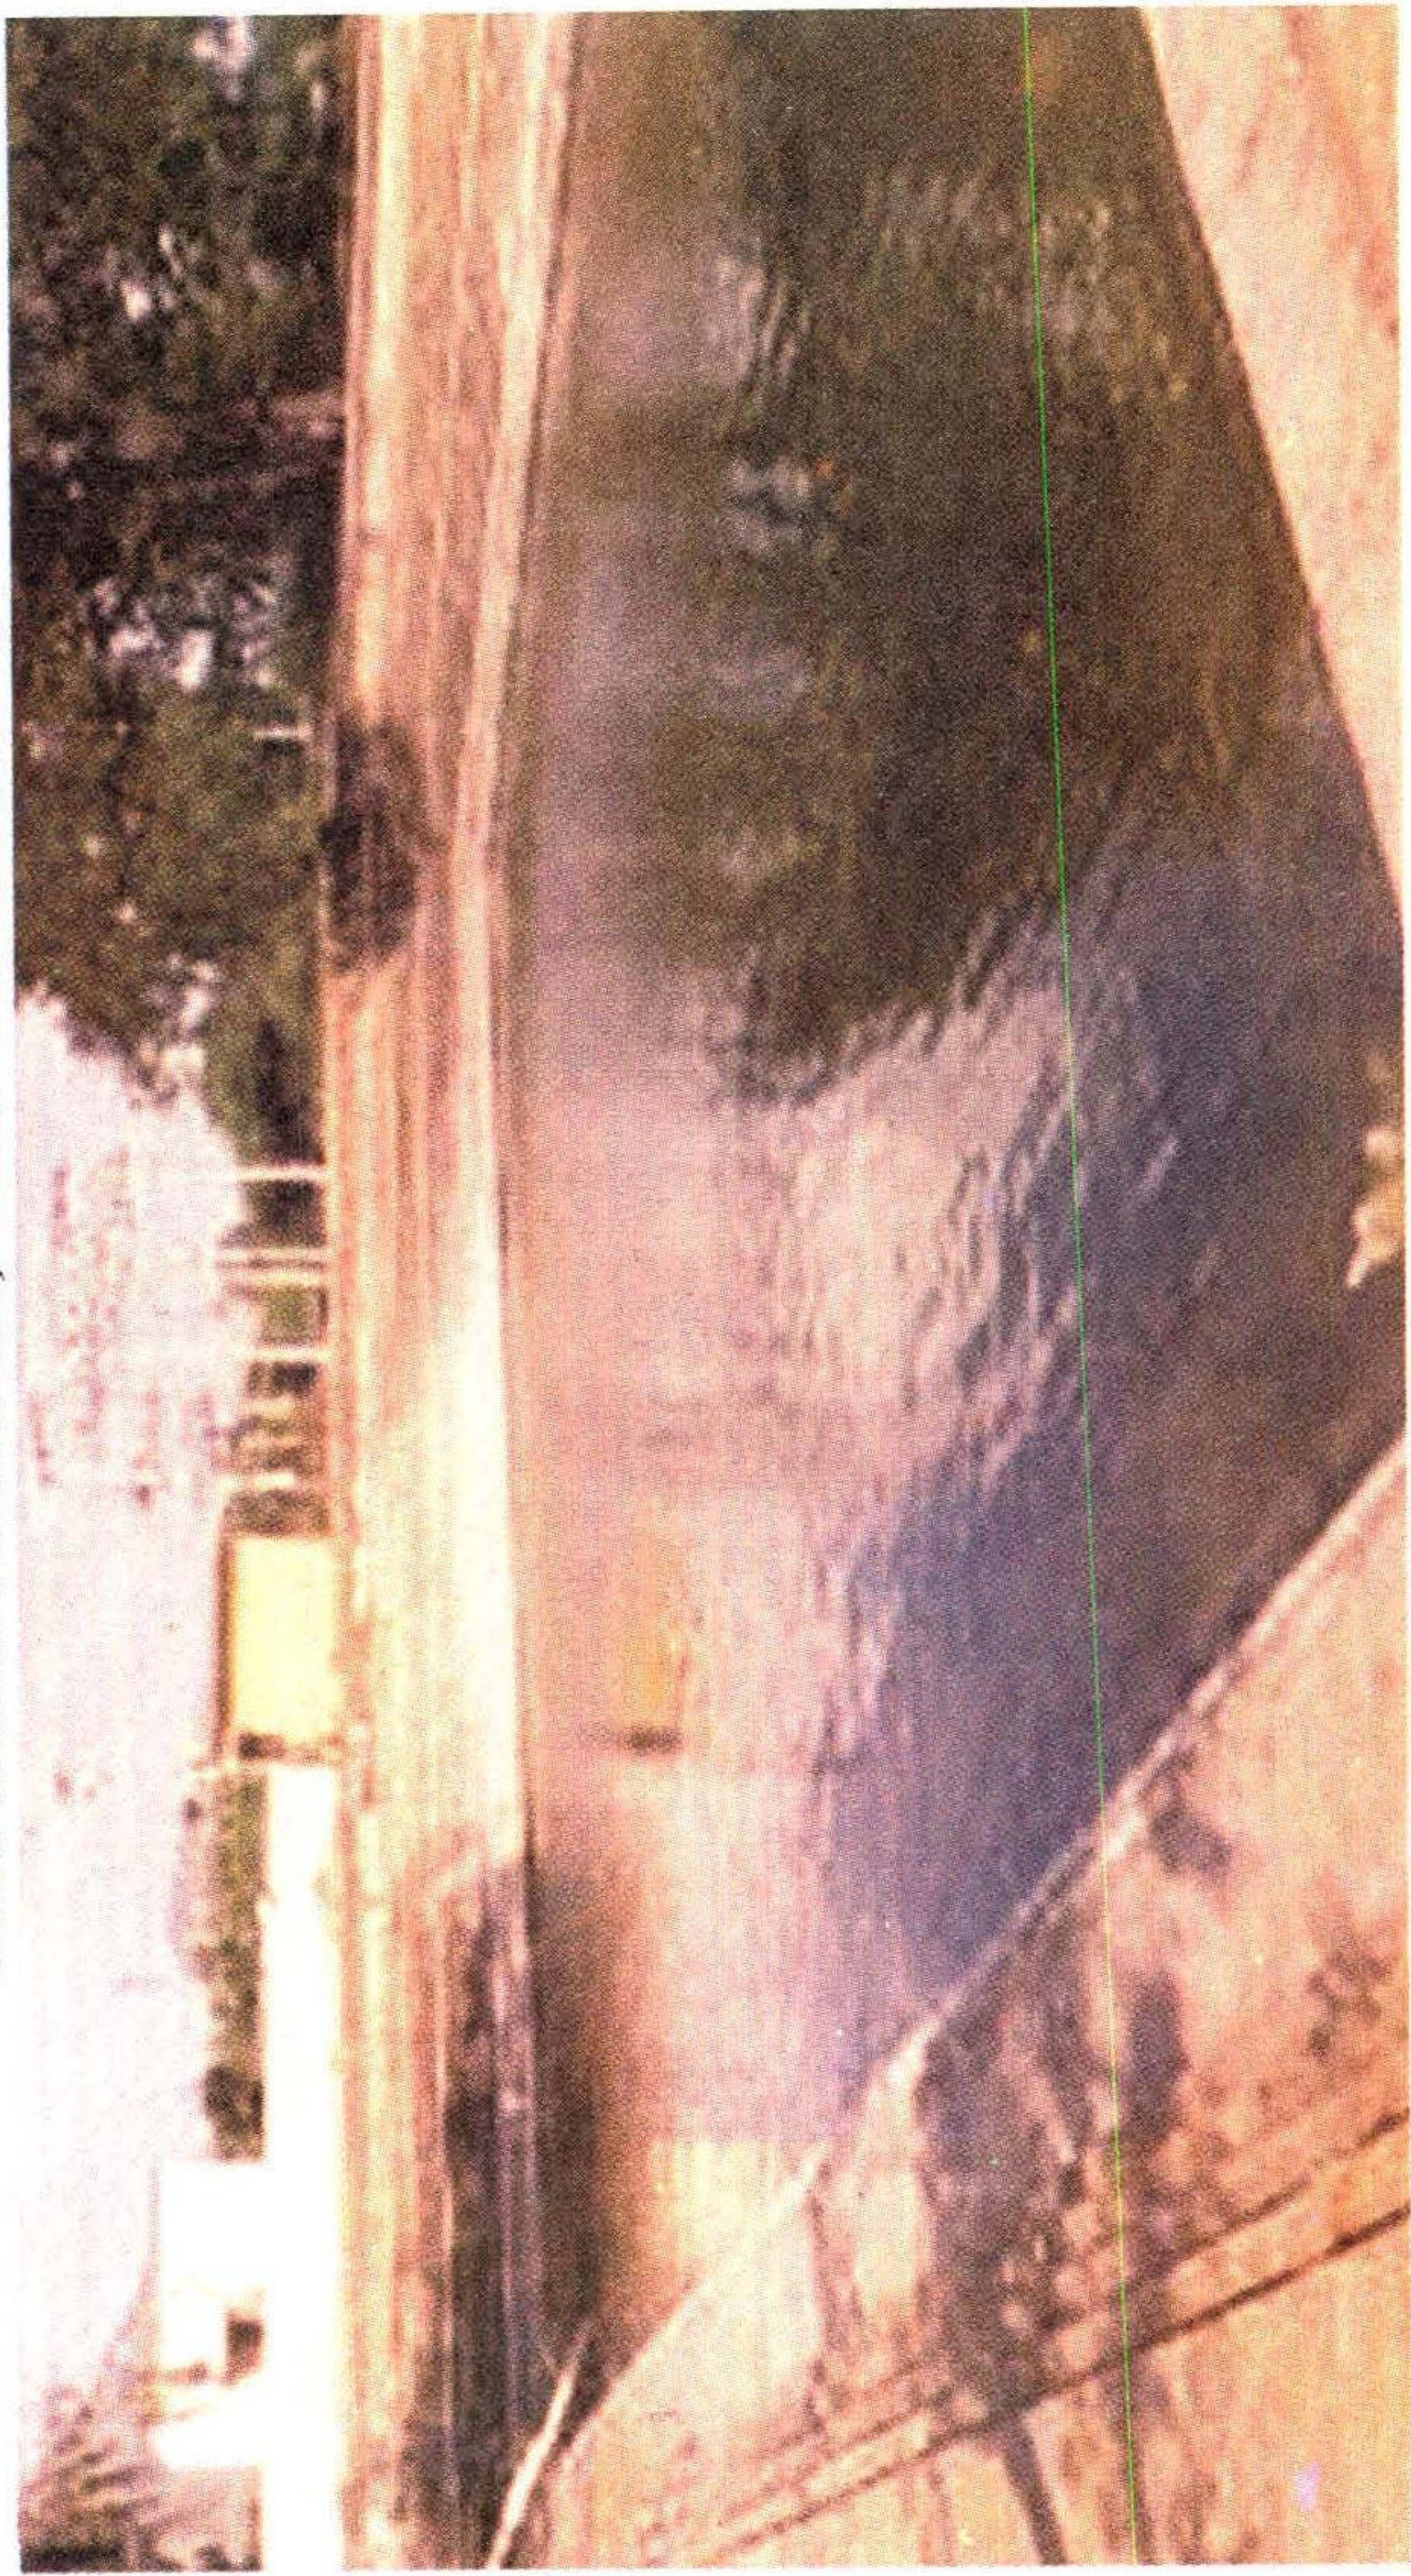
**CHINAYANKULAM, CHINNAYAMPET**

**After Conservation**

Vegetation growths found in the gaps of the stone slabs were removed. Silt has been removed by pumping water. Barbed wire fencing was provided around the tank with RCC post supports. Defects were rectified by removing and resetting the steps at the eastern and western portion of the tank from the base to top of the parapet. Existing gate pillars were strengthened and grill gate has been provided. Twin Nandhi joined with single head has been placed in its position. Vitreous enamel information and notice board were placed at the entry to the tank.
