# **Conservation works of Monuments**

**2006 - 2010**

**DEPARTMENT OF ARCHAEOLOGY**  
**GOVERNMENT OF TAMIL NADU**  
**CHENNAI.**

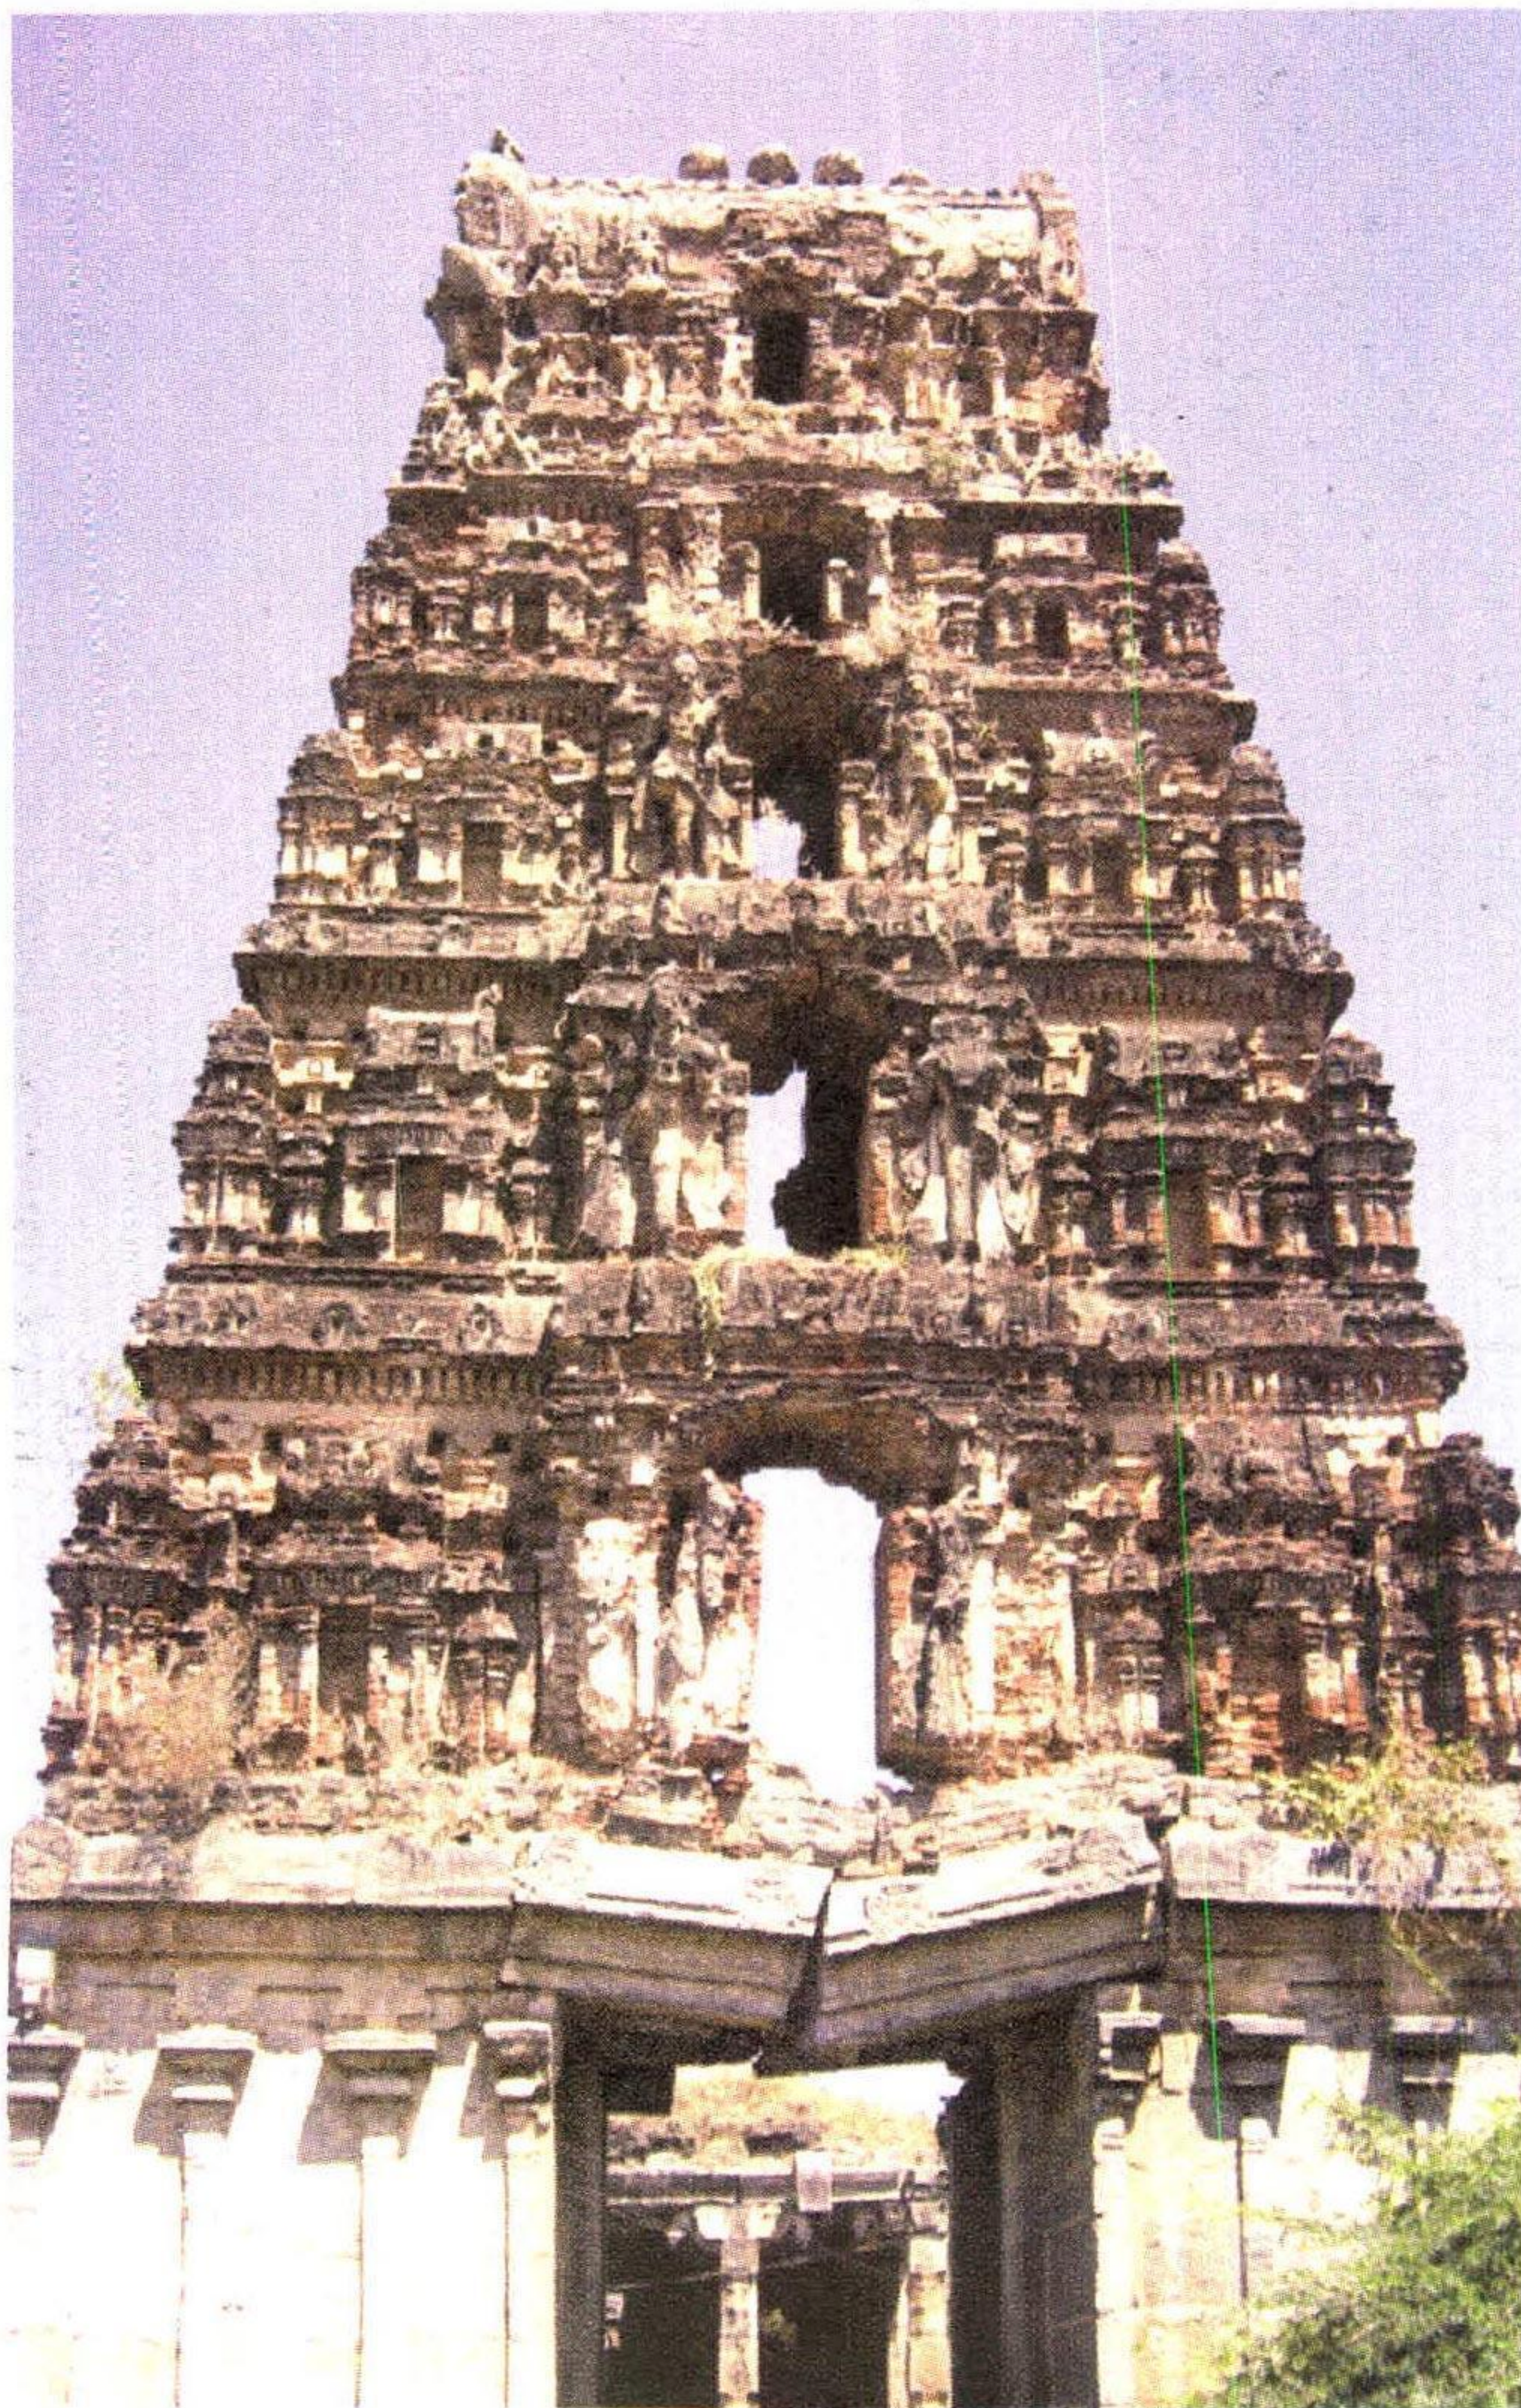
## **RAJA GOPURAM, MADAM**

Due to broken of main stone beams and stone door frame on either side of entrance, five tier Main Gopuram

constructed with stucco work over the kalkaram (Stone Masonry) has fallen by leaving certain evidences in north and southern side. Eastern and western side of the brick work with its niches and human figure are fully existing. Outer veneer of kalkaram portion is found slightly out of plumb due to growth of vegetation. However hanging brick work found without any support and rafters available at north and southern side may fall at any time. As per the archaeological principle, present stage of the Main Gopuram has been recorded by photo documentation. This is the most challenging item of work in the entire monument.

**Before Conservation**

- Superintending Engineer, HR&CE; suggested that “the entire main gopuram to be dismantled thoroughly; after strengthening foundation by RCC works it may be re-constructed”.

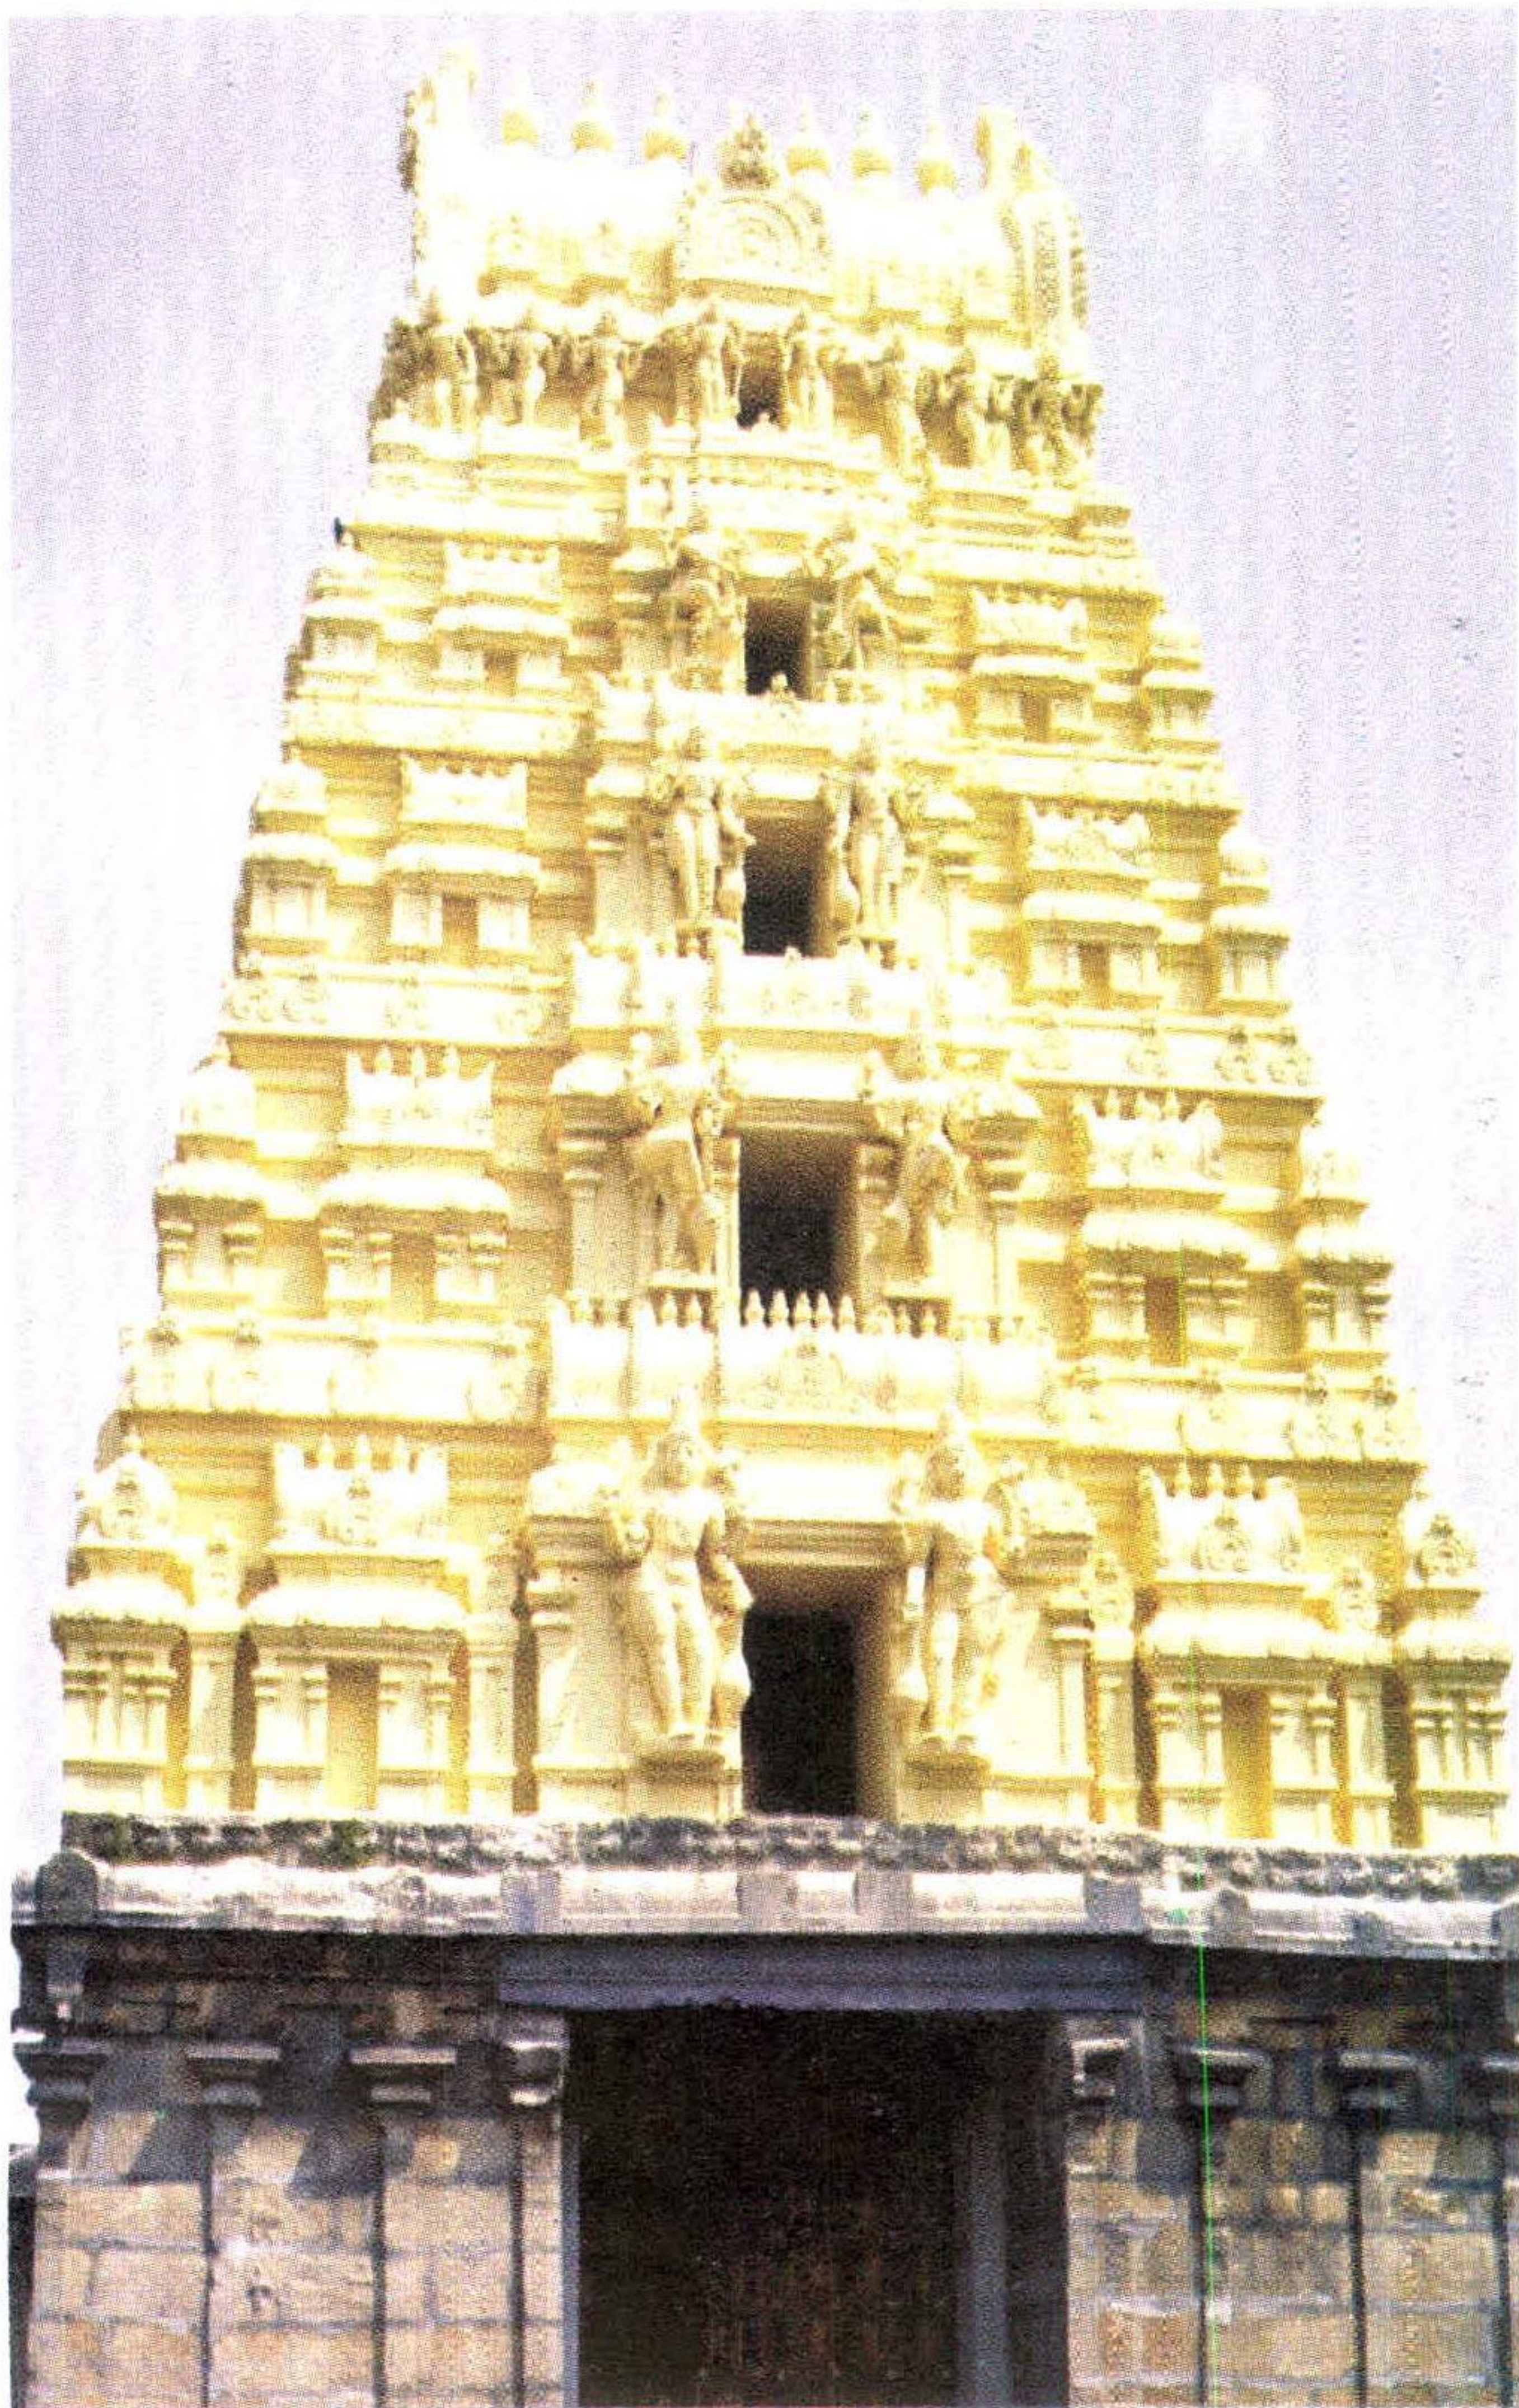
## **RAJA GOPURAM, MADAM**

**After Conservation**

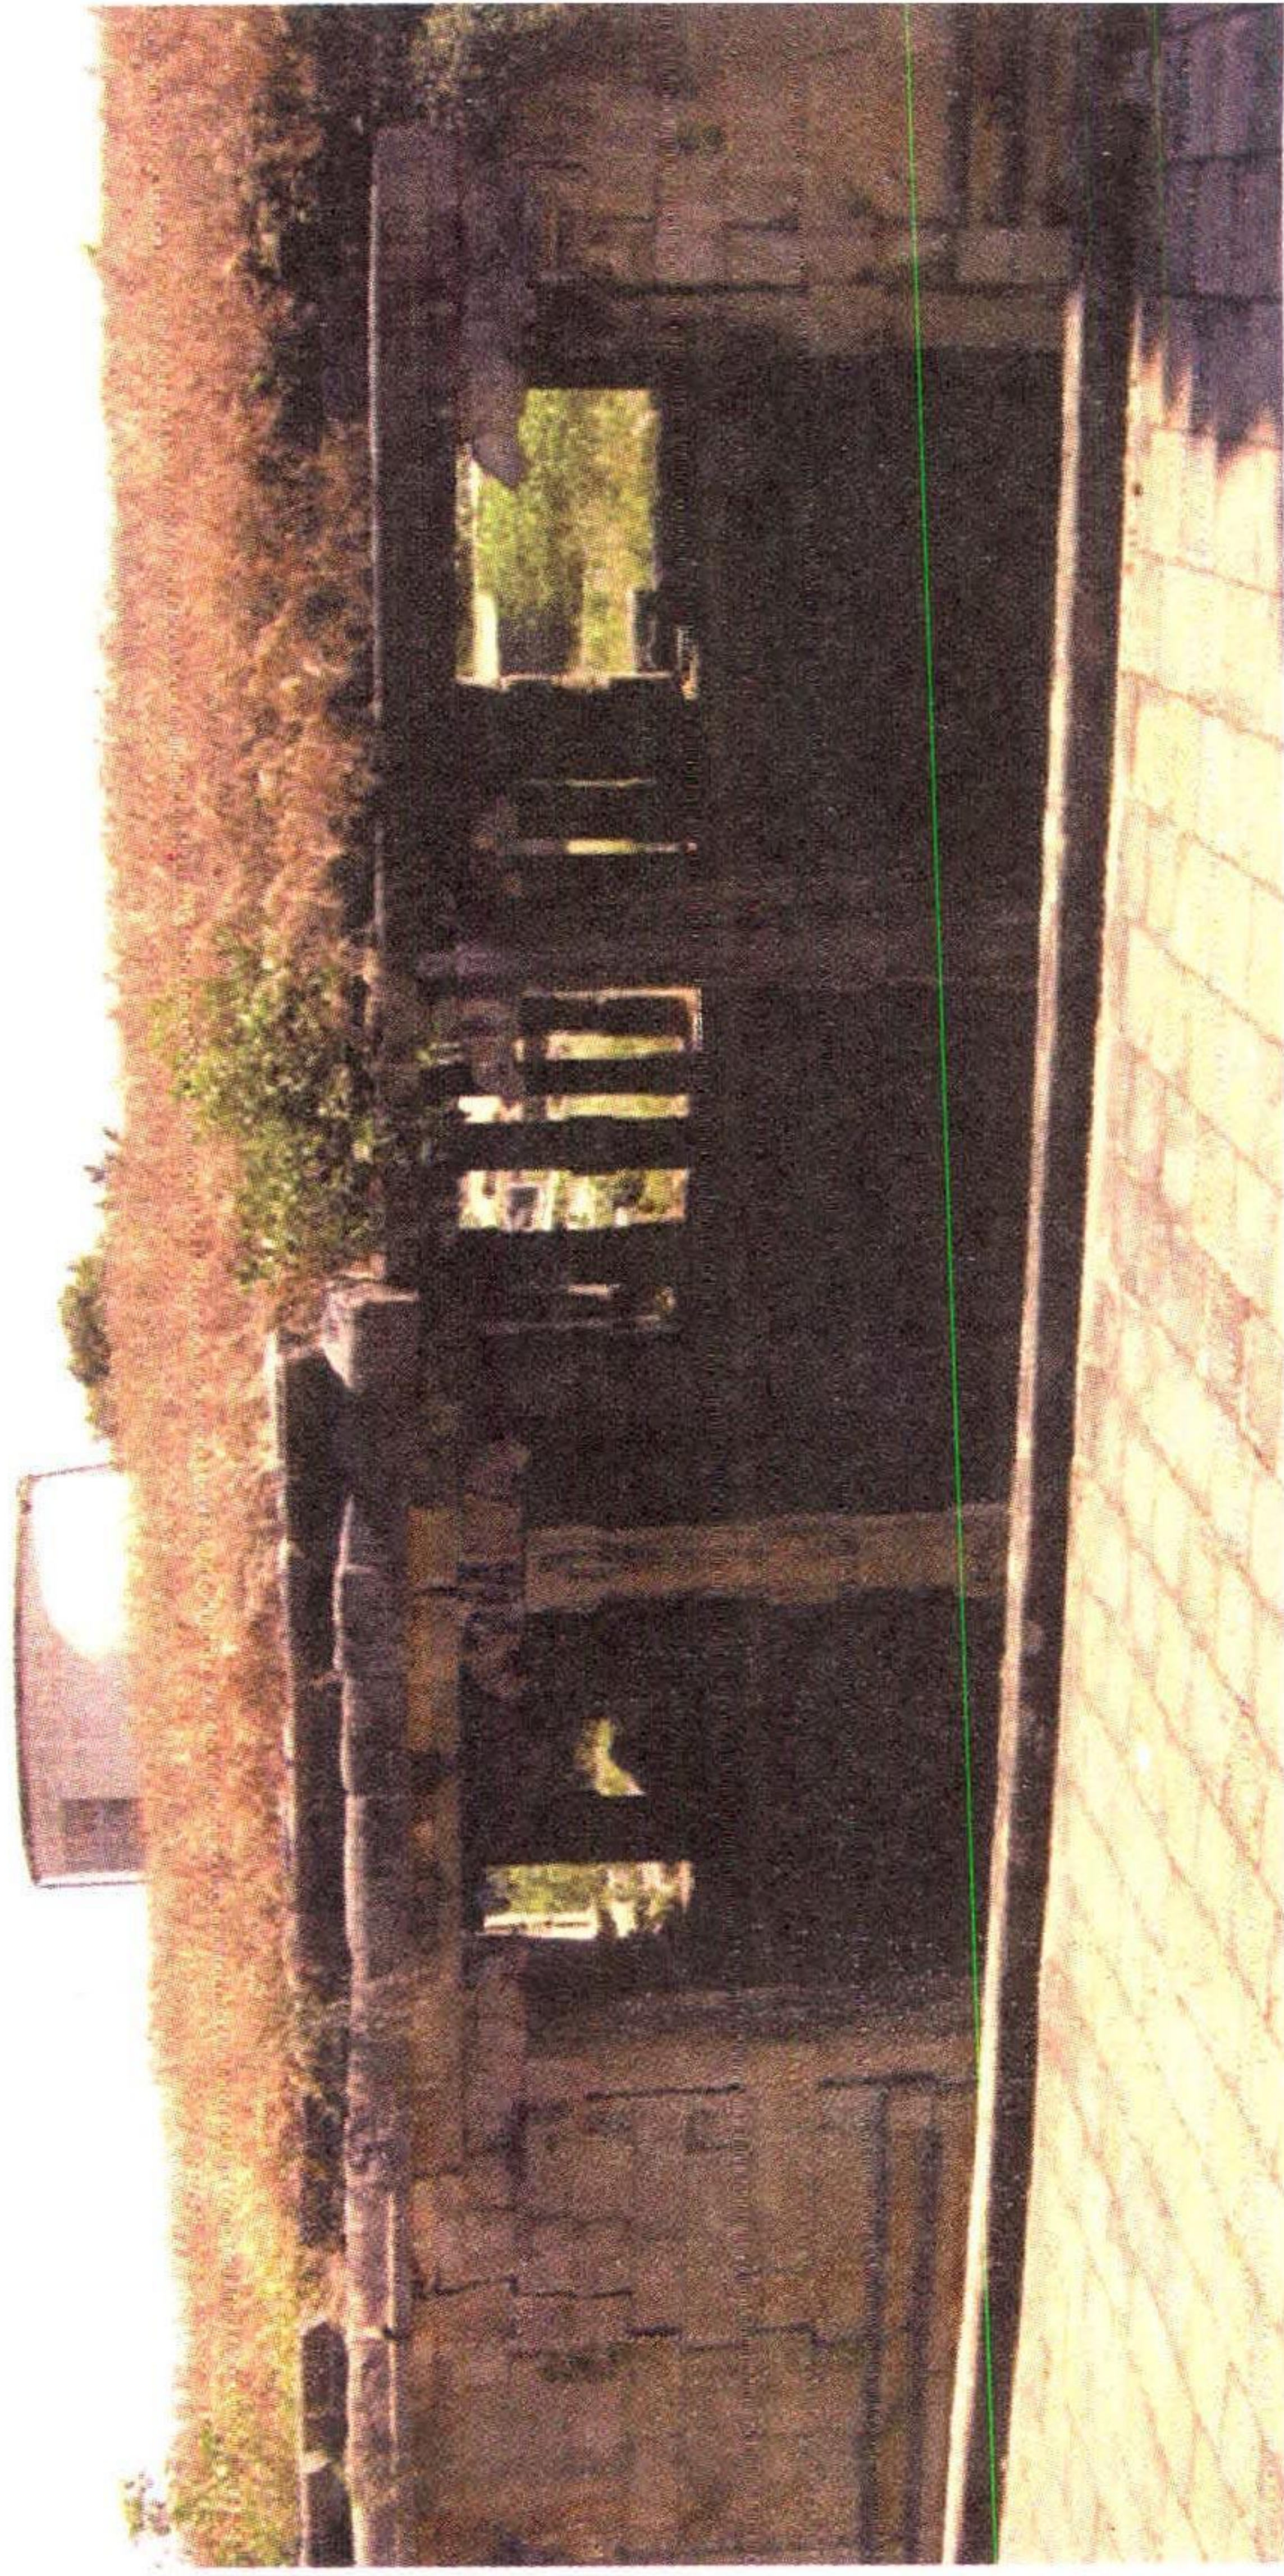
## KALYANA MANDAPAM, MADAM

Roof pavukkal had fallen down from its position at the stage portion. Supporting pillars at the front mandapam were also disturbed. Weathering course was found with heavy dead load.

**Before Conservation**

- By removing the Weathering course, broken pavukkal and stone beams may be removed and replaced both in the mandapam and stage portion with same texture and colour after providing necessary additional supports like centering.

- Broken Bothiyal may also be replaced wherever required.

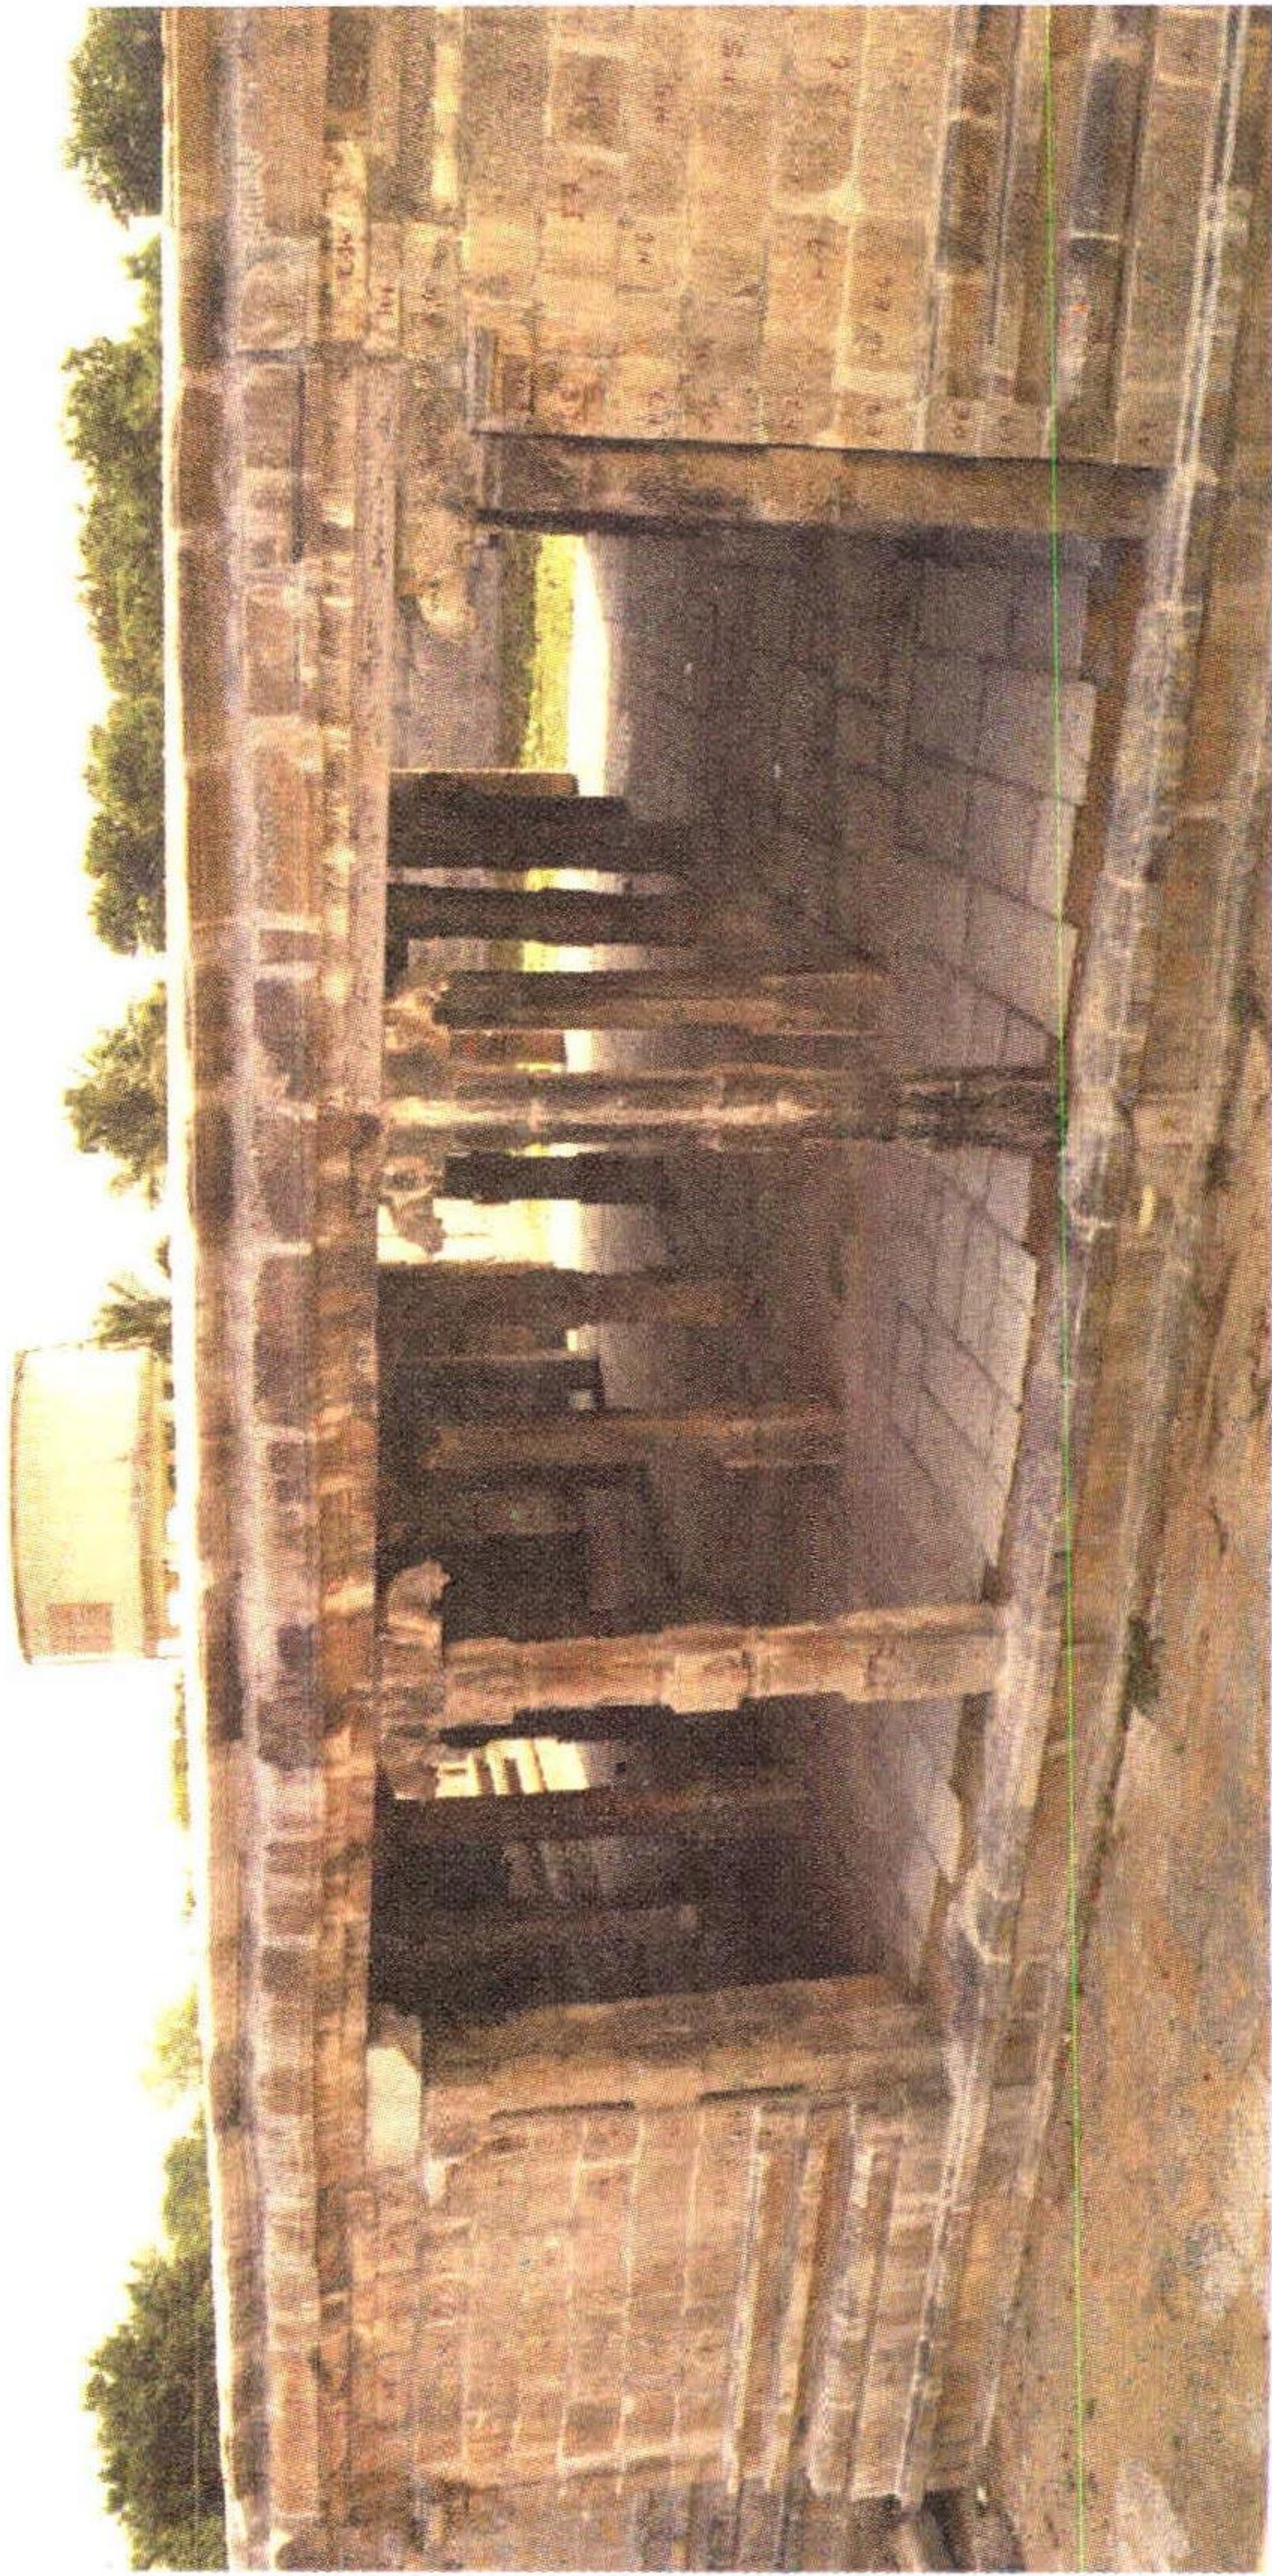
## KALYANA MANDAPAM, MADAM

**After Conservation**

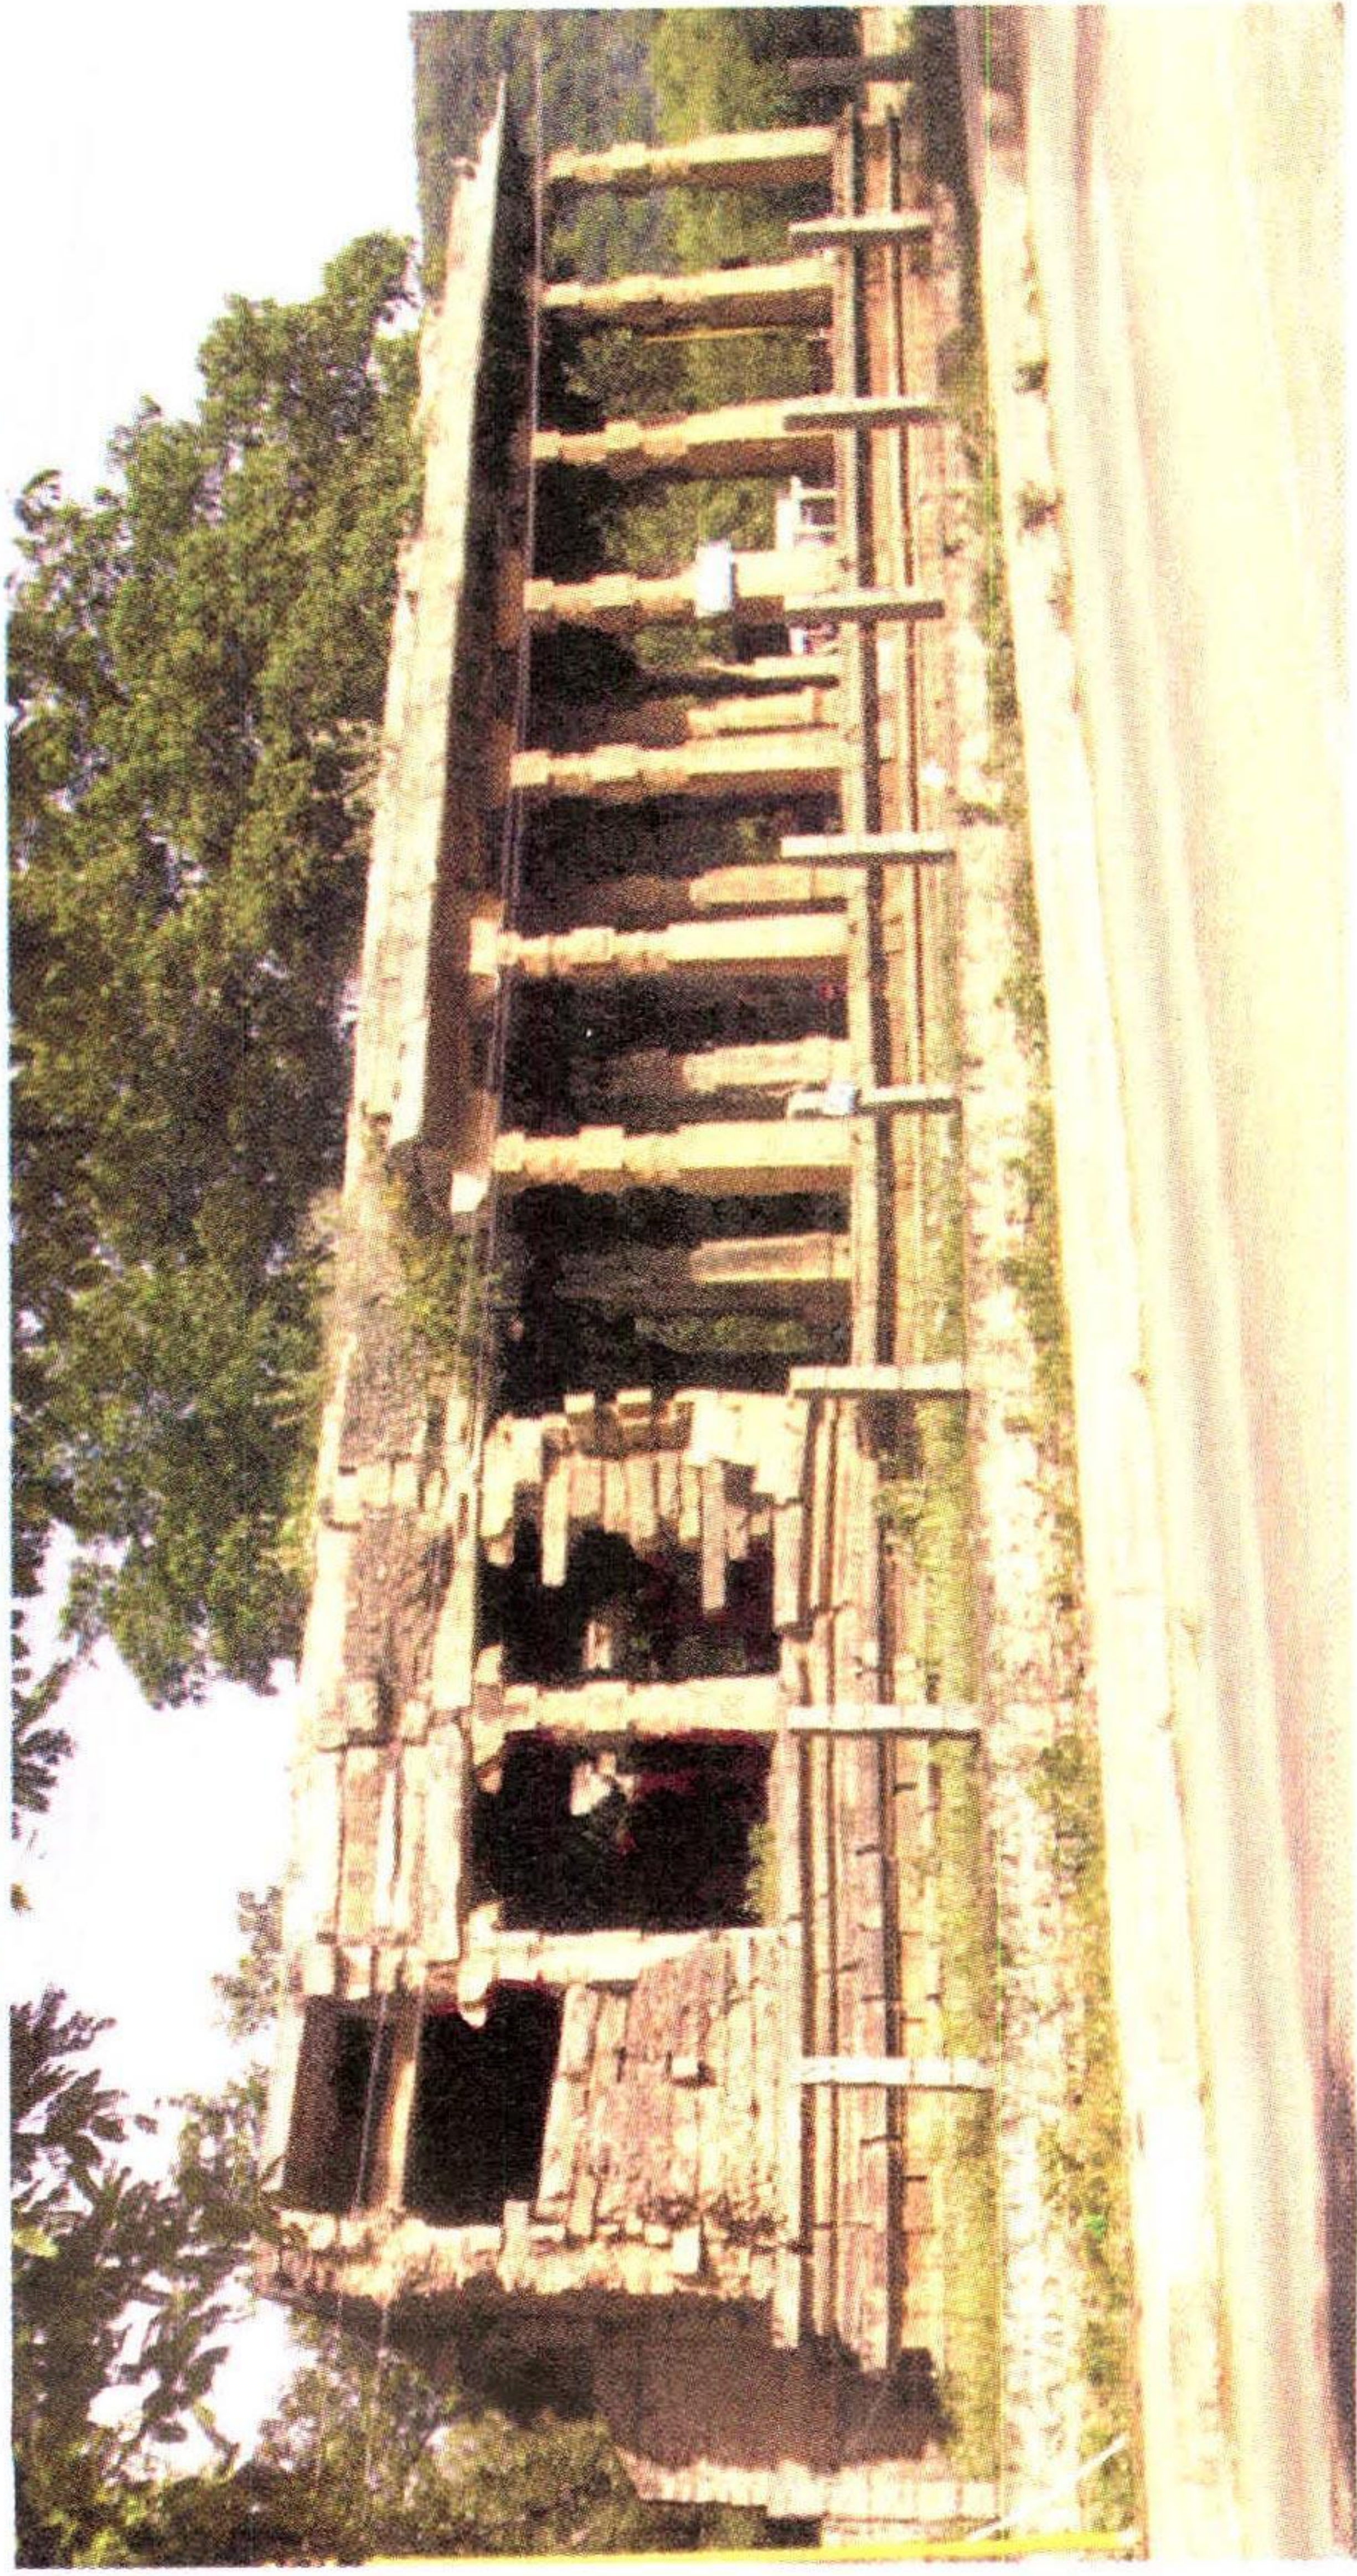
## THIRUMALAI NAYAKKAR MANDAPAM, ALAGAR KOIL

**Before Conservation**

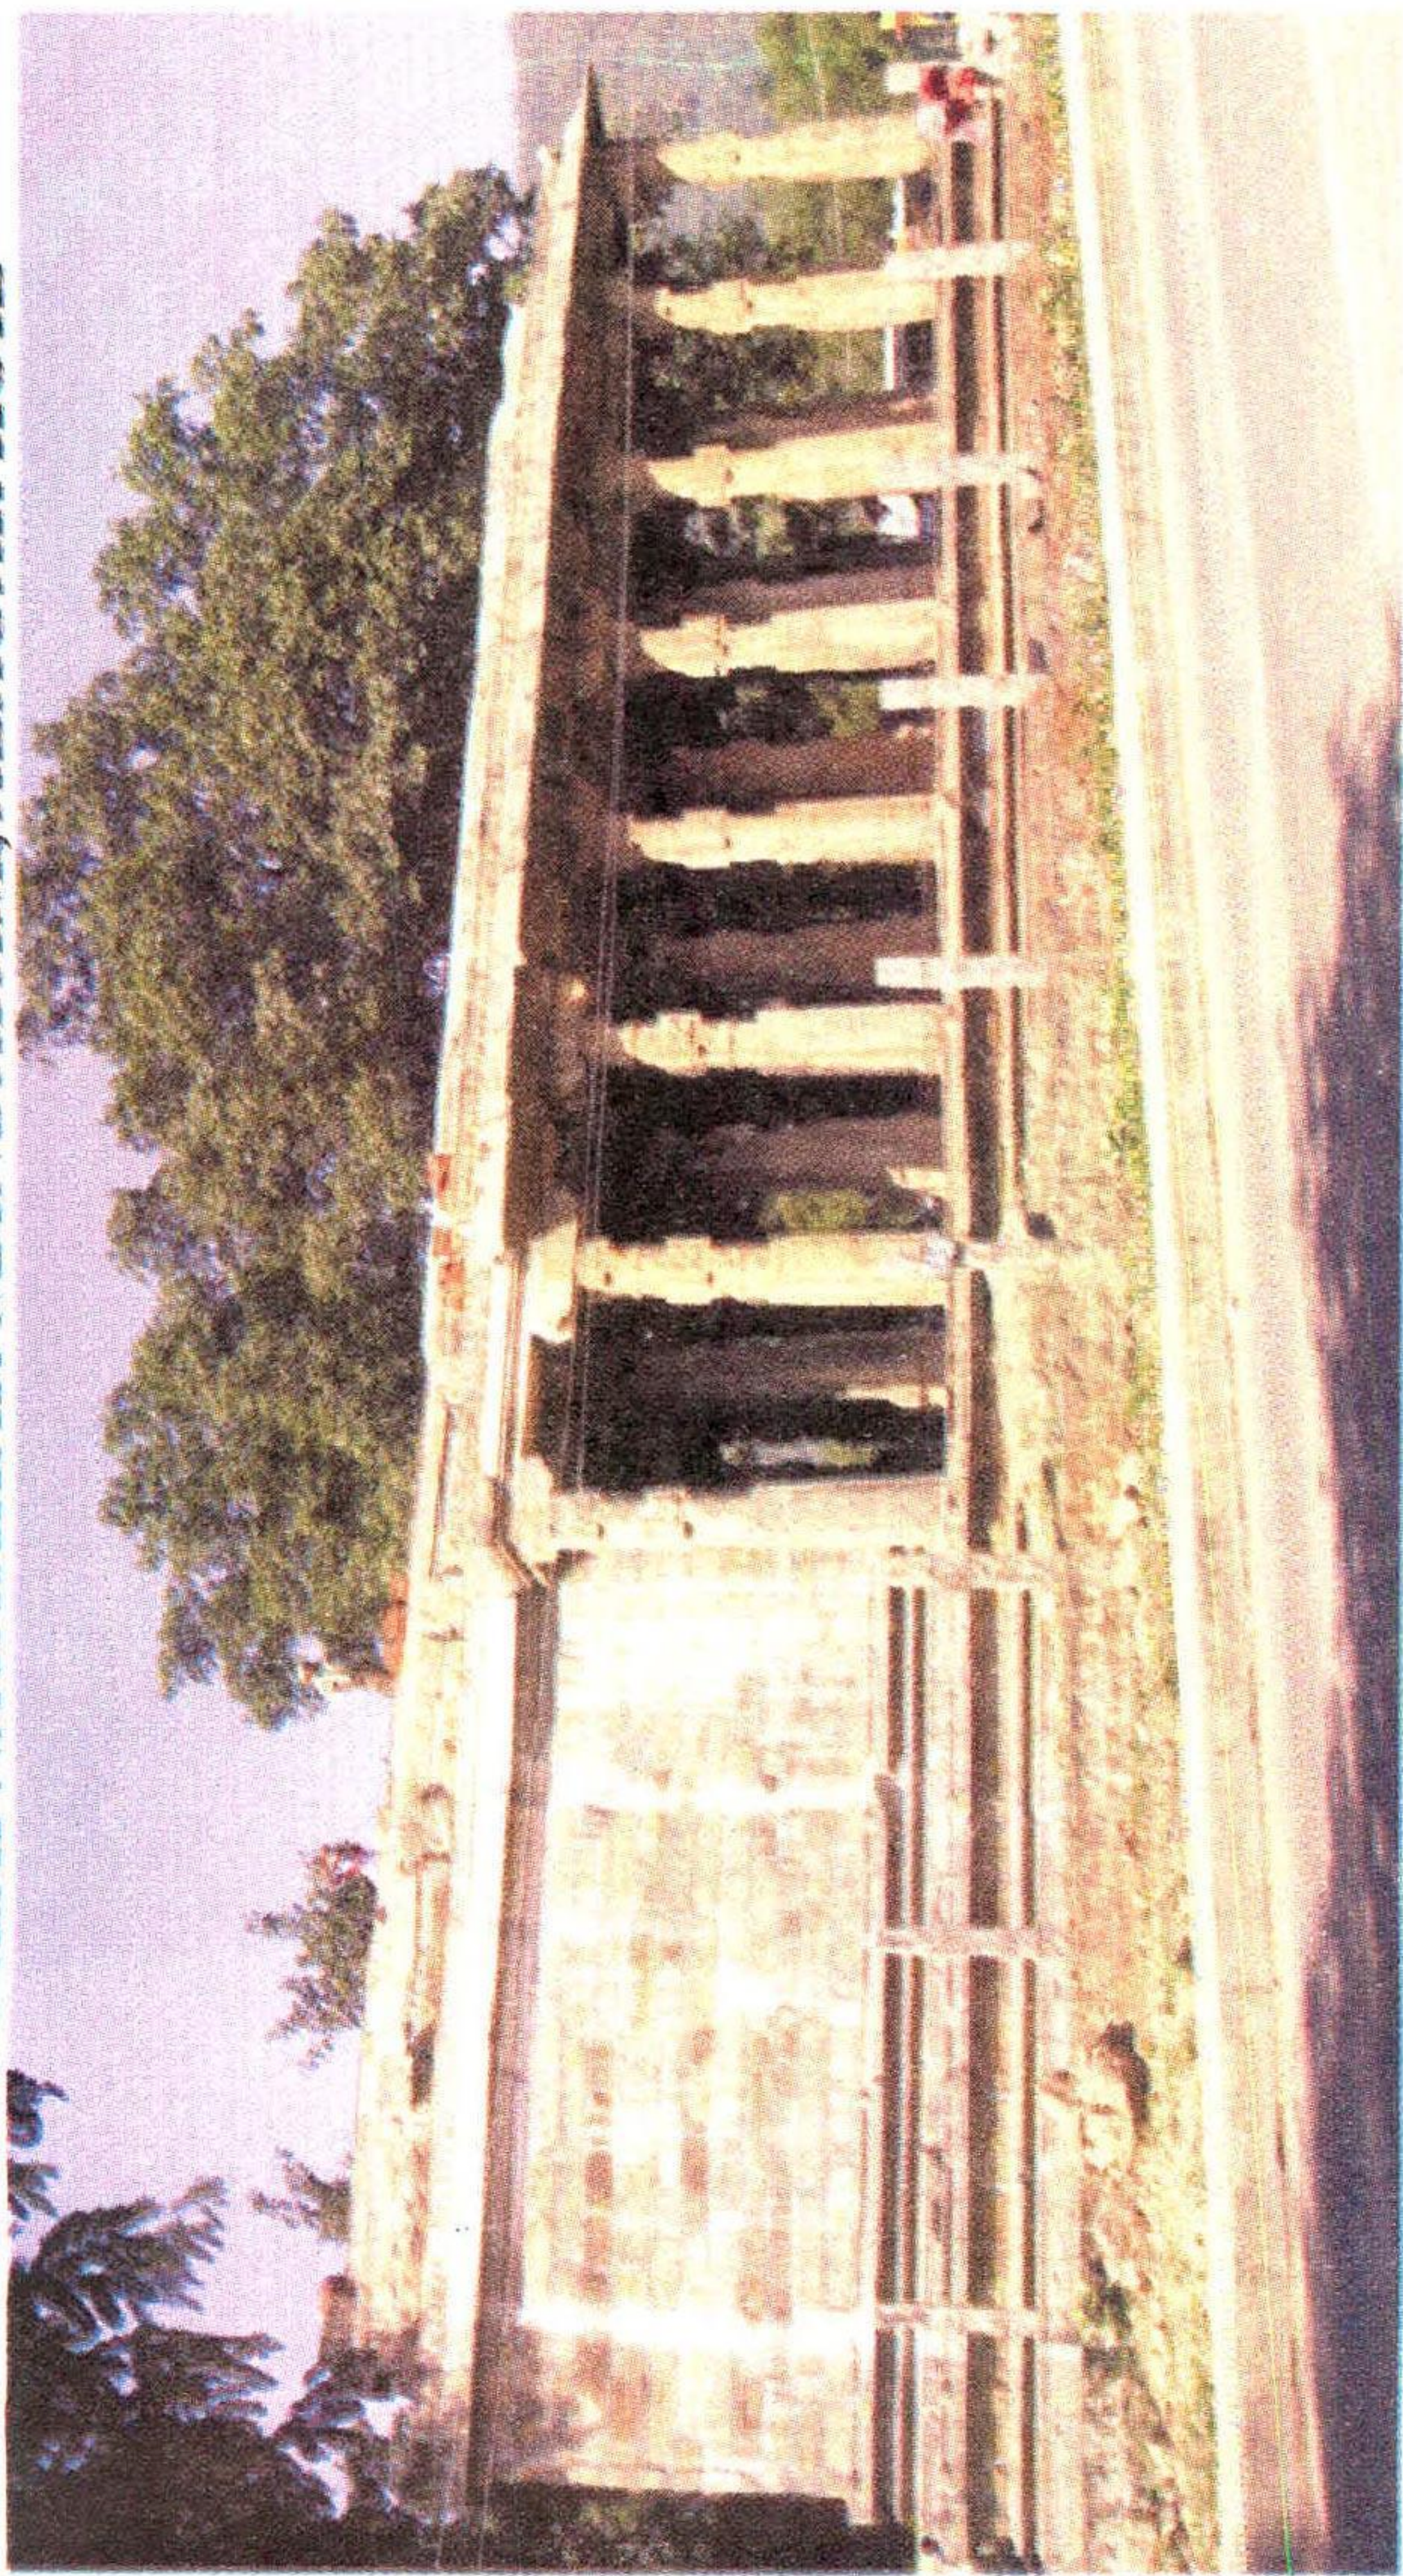
**After Conservation**
