# **Conservation works of Monuments**

**2006 - 2010**

**DEPARTMENT OF ARCHAEOLOGY**  
**GOVERNMENT OF TAMIL NADU**  
**CHENNAI.**

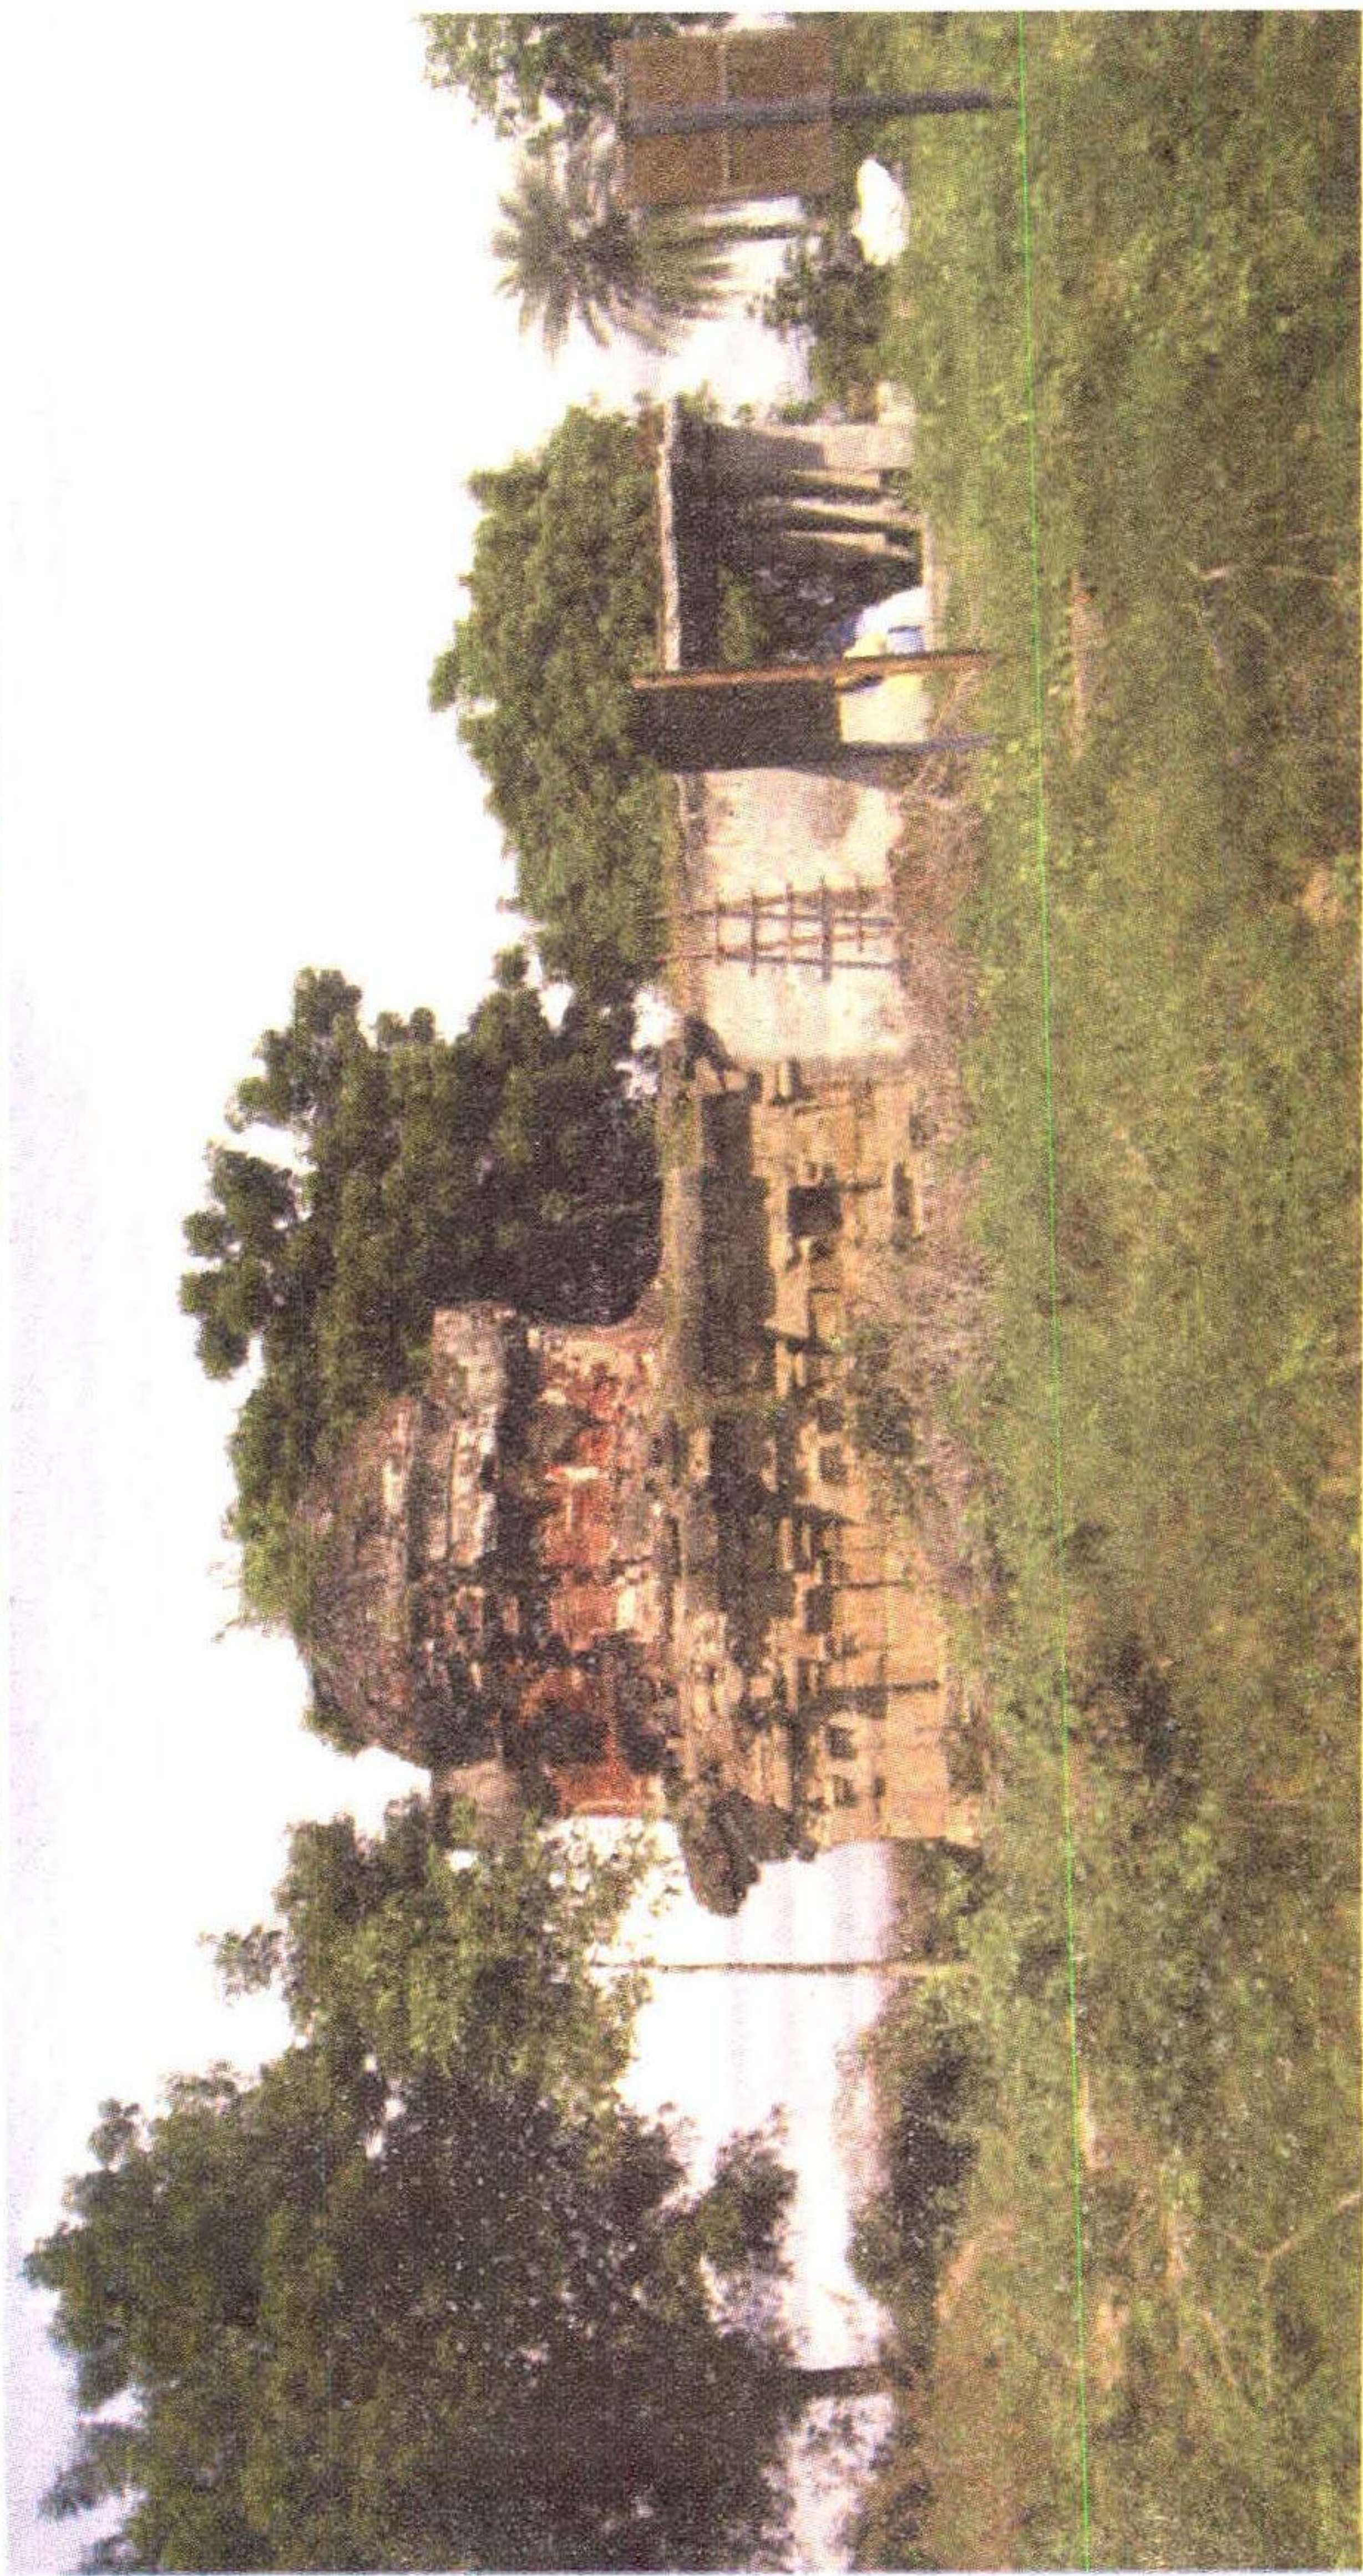
## VALEESWARAR KOIL, THAKKOLAM

**Before Conservation**

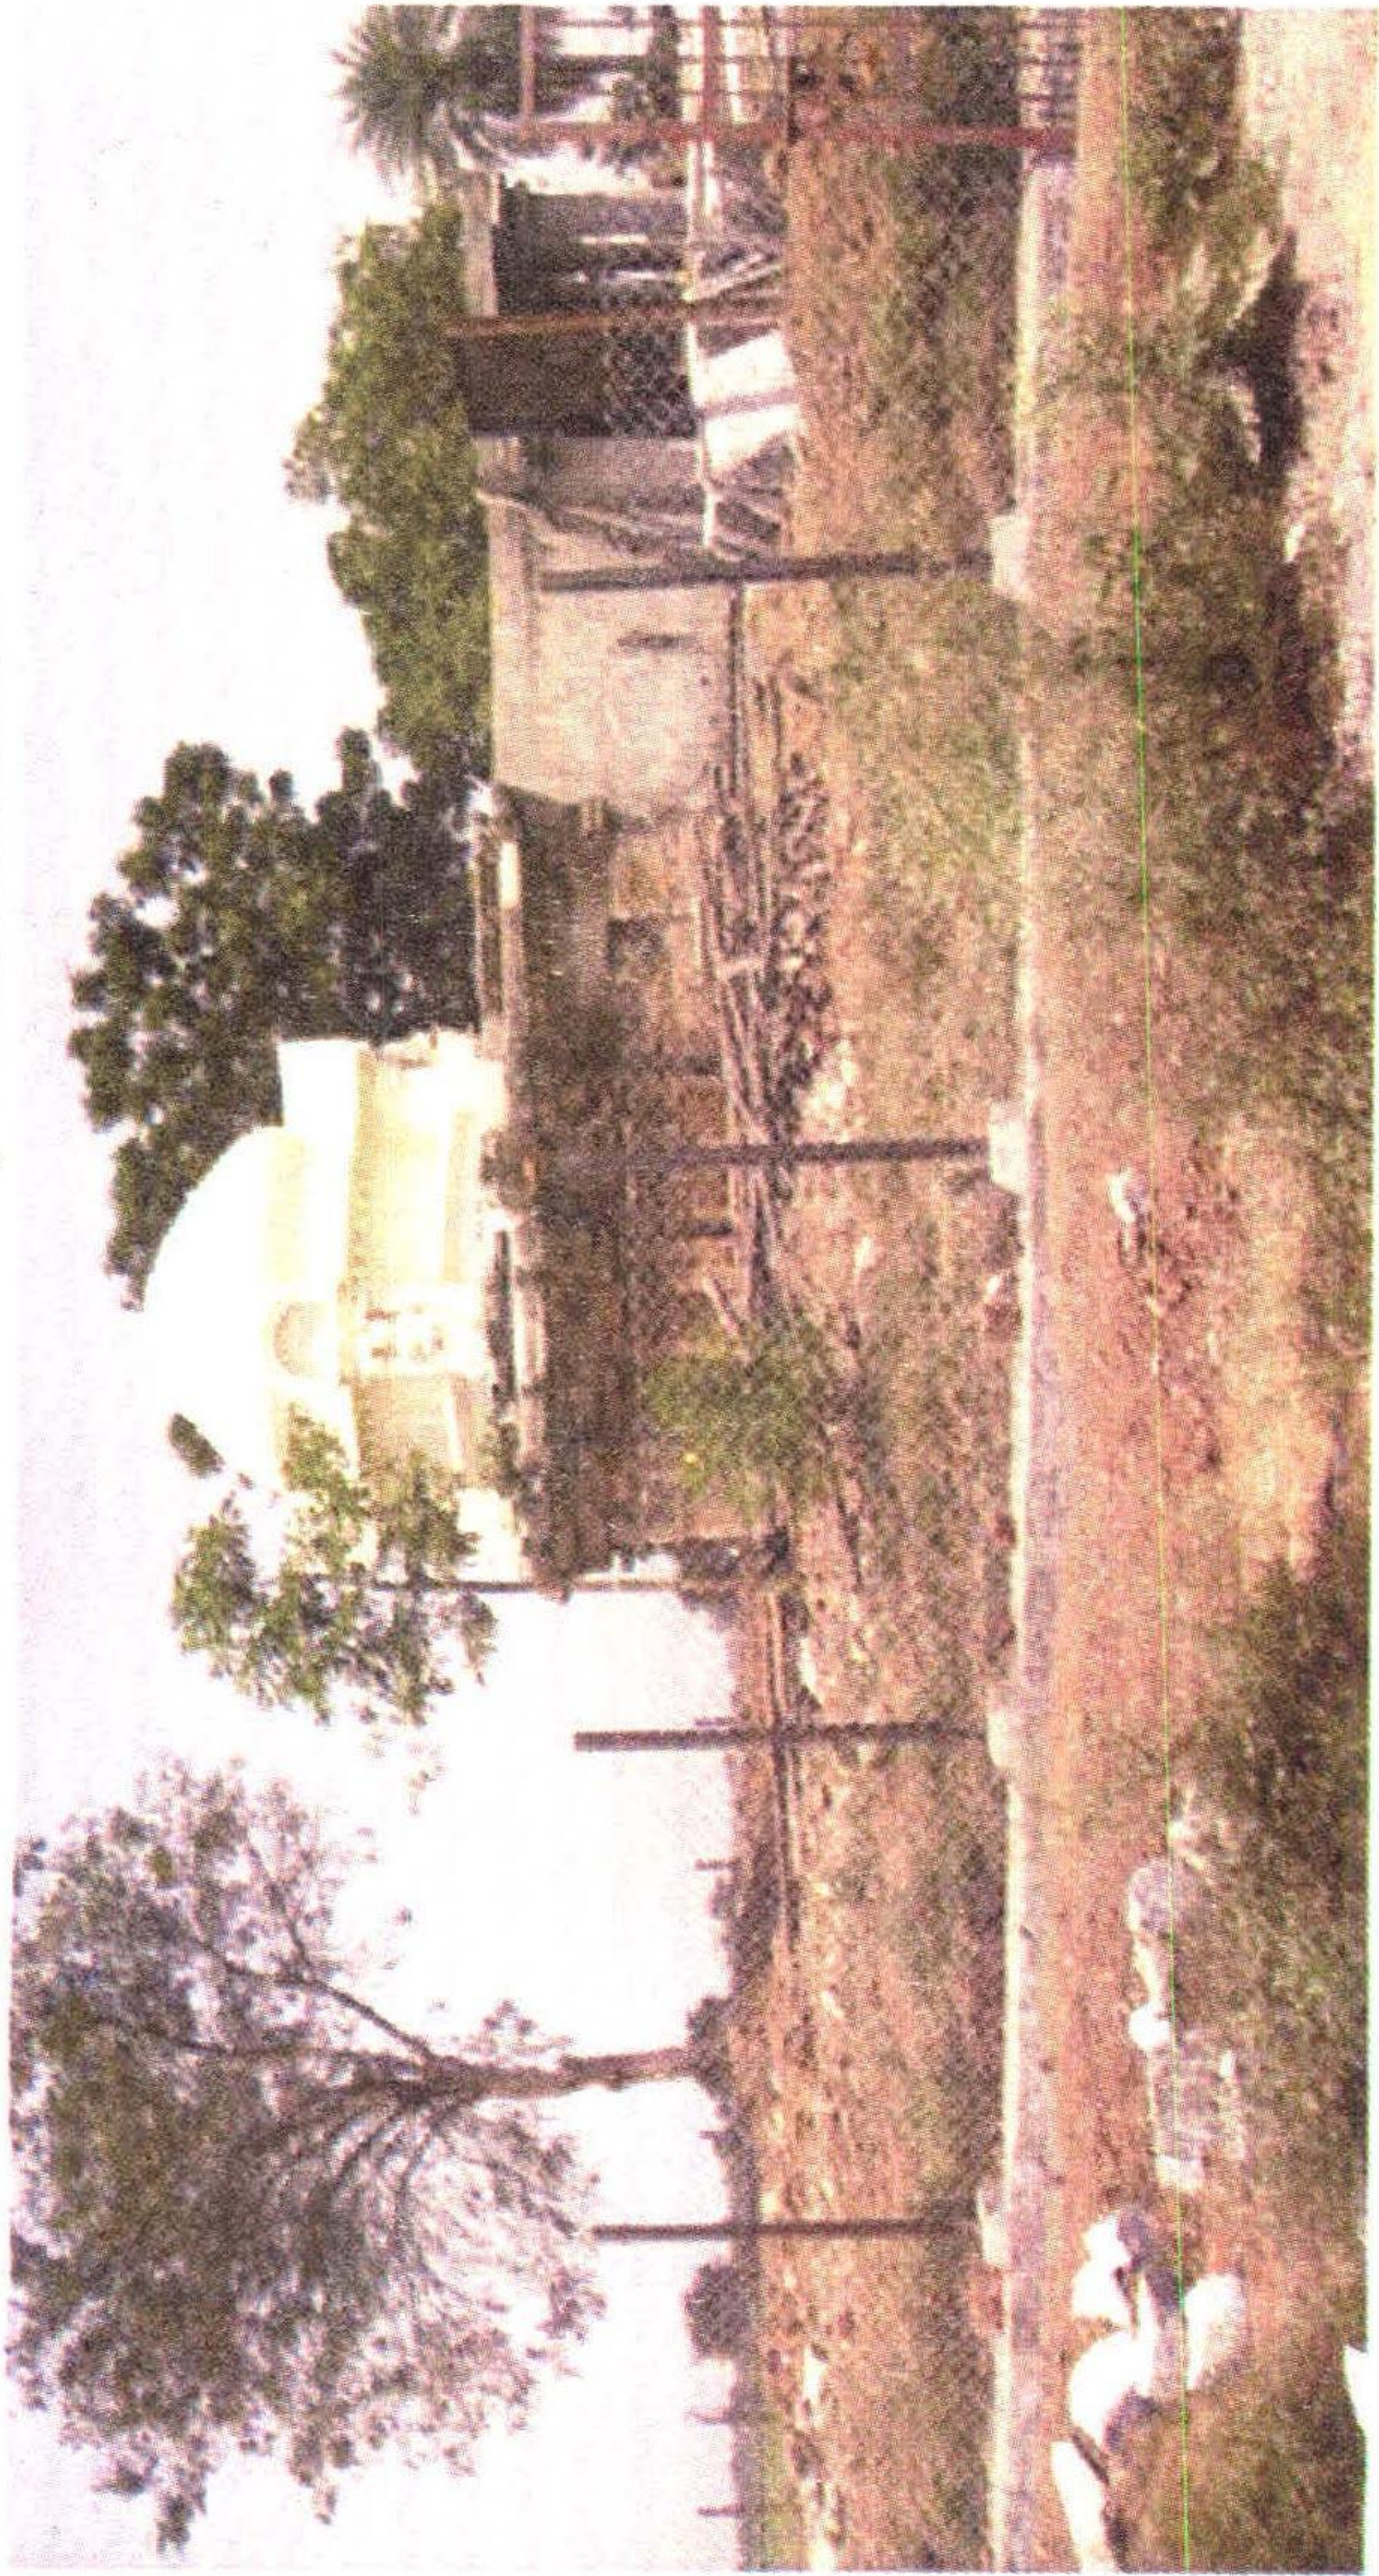
## VALEESWARAR KOIL, THAKKOLAM

**After Conservation**

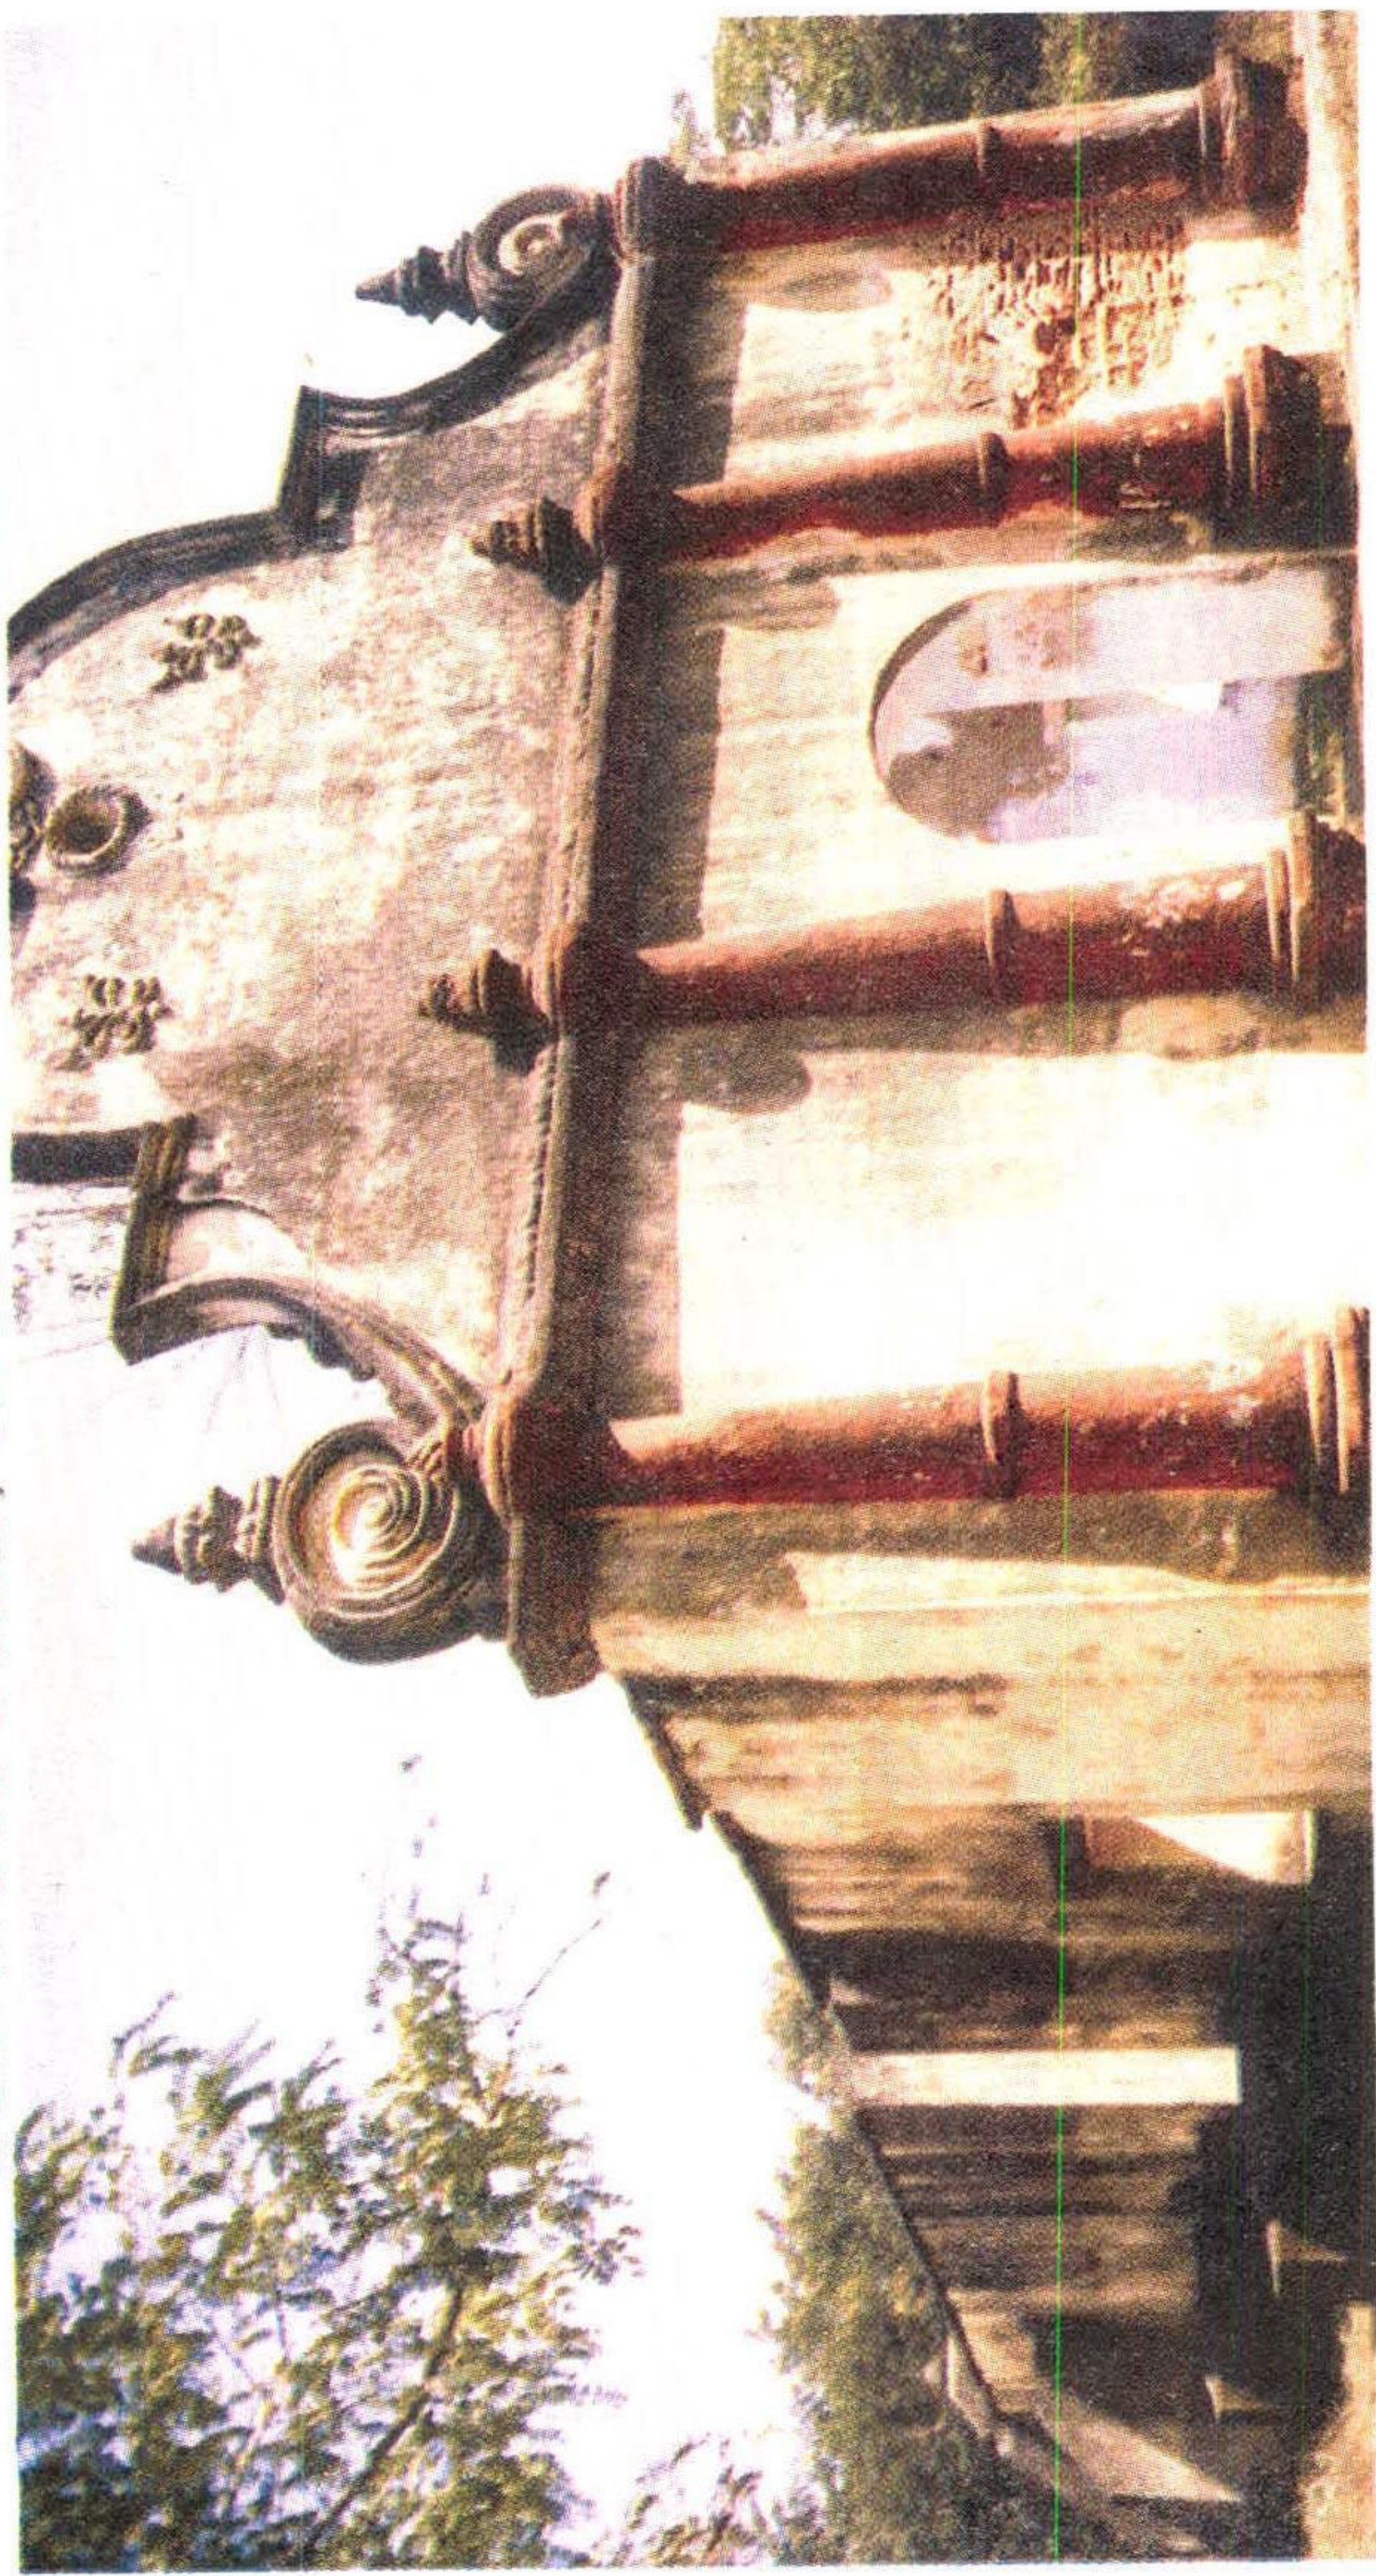
## DLANNOY'S TOMB, UDYAGIRI FORT COMPLEX

- Estimate stated that “collapsed and the remaining out of plumb, few of ornamental grills are found missing”. While inspecting the tomb it was found that it is in tact, except the tiled roof of the said tomb.

Dr. Lal mohan, Convenor of INTACH, Nagercoil chapter has been repeatedly writing to us and insisting that D'Lannoy's tombs are in fact a church with the dilapidated roof covering it. To prove his point, he has also attached copies of various letters and orders issued from time to time during the Travancore Maharaja's period. However, perusal of those documents undoubtedly makes it clear that the tombs were left uncovered (without any roof) which led to a dilapidated condition of those tombs. The Assistant Engineer, Southern Division Mr.S.Horsley in his report dated 31<sup>st</sup> May 1875 has clearly referred to the roofless condition of the tombs

**Before Conservation**

which hastened the sorry state of the tomb structures. In order to prevent the graves from being destroyed, he has suggested “that it would be best to roof the building and execute sundry repairs to the door/ and window ways /and provide them with cannon rough shutters”. In the same letter he has also mentioned that the building (now roofless) “is so much overgrown with trees and bushes which have spread their roots into the cracks in the walls that in a few years I expect the walls will fall down altogether and thereby obliterate all traces of the graves.” The above fact also confirms that in the year 1873, the building surrounding the tomb at the time of inspection by the Assistant Engineer were roofless which must have been the original design as well. Moreover the side walls of the building have been finished with coping, leaving no grooves for fixing the rafters for supporting the tiles. This design of the wall proves without doubt that the tomb blocks had dwarf walls only and no connecting wall covering the entire length and breath of the monument. Moreover there is no mention anywhere in our records to show that it was used as a church. Hence the argument that this must have been a church with tiled roofing cannot be accepted. Accordingly the design as available now be retained and the restoration and maintenance work may be proceeded with taking the above facts in view.

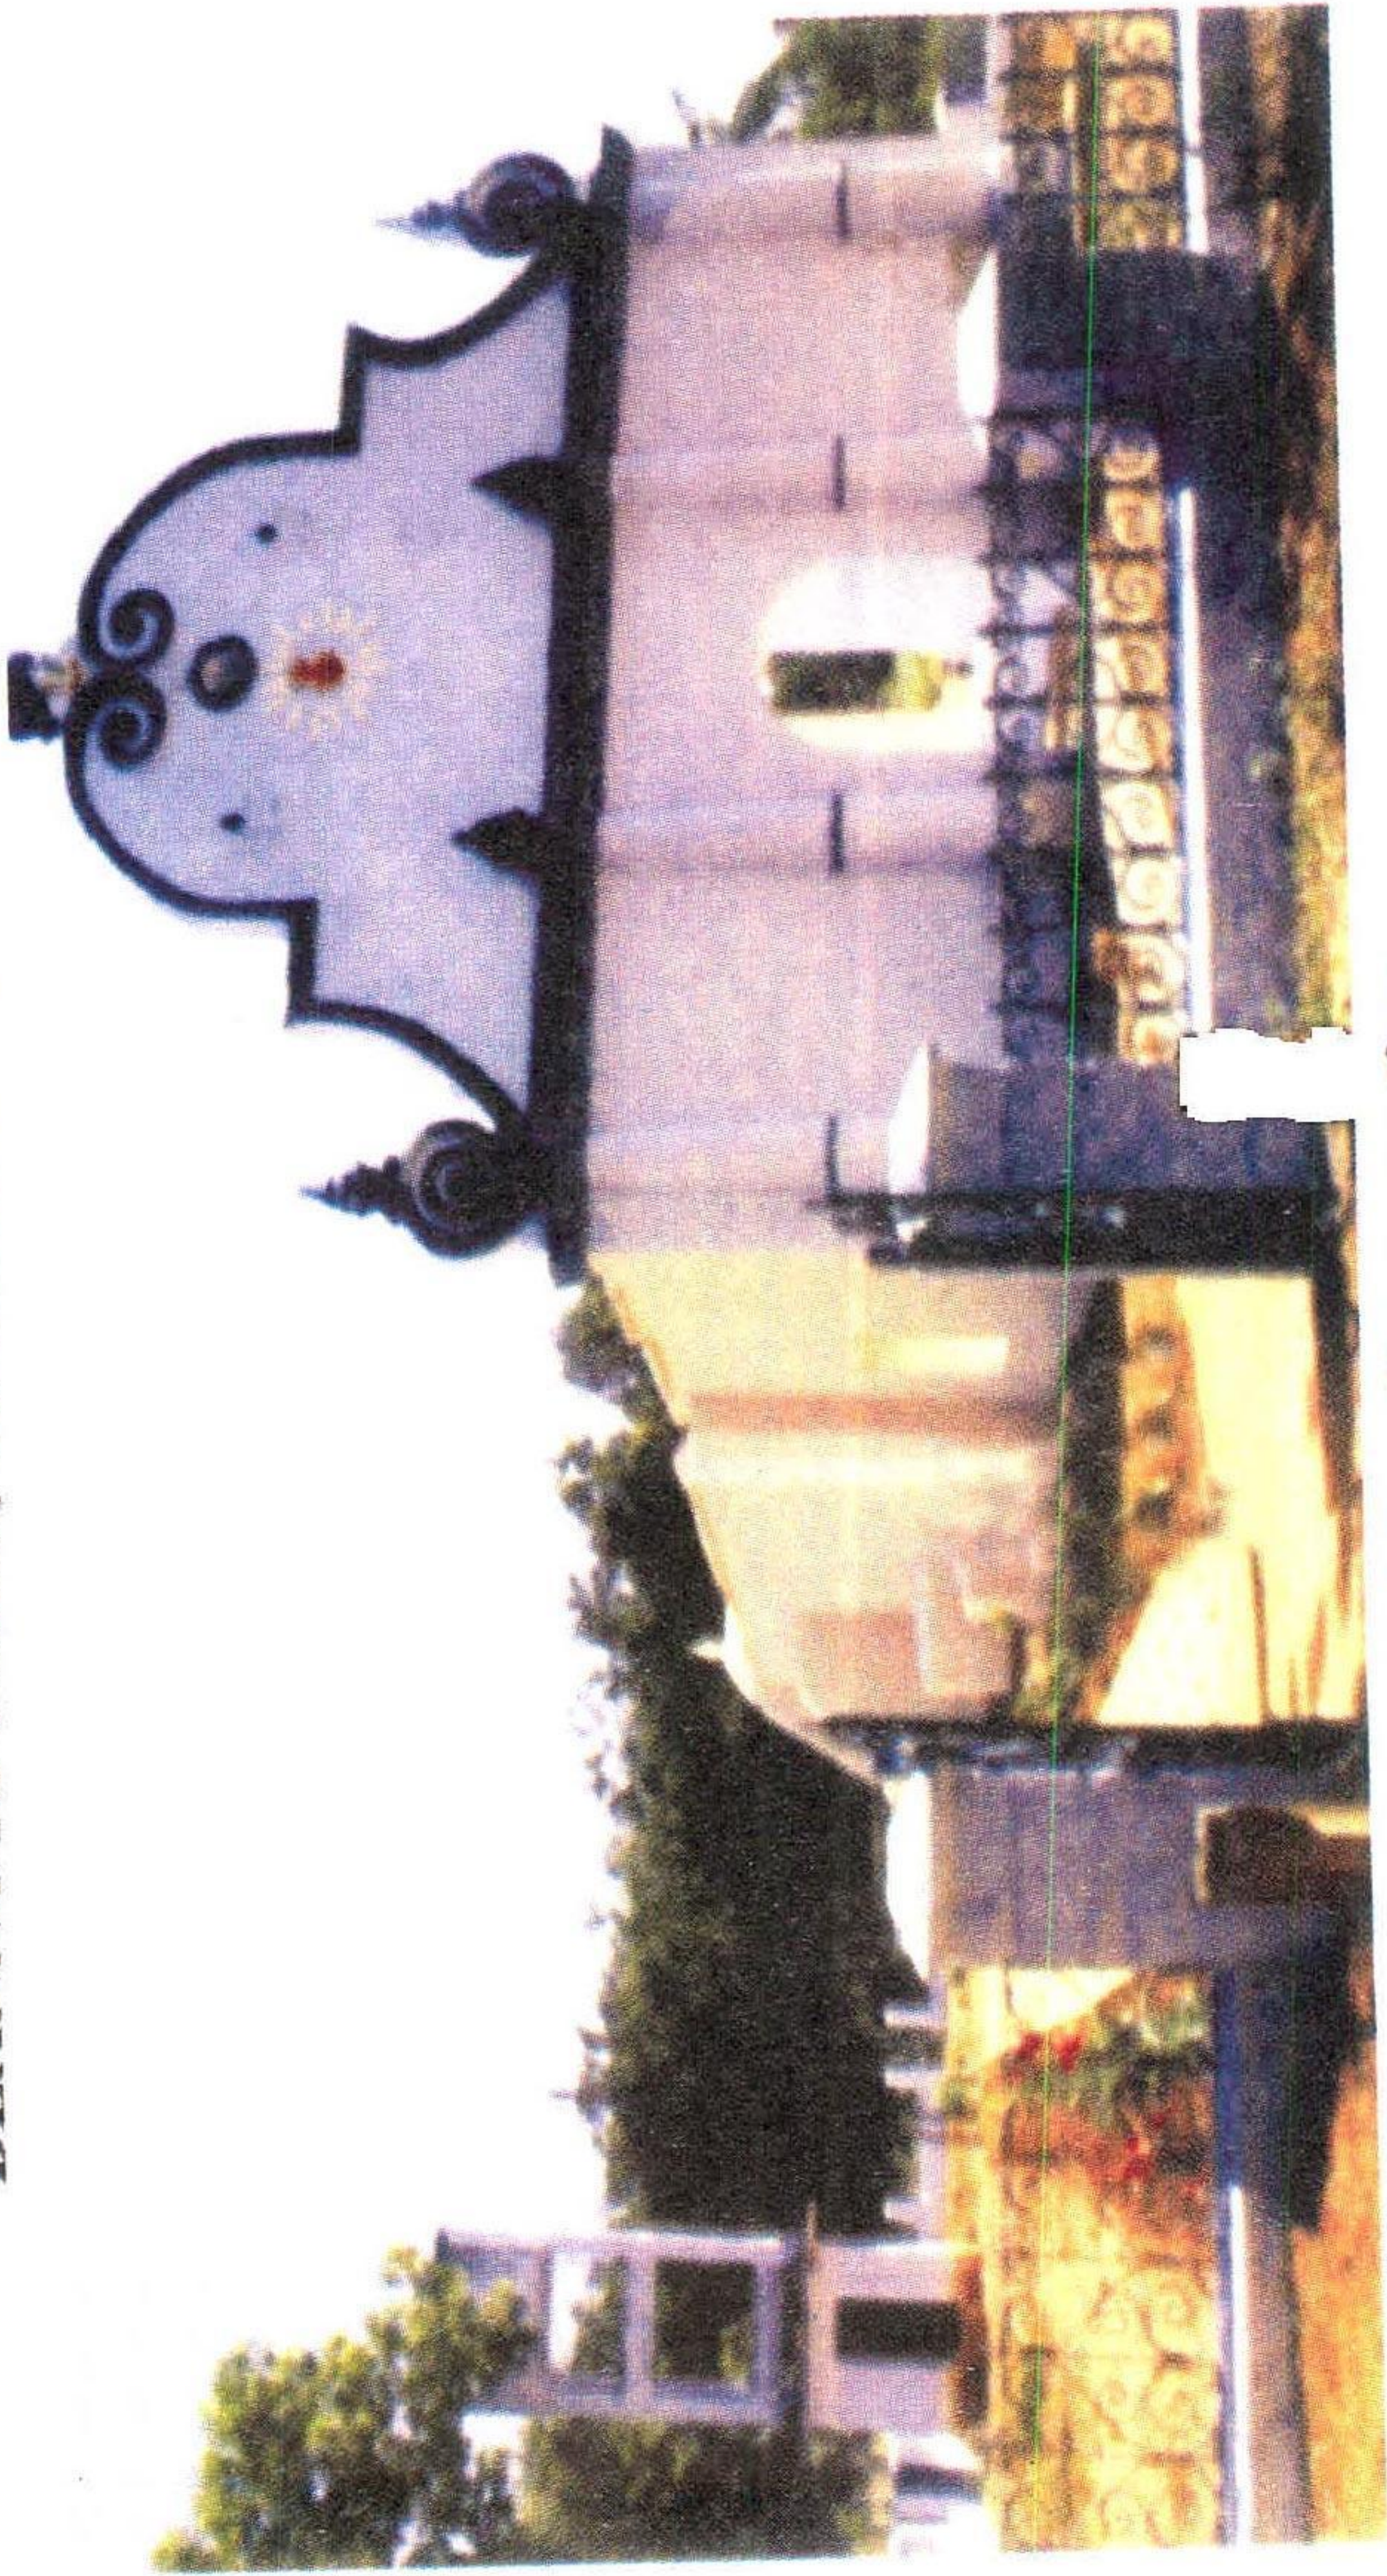
## DLANNOYS TOMB, UDYAGIRI FORT COMPLEX

**After Conservation**

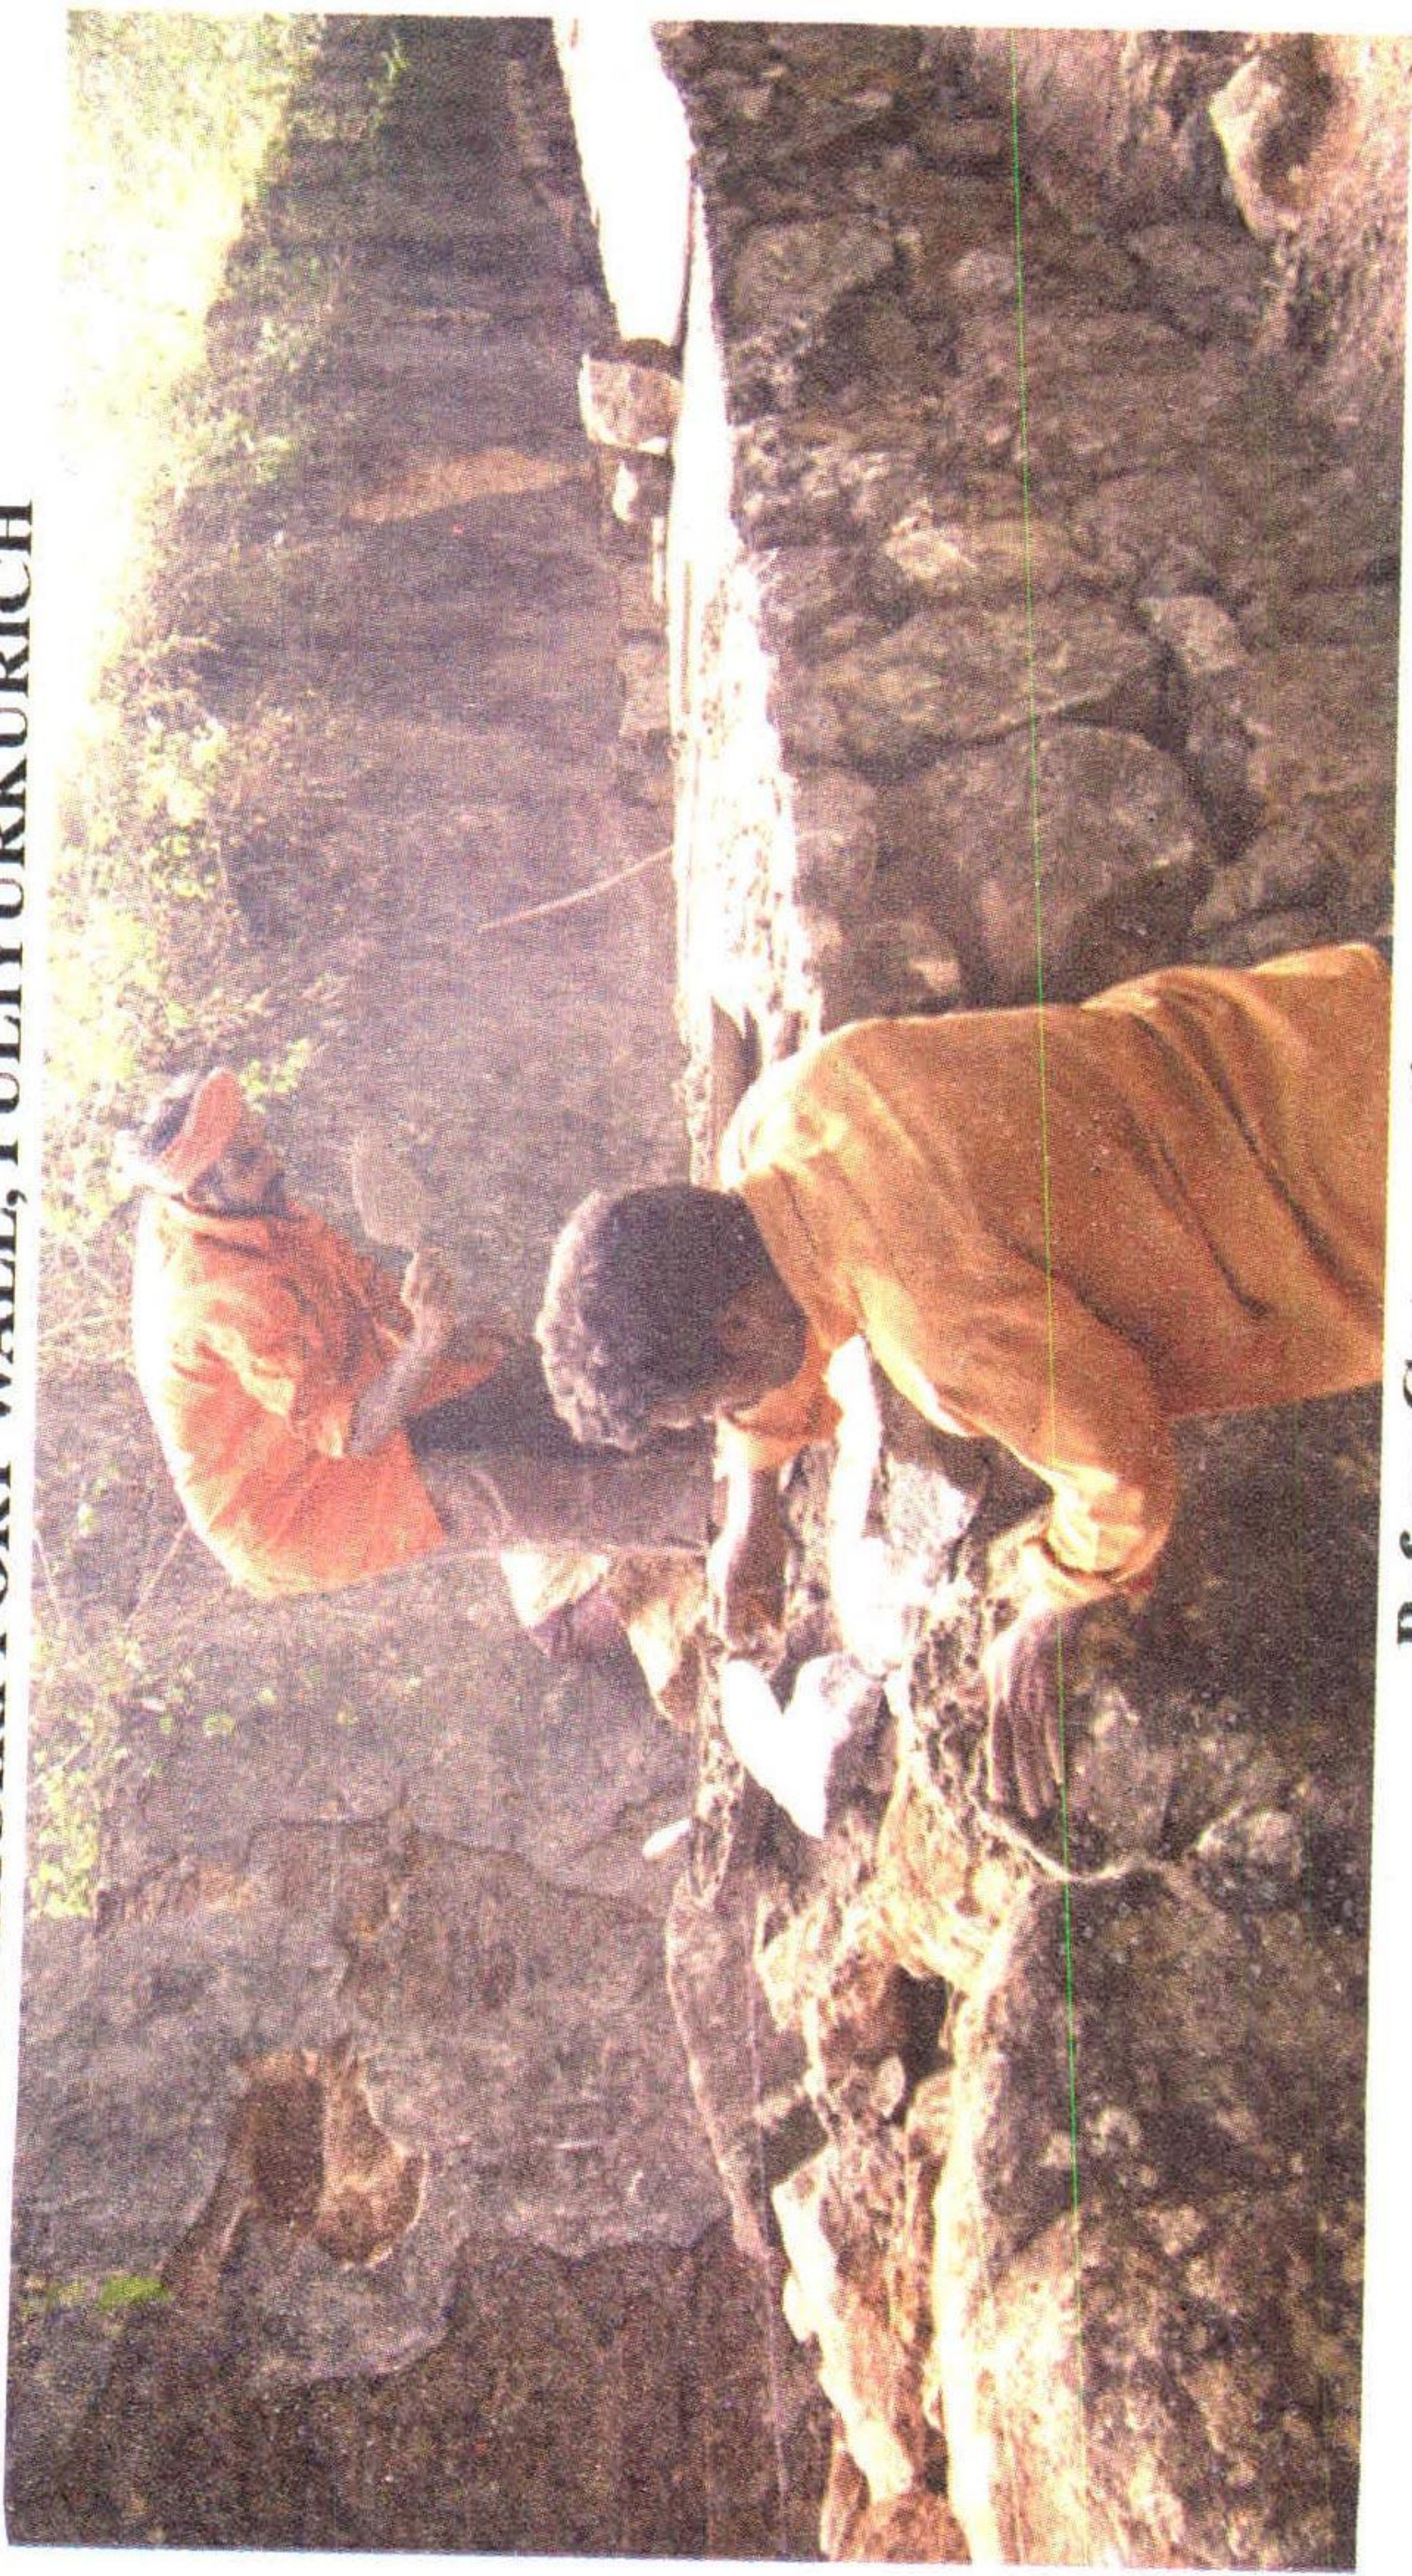
## UDYAGIRI FORT WALL, PULIYURKURICH

The massive hillock was covered by constructing fort wall to a length of 2800 M with a height varying from 5.0 m to 7.0 m using granite stones and laterite blocks. Top of the coping has been finished with trapezoidal shape leaving alternate gaps for positioning guns and the same has been plastered with grinded lime mortar. Two remnants of manufacturing unit used for the arms and ammunitions found at the inner fort are in ruined condition.

Accordingly, the adjacent inner site around the Fort wall except eastern side other sides were found with clear passage after the removal of vegetation. At present 210.0 RM fort wall restoration has been completed at eastern part of the Traveler's Bungalow. By including this, totally 1245.0 RM fortress has been restored out of 2800 RM. Due to negligence of curing, cracks found here and there in the recently restored bream wall at southern side. Tree plants grown over the bastions were not uprooted properly at southern side.

**Before Conservation**

- Openings found at western side to reach Traveler's Bungalow may be closed about a length of 8.00 metres using RR Masonry in cement mortar 1:5 and also attending the further disturbed portion of 8.0 metres at southern side.

- The coping of the arch finish was found broken here and there of the northern side may be rectified as per the original pattern.

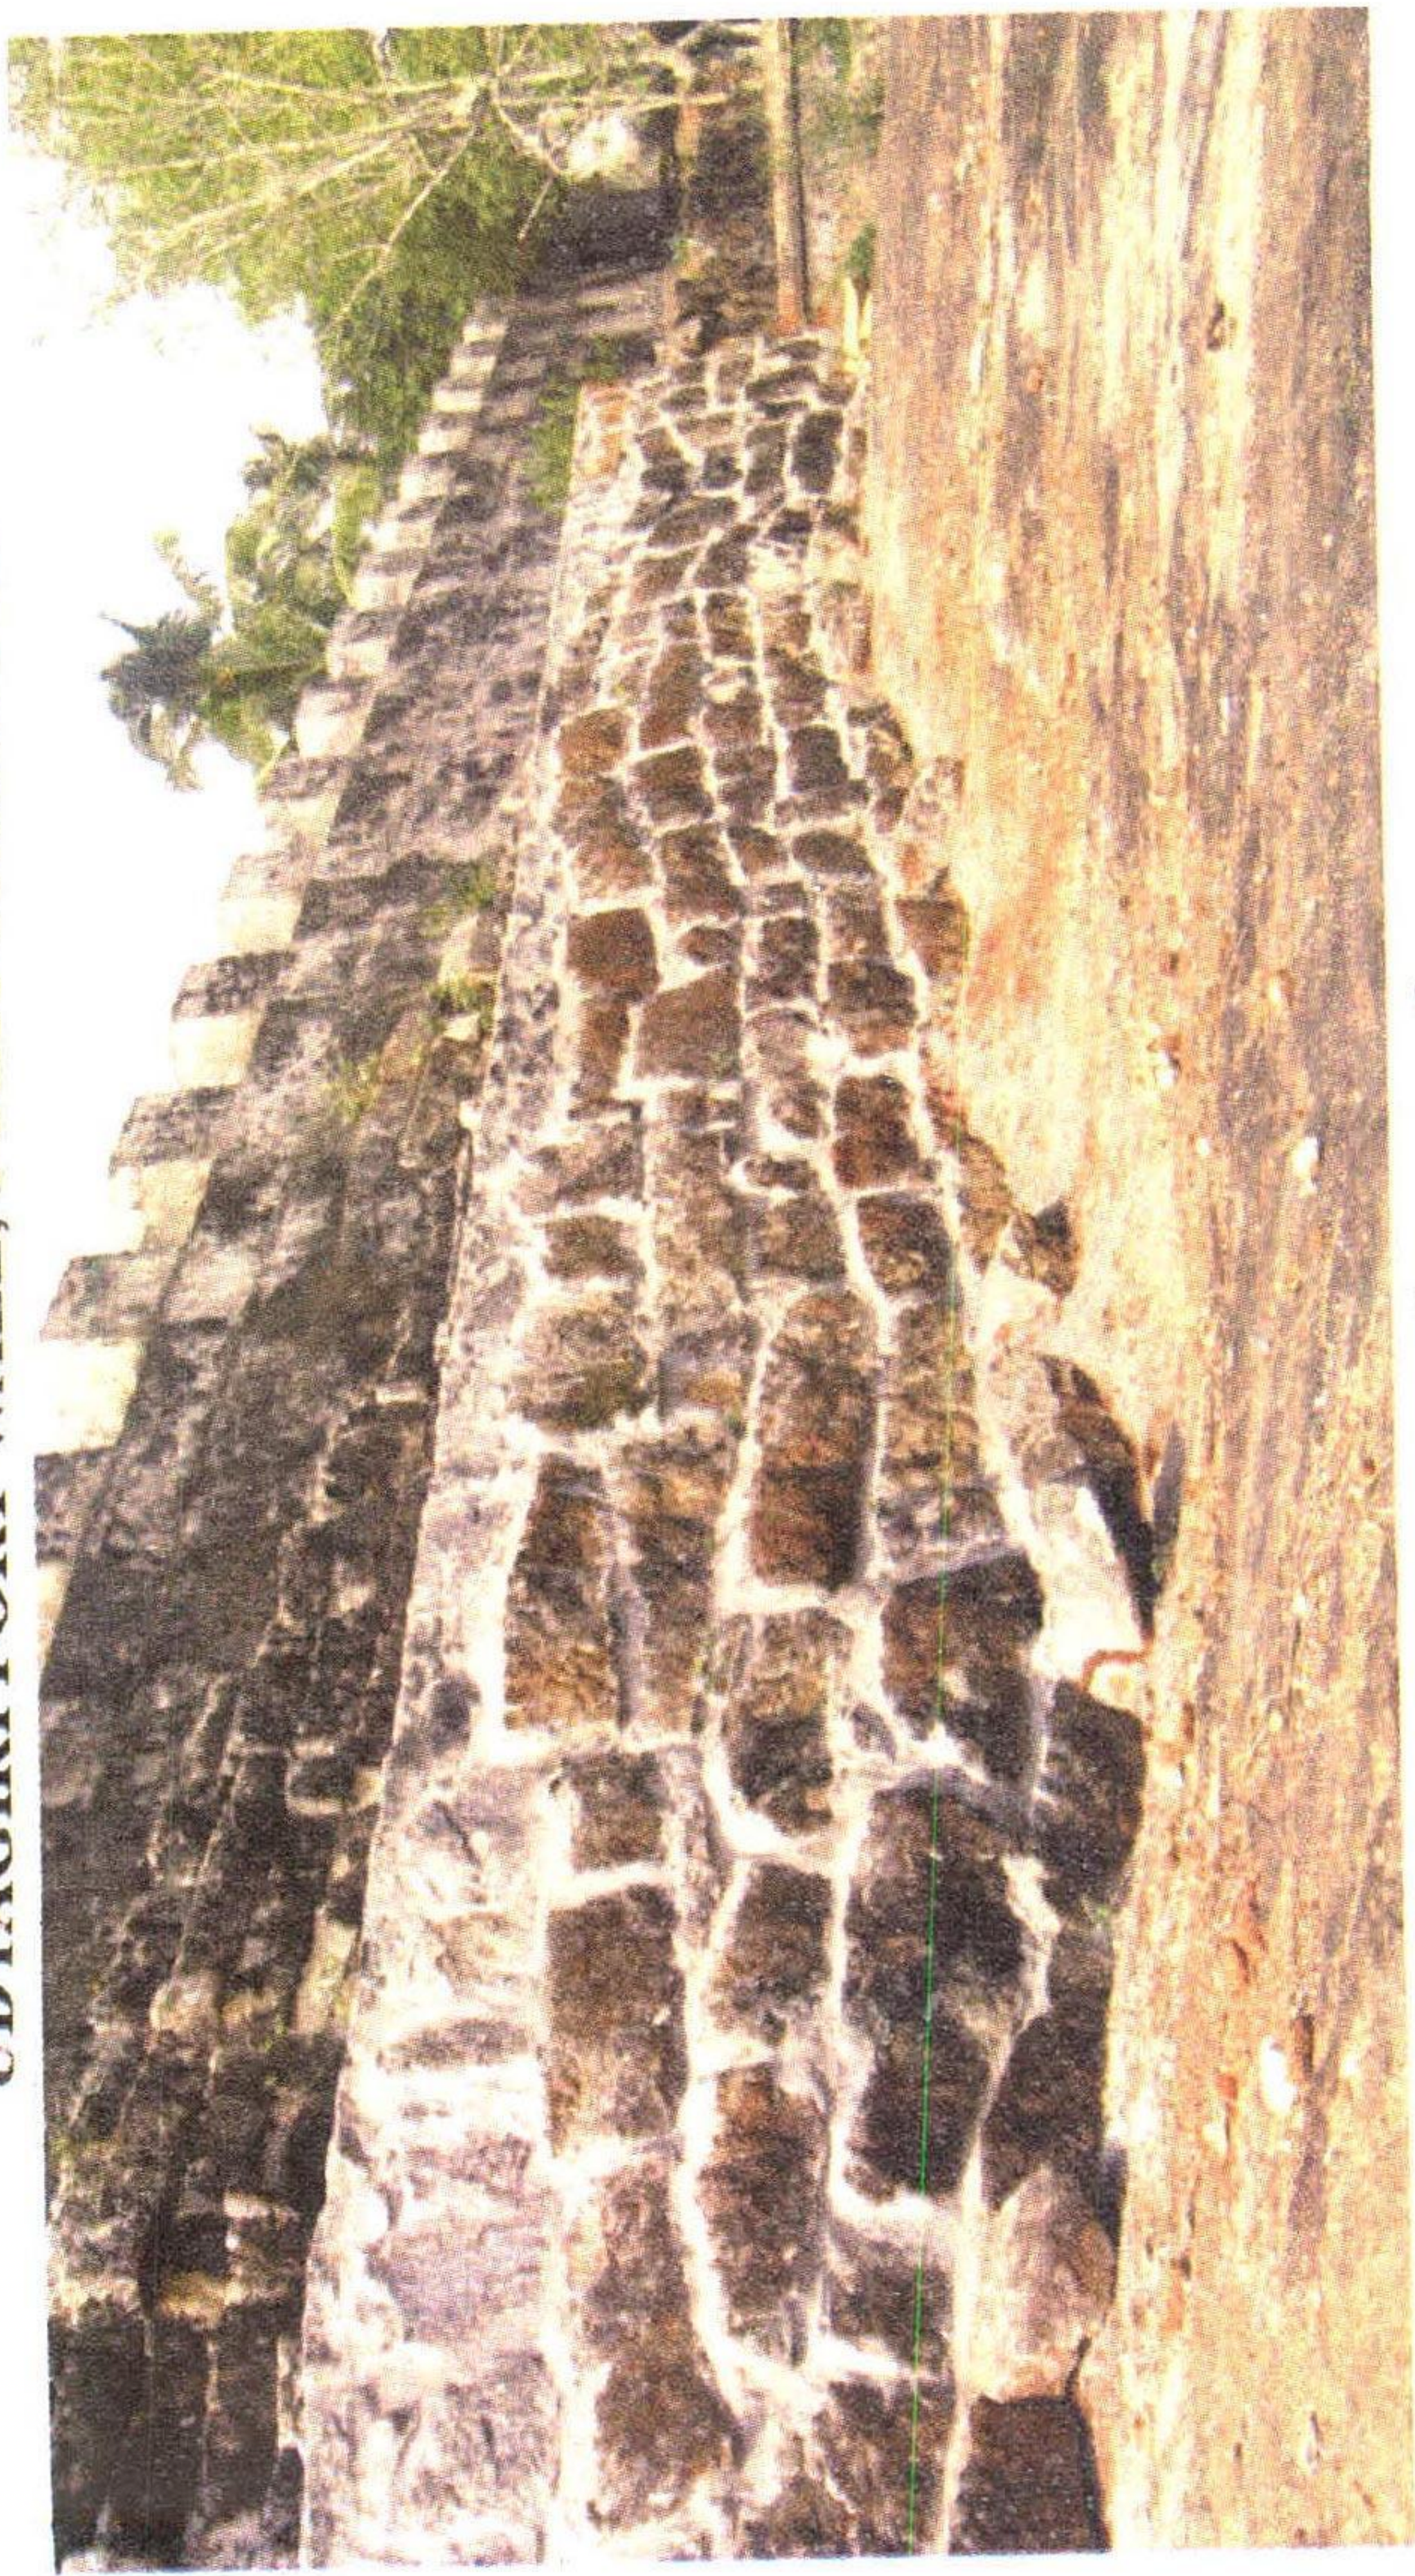
## **UDYAGIRI FORT WALL, PULIYURKURICH**

**Before Conservation**
