# **Conservation works of Monuments**

**2006 - 2010**

**DEPARTMENT OF ARCHAEOLOGY**  
**GOVERNMENT OF TAMIL NADU**  
**CHENNAI.**

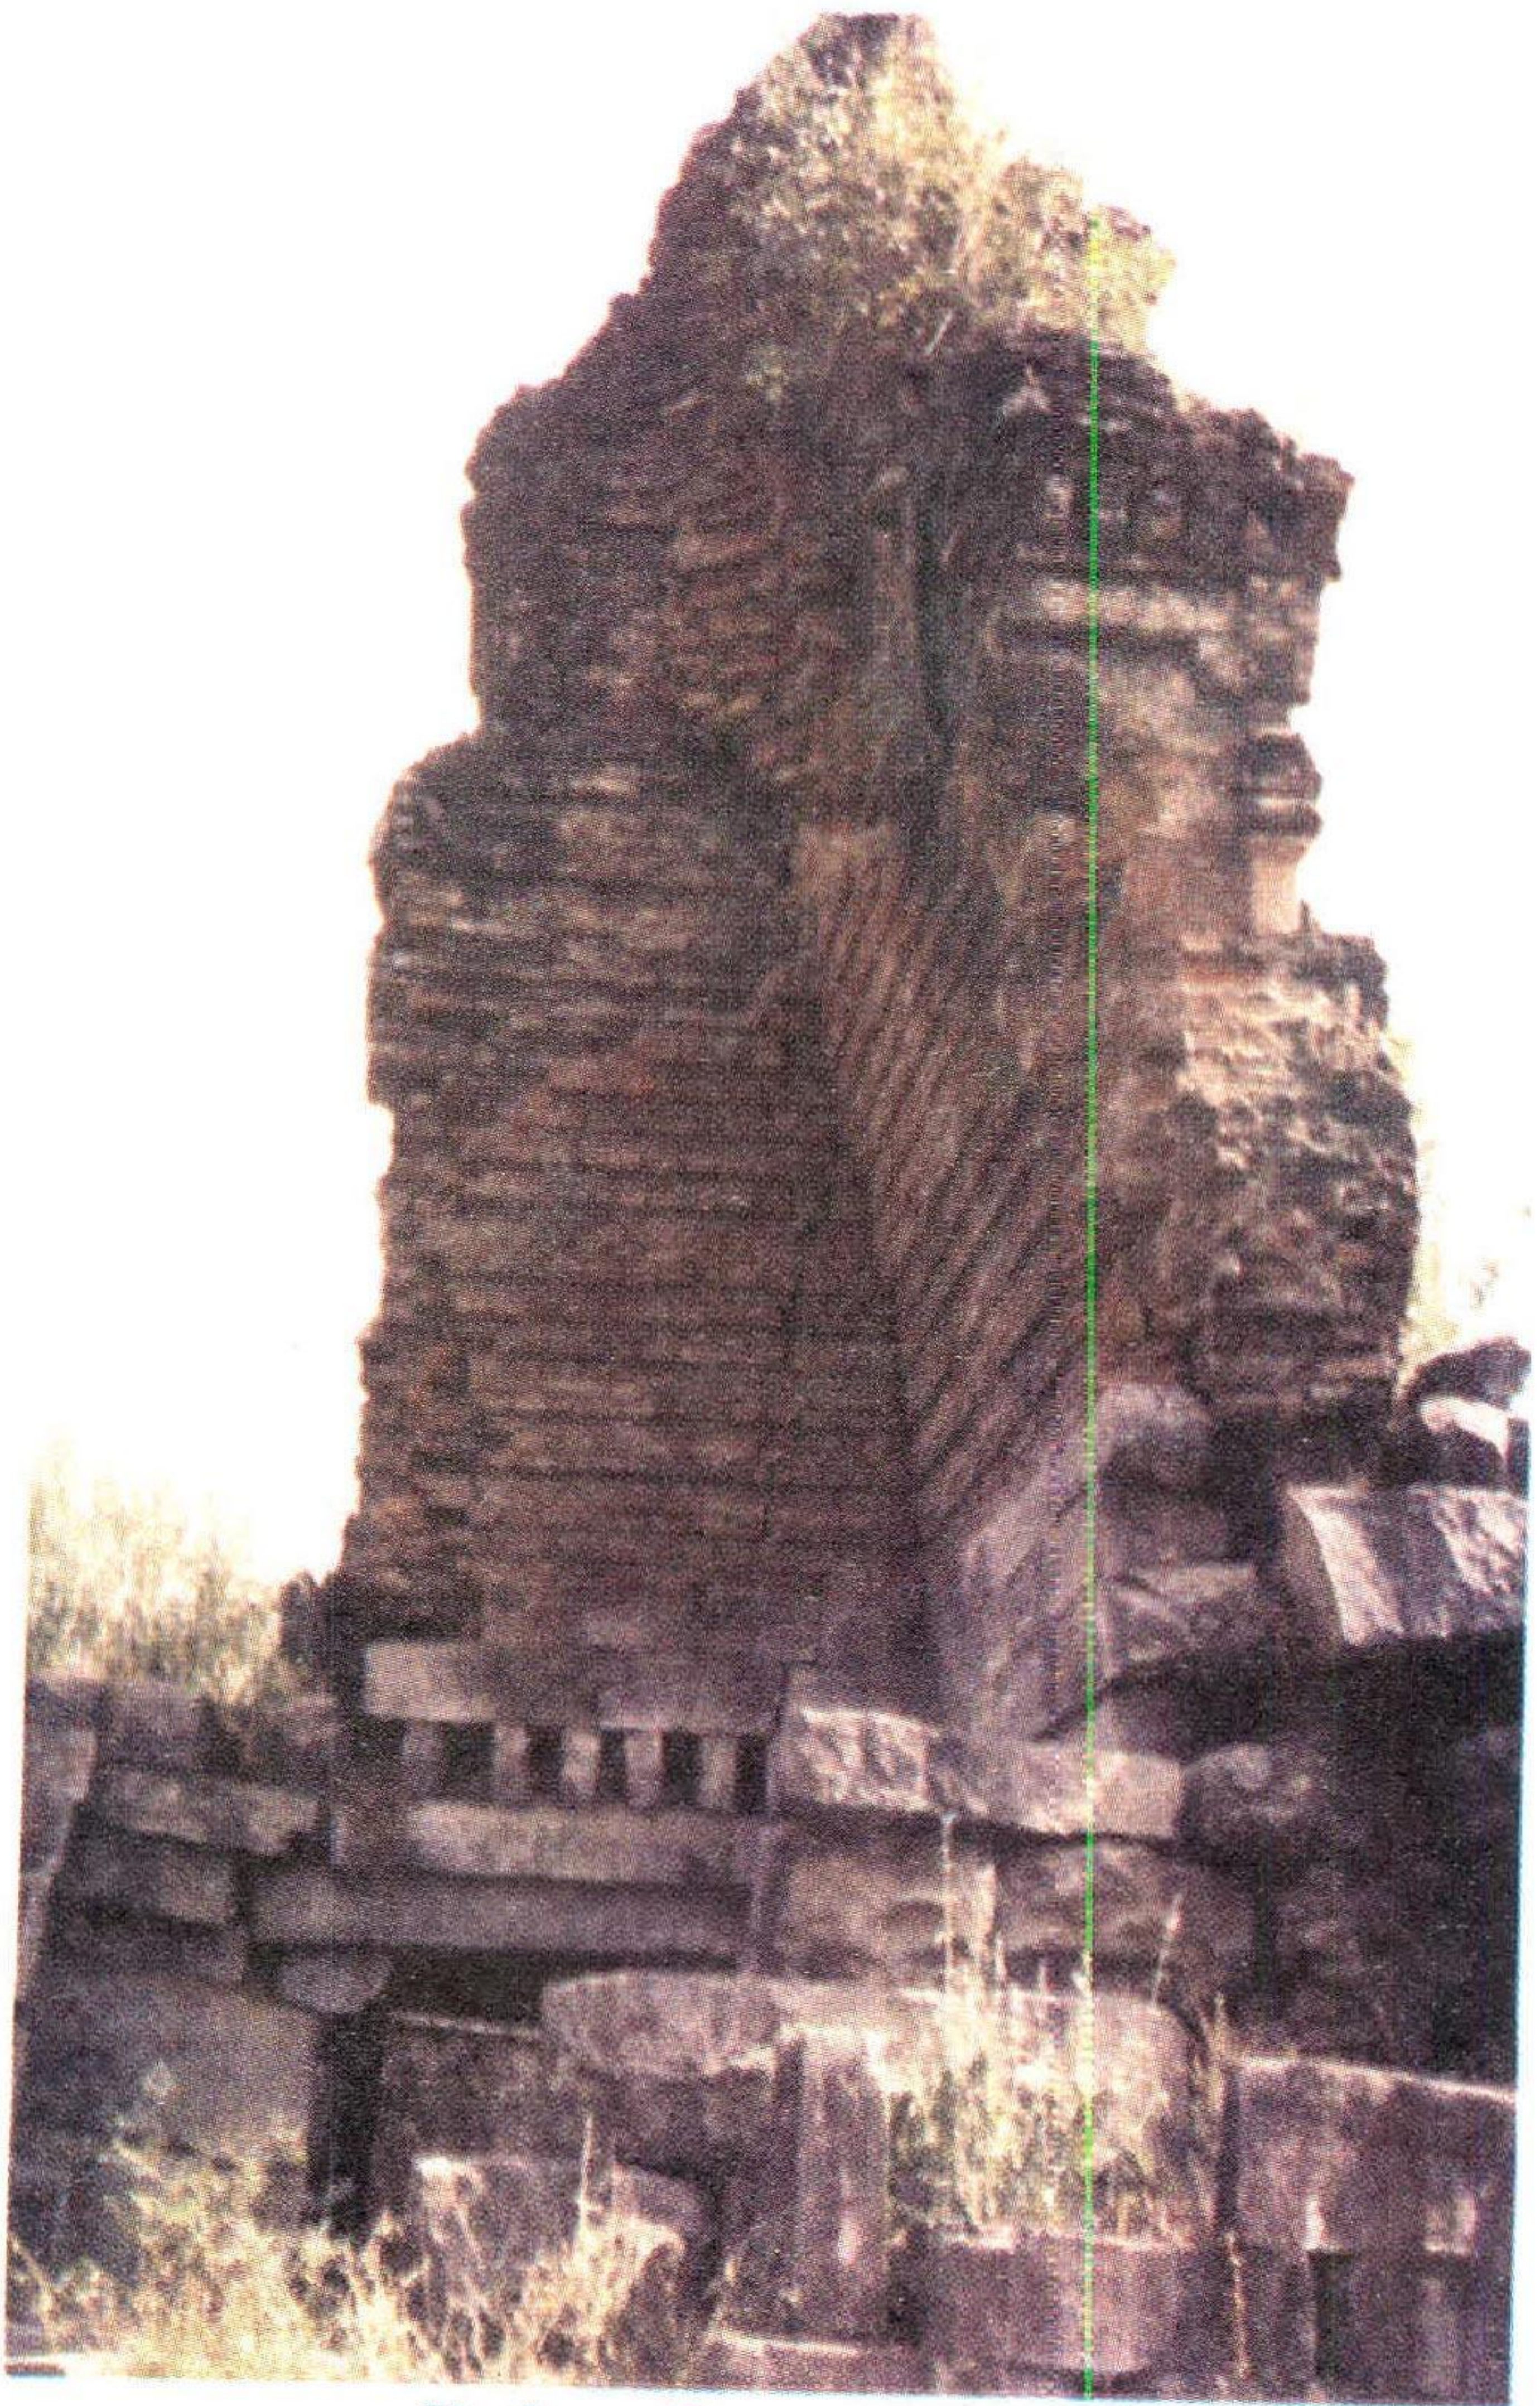
## **SIVAN KOIL ULAGAPURAM**

**Before Conservation**

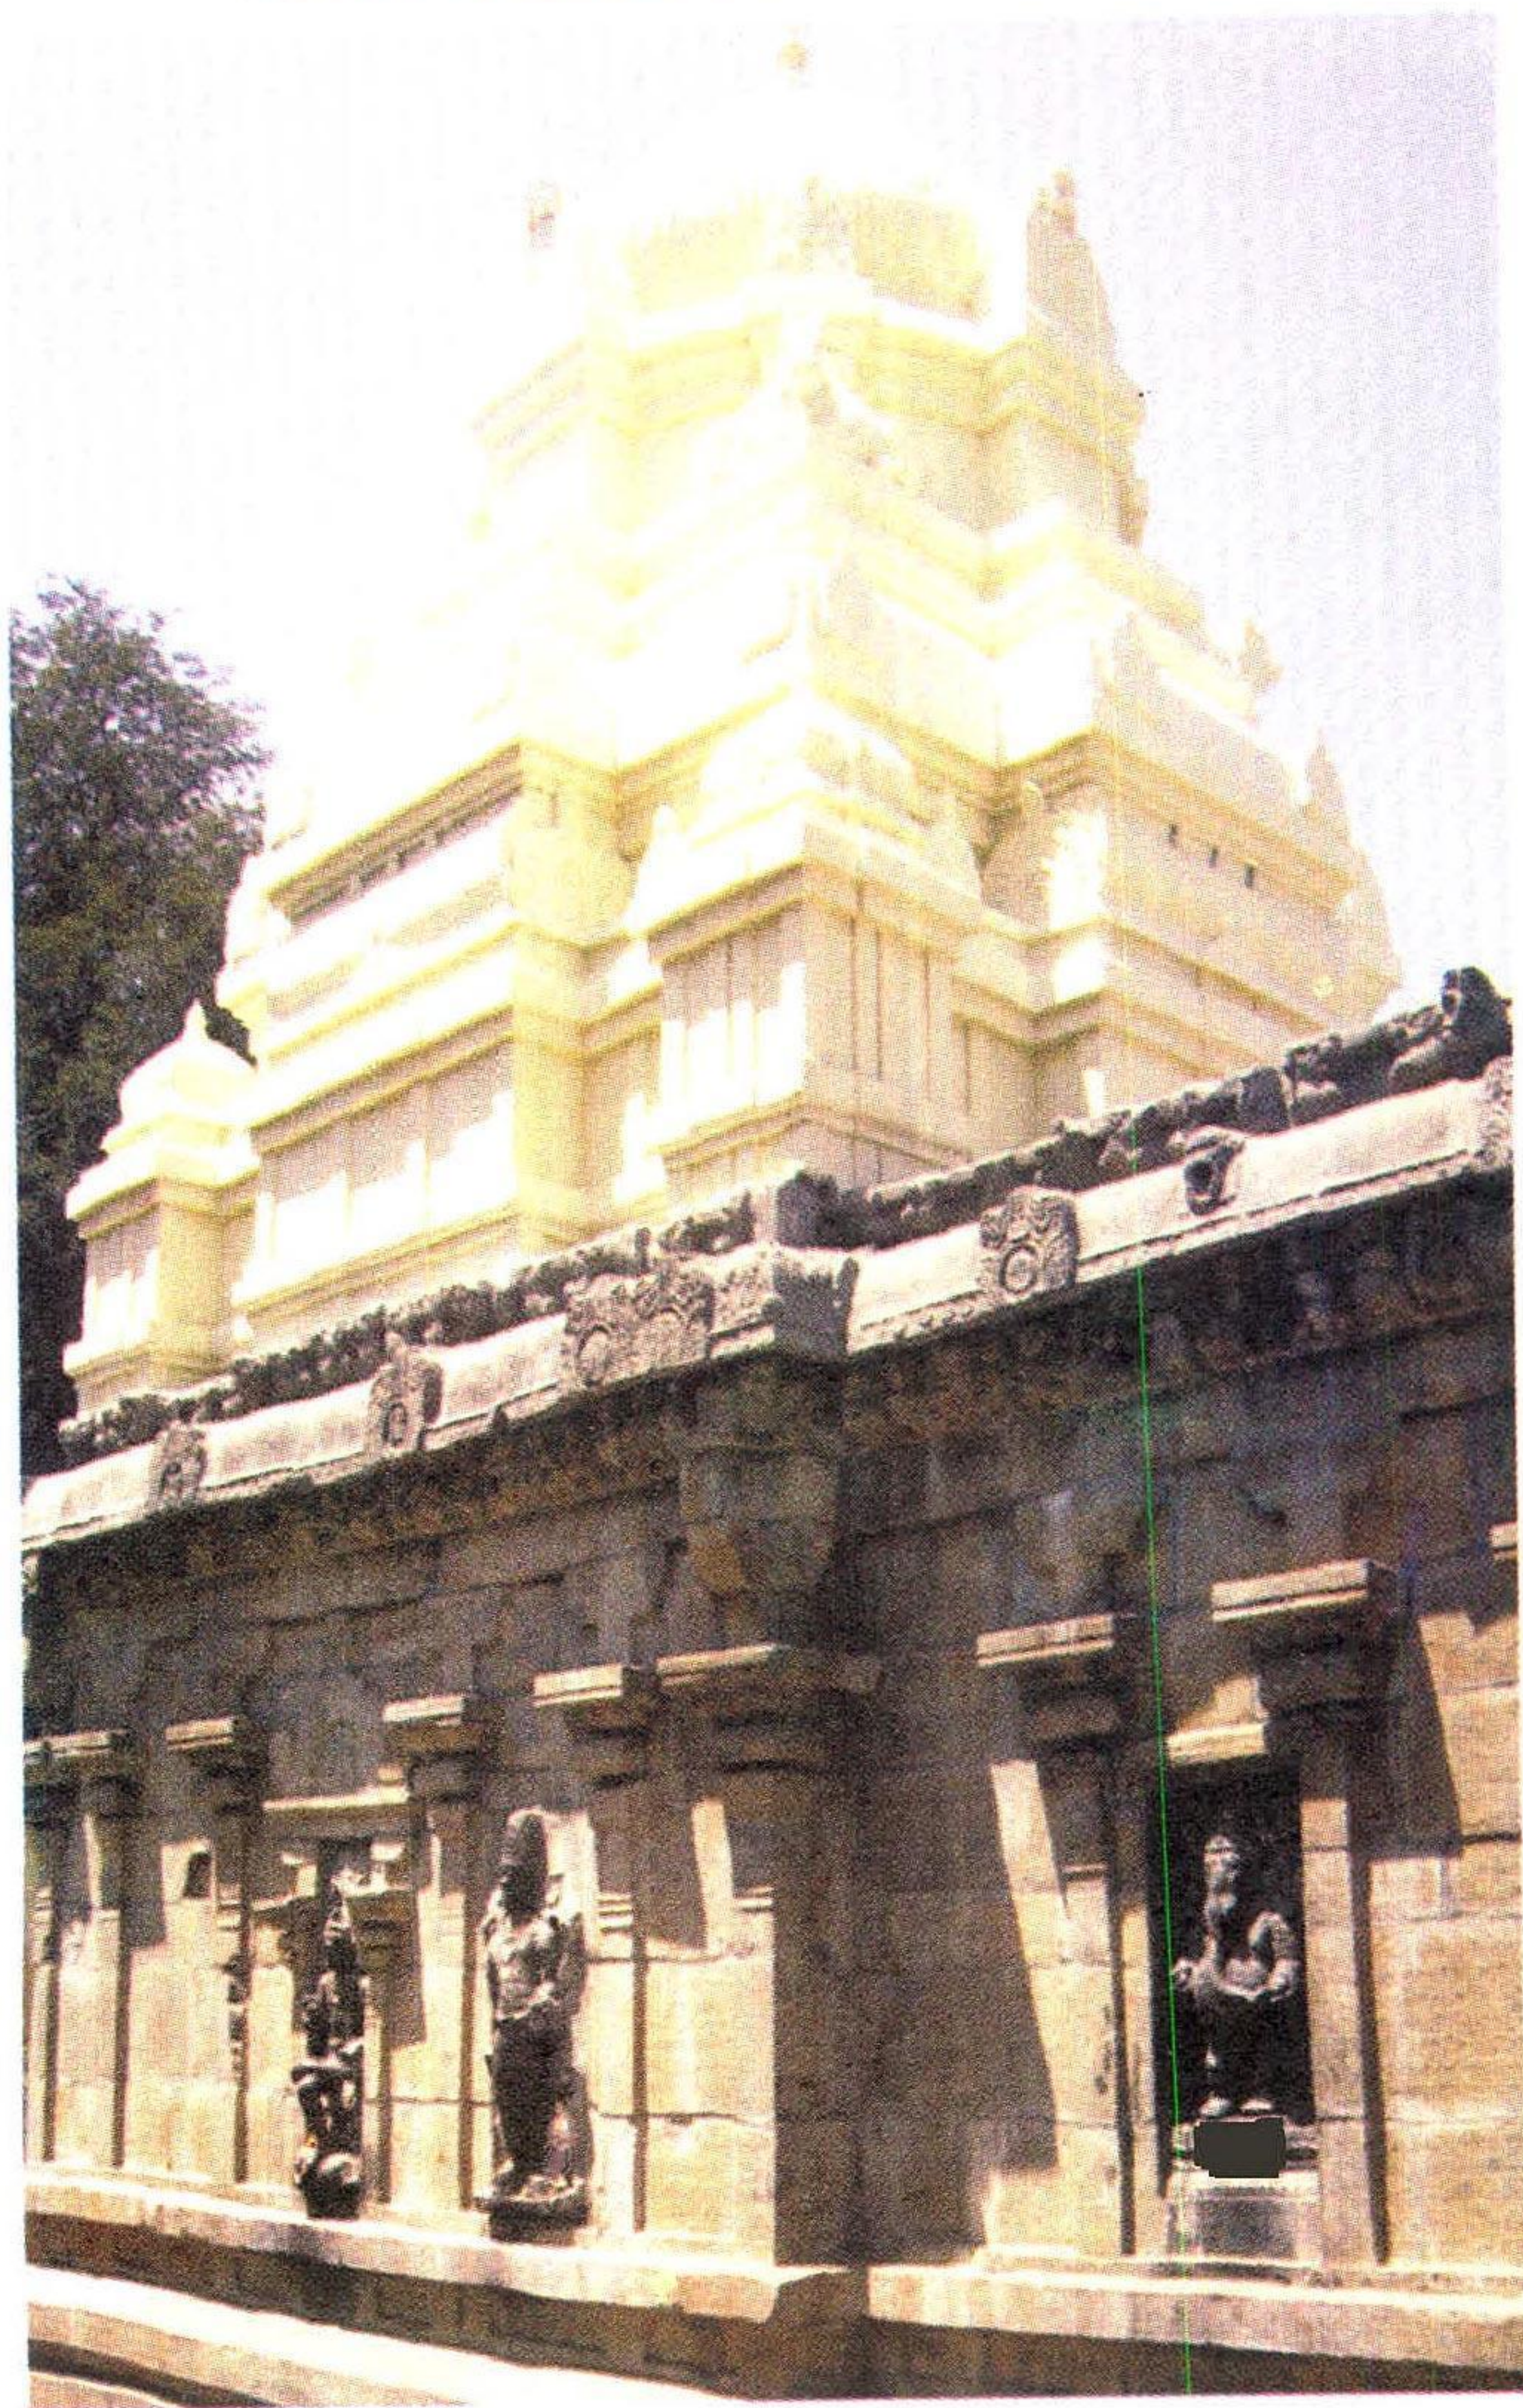
## **SIVAN KOIL ULAGAPURAM**

**After Conservation**
