# **TARANGAMPADI (TRANQUEBAR) EXCAVATION & CONSERVATION REPORT**

**2001 - 2002**

Department of Archaeology,  
Government of Tamilnadu, Chennai - 600 113.

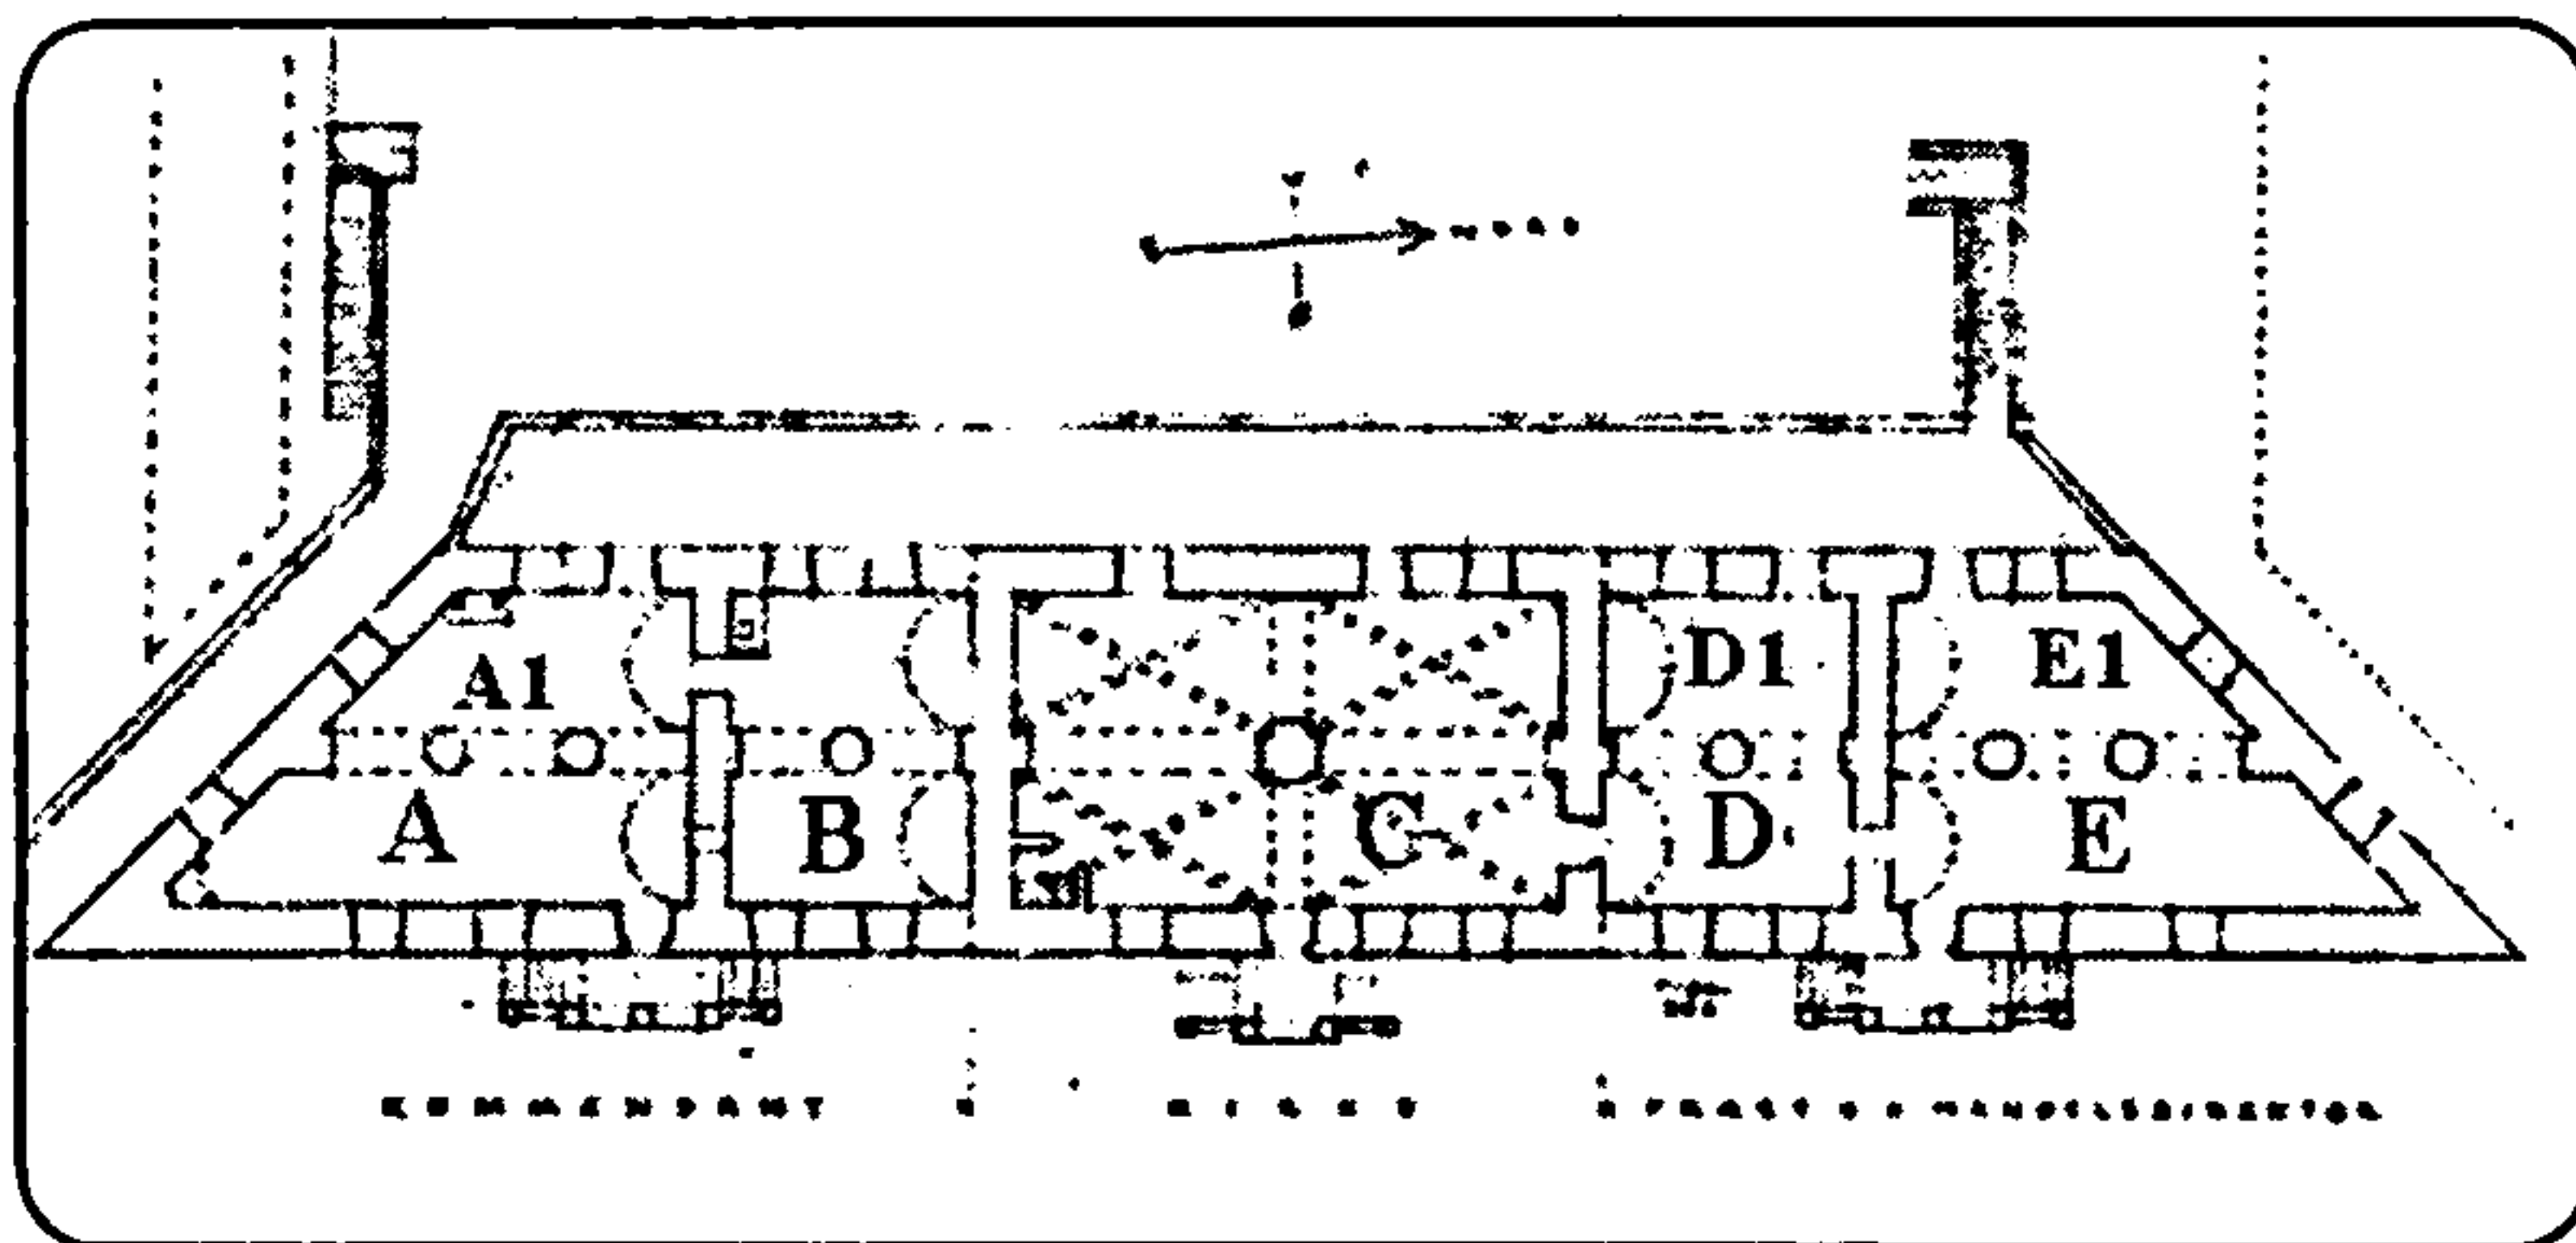
THE PLAN FOR THE FORT DANSBORG

Tarangampadi fort consisted of two large structures. They were the rampart wall and the main buildings. The rampart wall was a fairly large foursided structure with bastions at each cardinal point. Along the three inner sides of the fort wall, a single storied building was constructed. These rooms were used for barracks, warehouse, kitchen and jail. Now, the rooms on the southern side are in good condition but the rooms on the western and northern sides have been completely damaged. On the eastern side of the fort, there was a two-storied building facing the sea. It was the main building of the fort. The vaulted lower storey served as magazines and a warehouse while the vaulted upper storey contained the church and the lodgings of the governor, the senior merchants and the chaplain. The fort was surrounded by a moat and access to the fort was over a drawbridge. This moat has completely disappeared. The sea on the eastern side and the river on the southern side protected it.

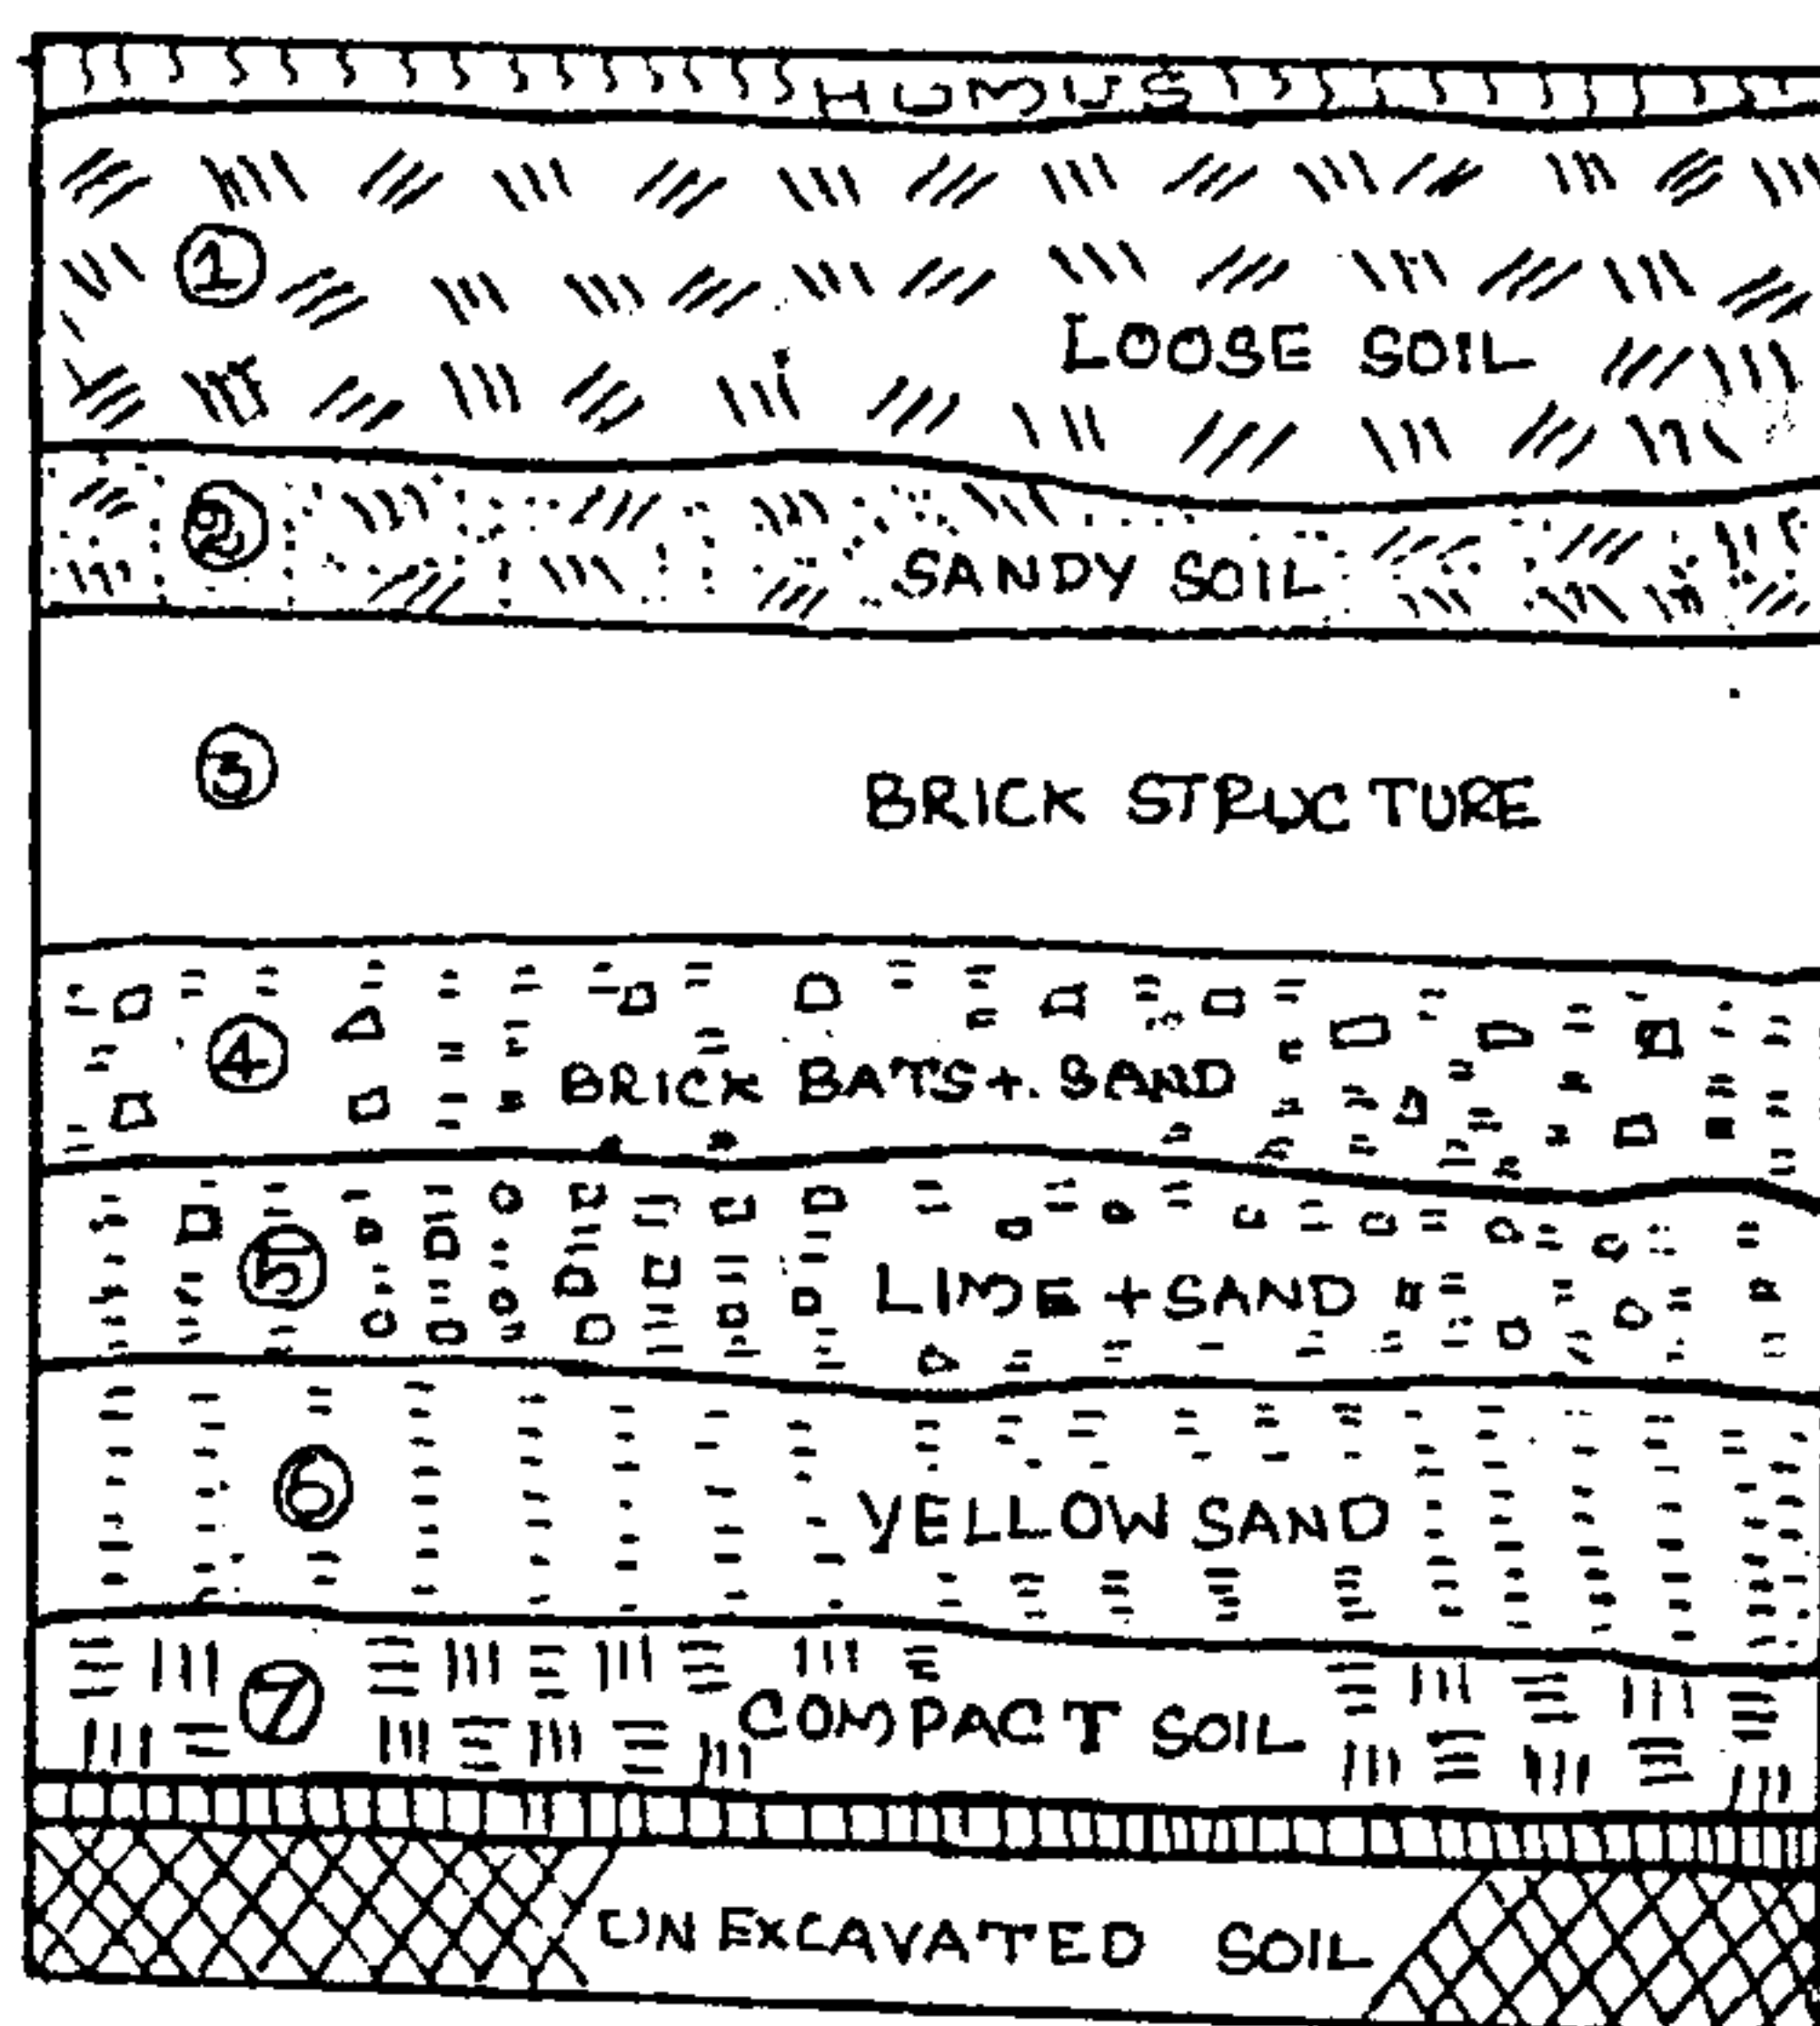
NORTHERN SECTION TGI-1

The trial trench TGI-1 was laid on the rampart wall in 2001. It measured 2x2 meters and was oriented in south-north direction. The removal of the humus exposed the sand mixed with soil. Below this layer 75 cm breadth of rampart wall was exposed. The exposure of the wall restricted the area of digging to 1.25 m. To overcome this, the area of the trench was extended a further 50 cm on either side and this made the total extension to 1 m. At the depth of one meter brick paved floor was exposed. Full bricks as well as half bricks were used for the floor. Above this floor three layers were noticed.

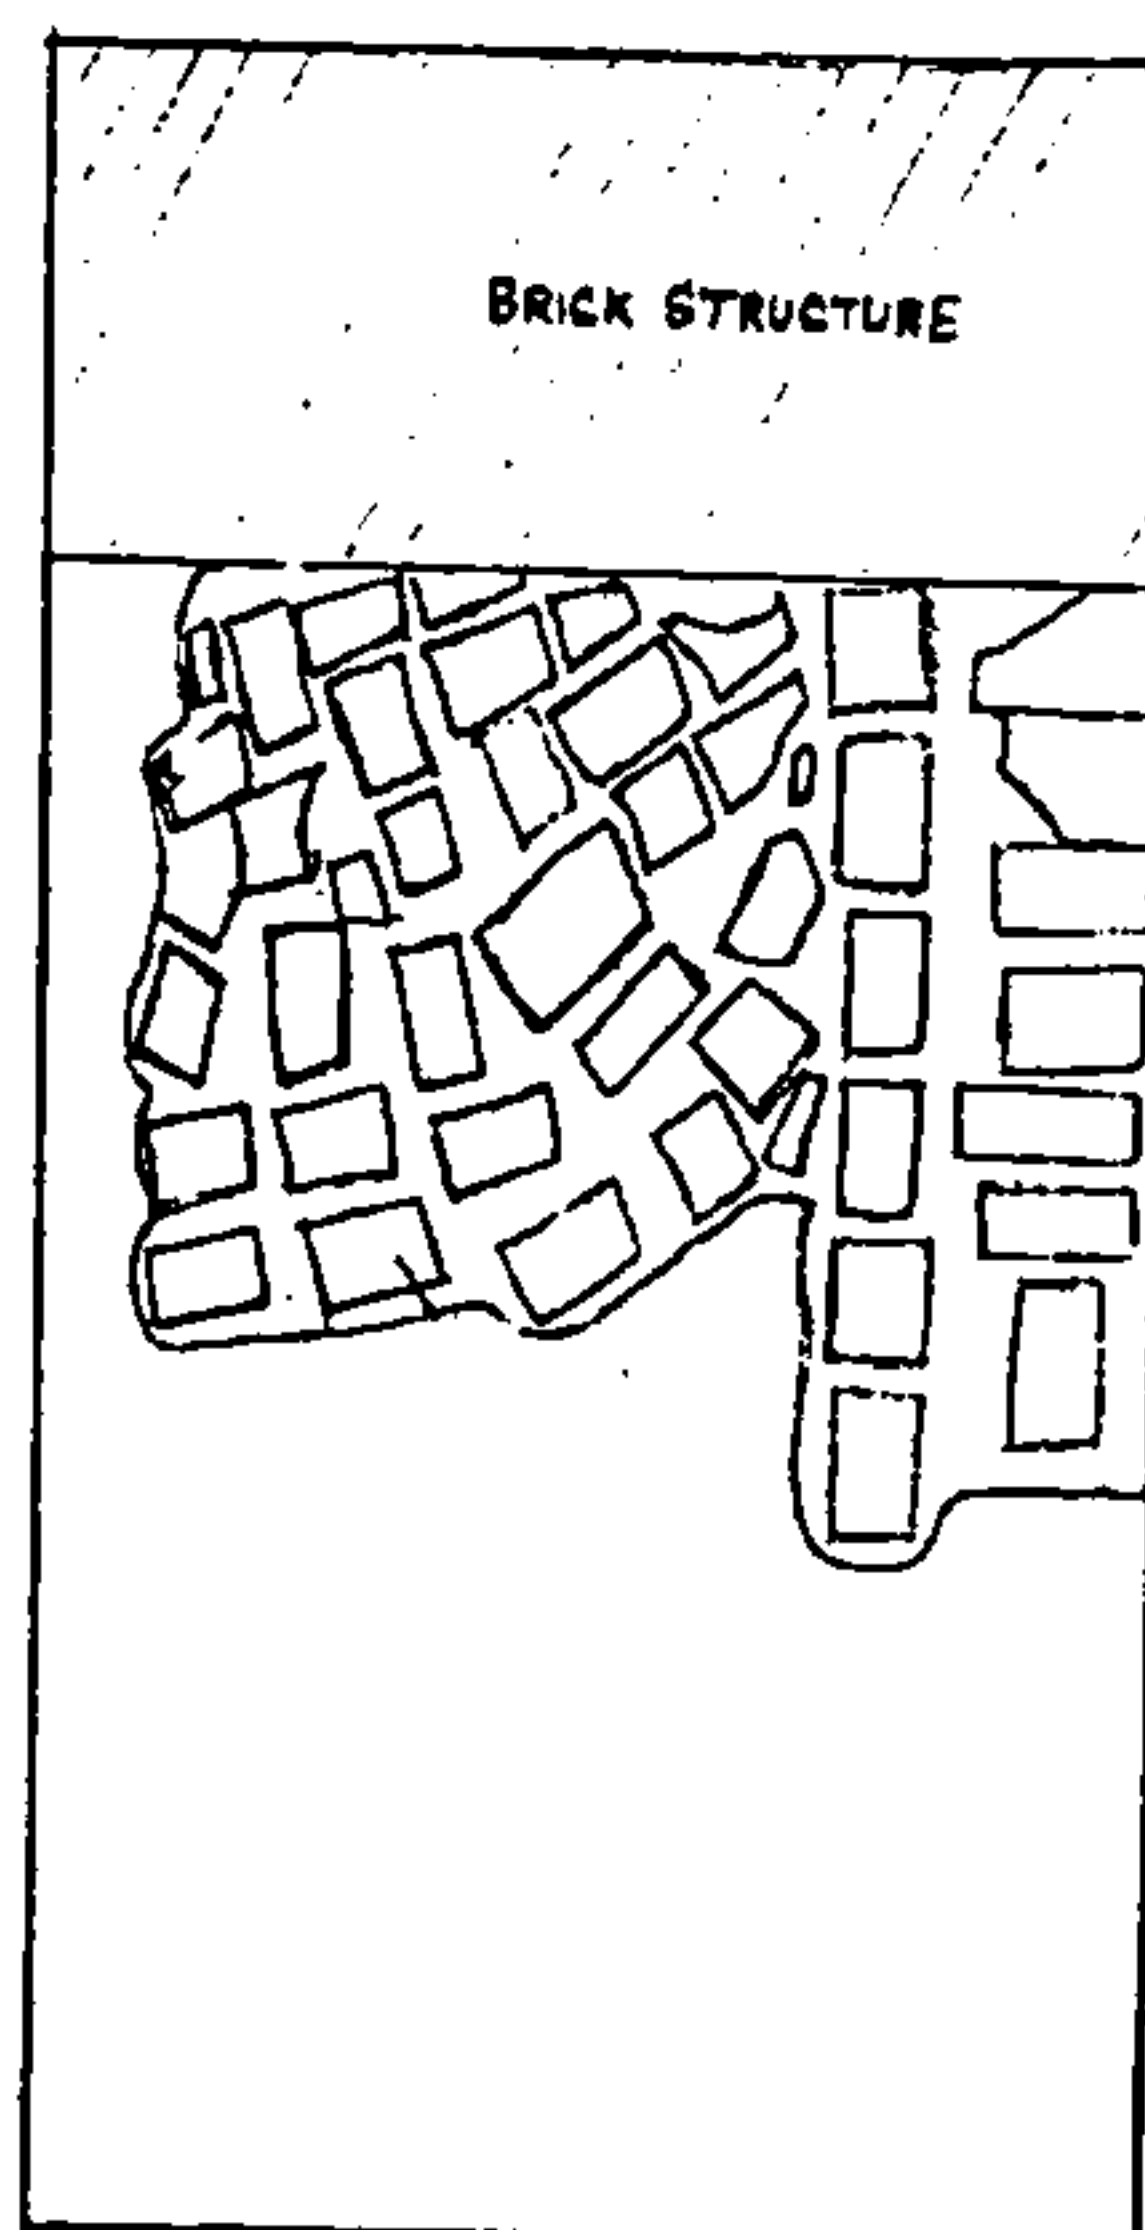
TGI-2 PAVED BRICK

The exposure of constructional material that was found at different levels clearly suggested the method of construction. A single layer paved brick was laid right on the natural soil i.e., sea sand at this place. Above this brick paved floor, 30 cm thick compact clay mixed with brickbats and lime was laid. Above this compact earth filling, again 30 cm thick yellowish soil, locally called *tavittuman*, was used. Over this yellowish soil, another brick floor was paved. The total breadth of this floor comes to 12.25 m. By leaving a metre on the interior, the rampart wall is built upon this floor covering breadth of 11.25 m. The rampart wall consists of two walls each having a thickness of 75 cm. The gap between the two walls (9.25 m) is filled with brickbats, soil and sand. The total height of the wall comes to 4 m. The binding material used in the wall is lime mortar. The size of the brick is 20x13x4 cm. The upper surface of the wall slopes inward in conical shape. The upper surface is completely covered with a brick paving. The conical shape and the brick paving helps to drain the rain water as well as prevent any seepage of water into the wall surface. The outer and inner surface of the wall is plastered with lime mortar. Two layers of lime mortar were exposed. The lime mortar is again washed with red ochre. Another buttress wall having a thickness of 65 cm was added attached on the outside of the wall. It seems, this

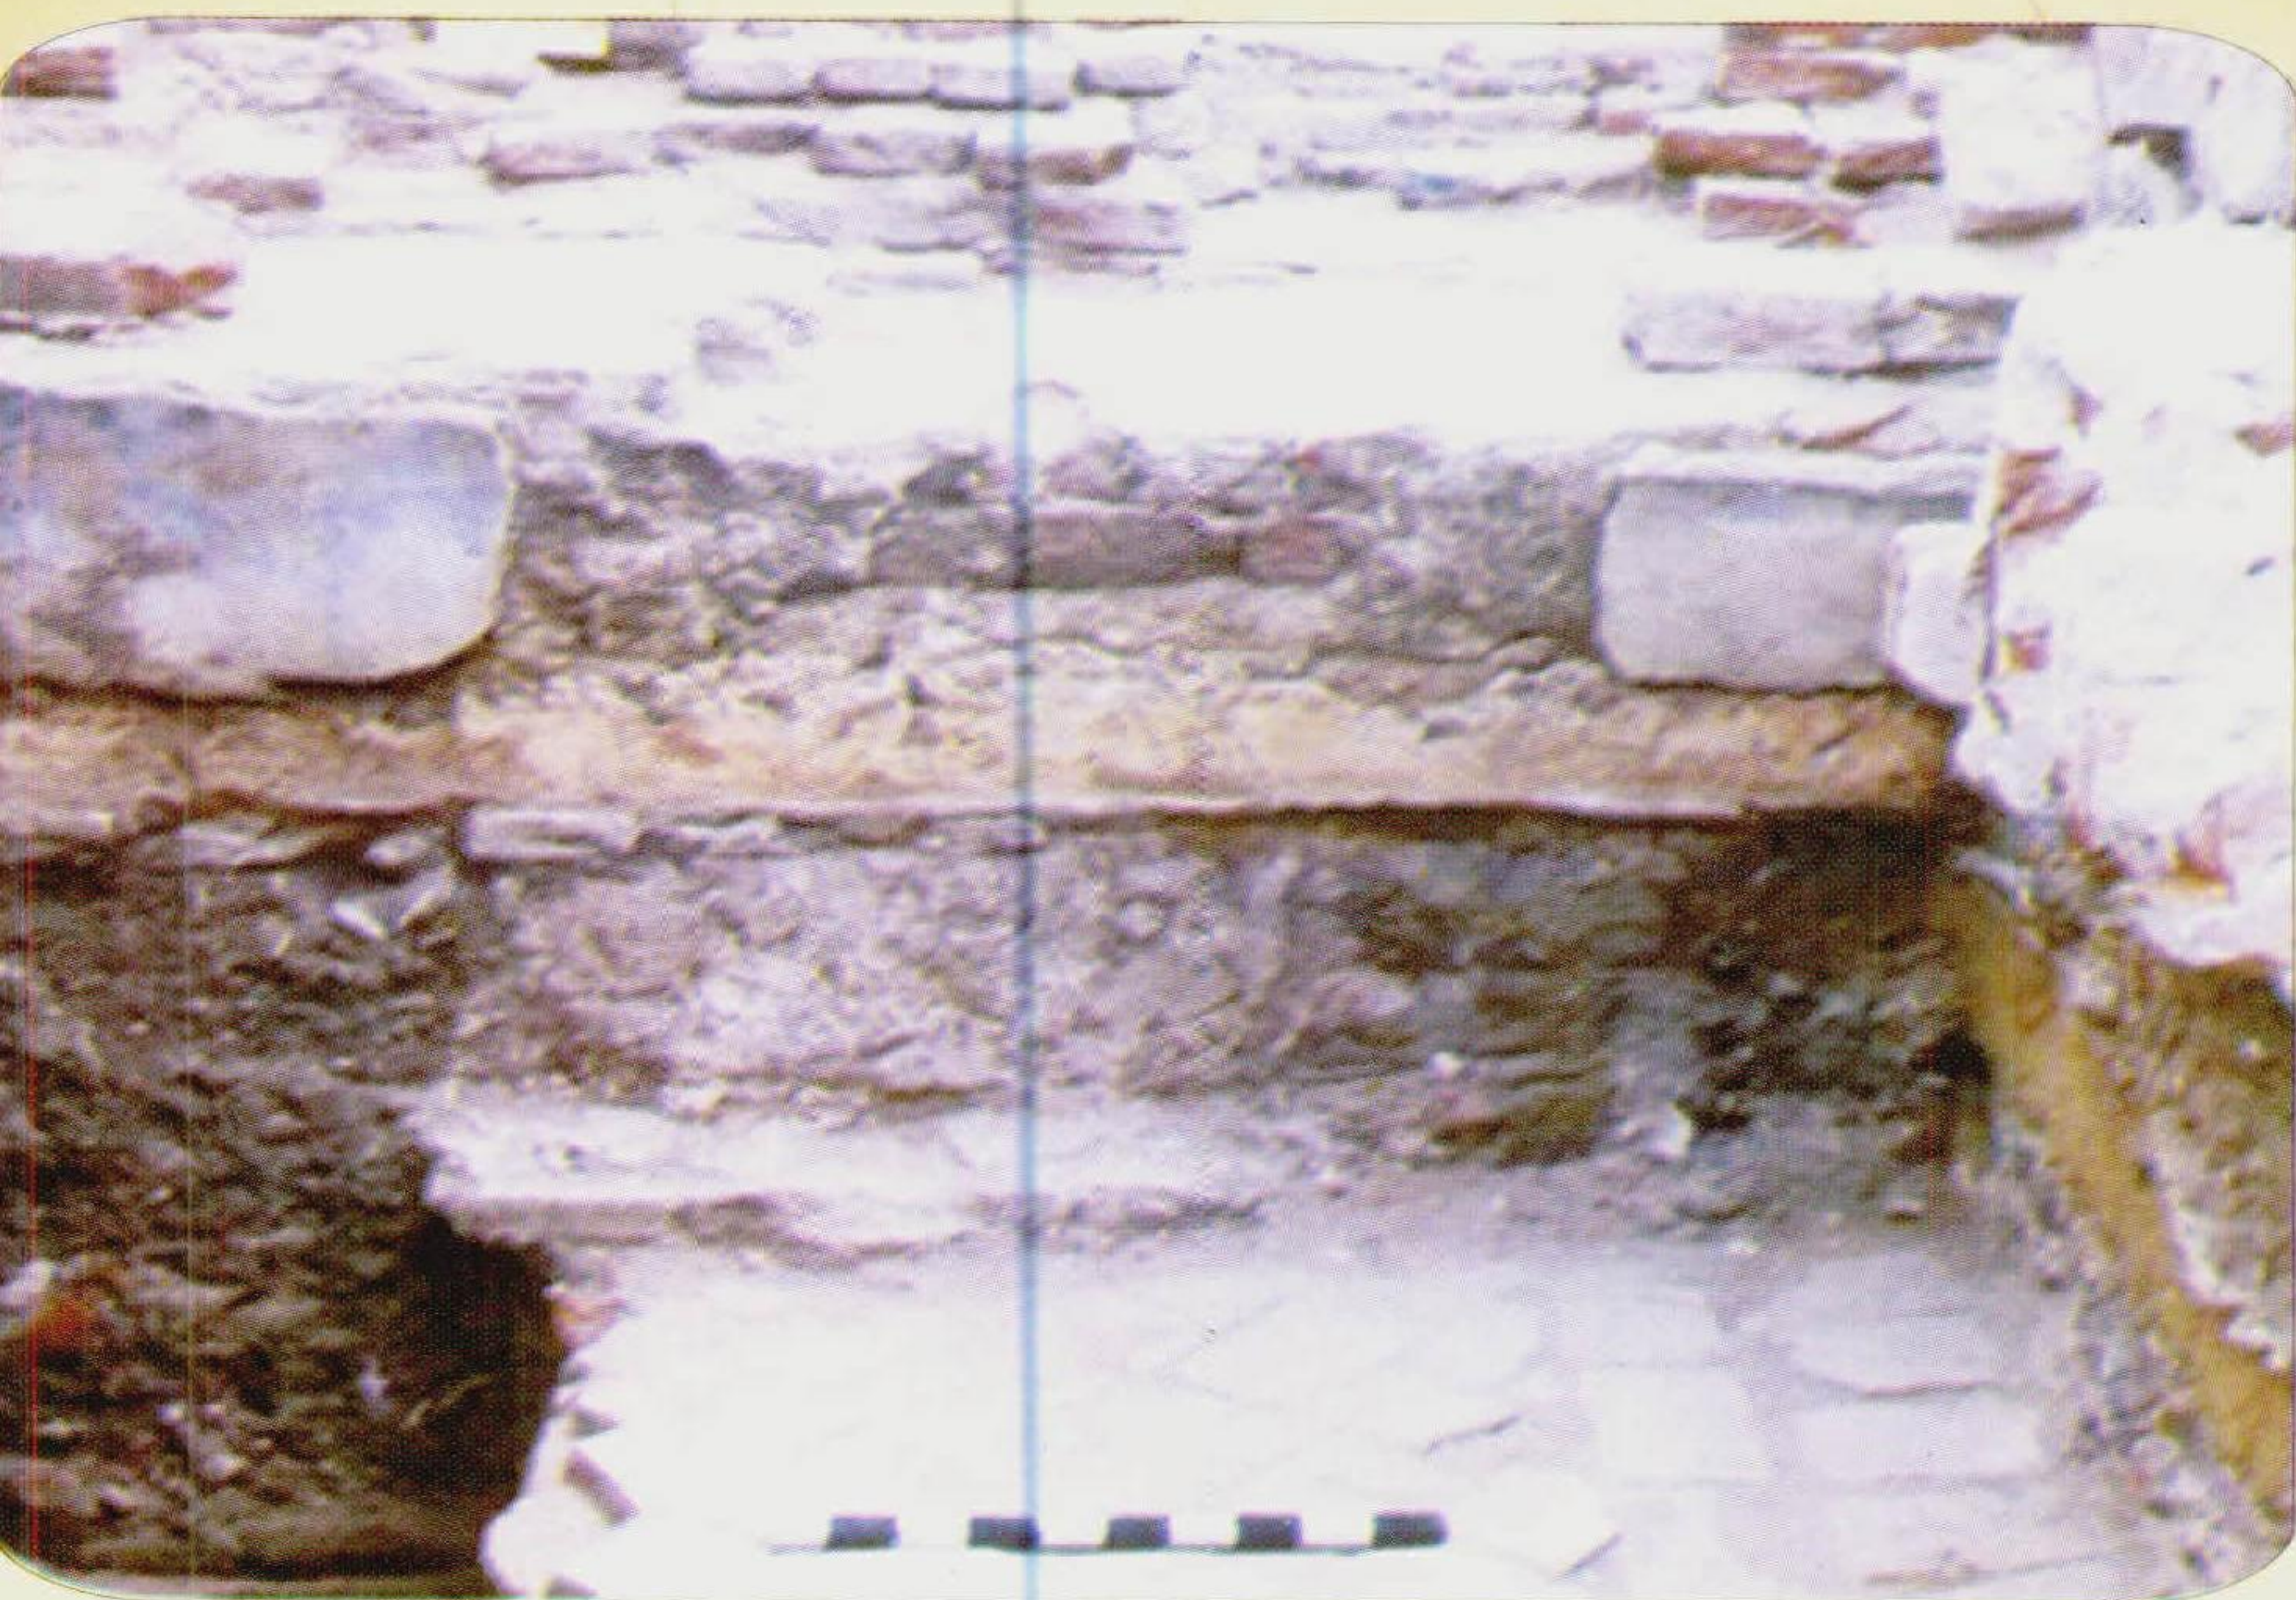
View of the floor

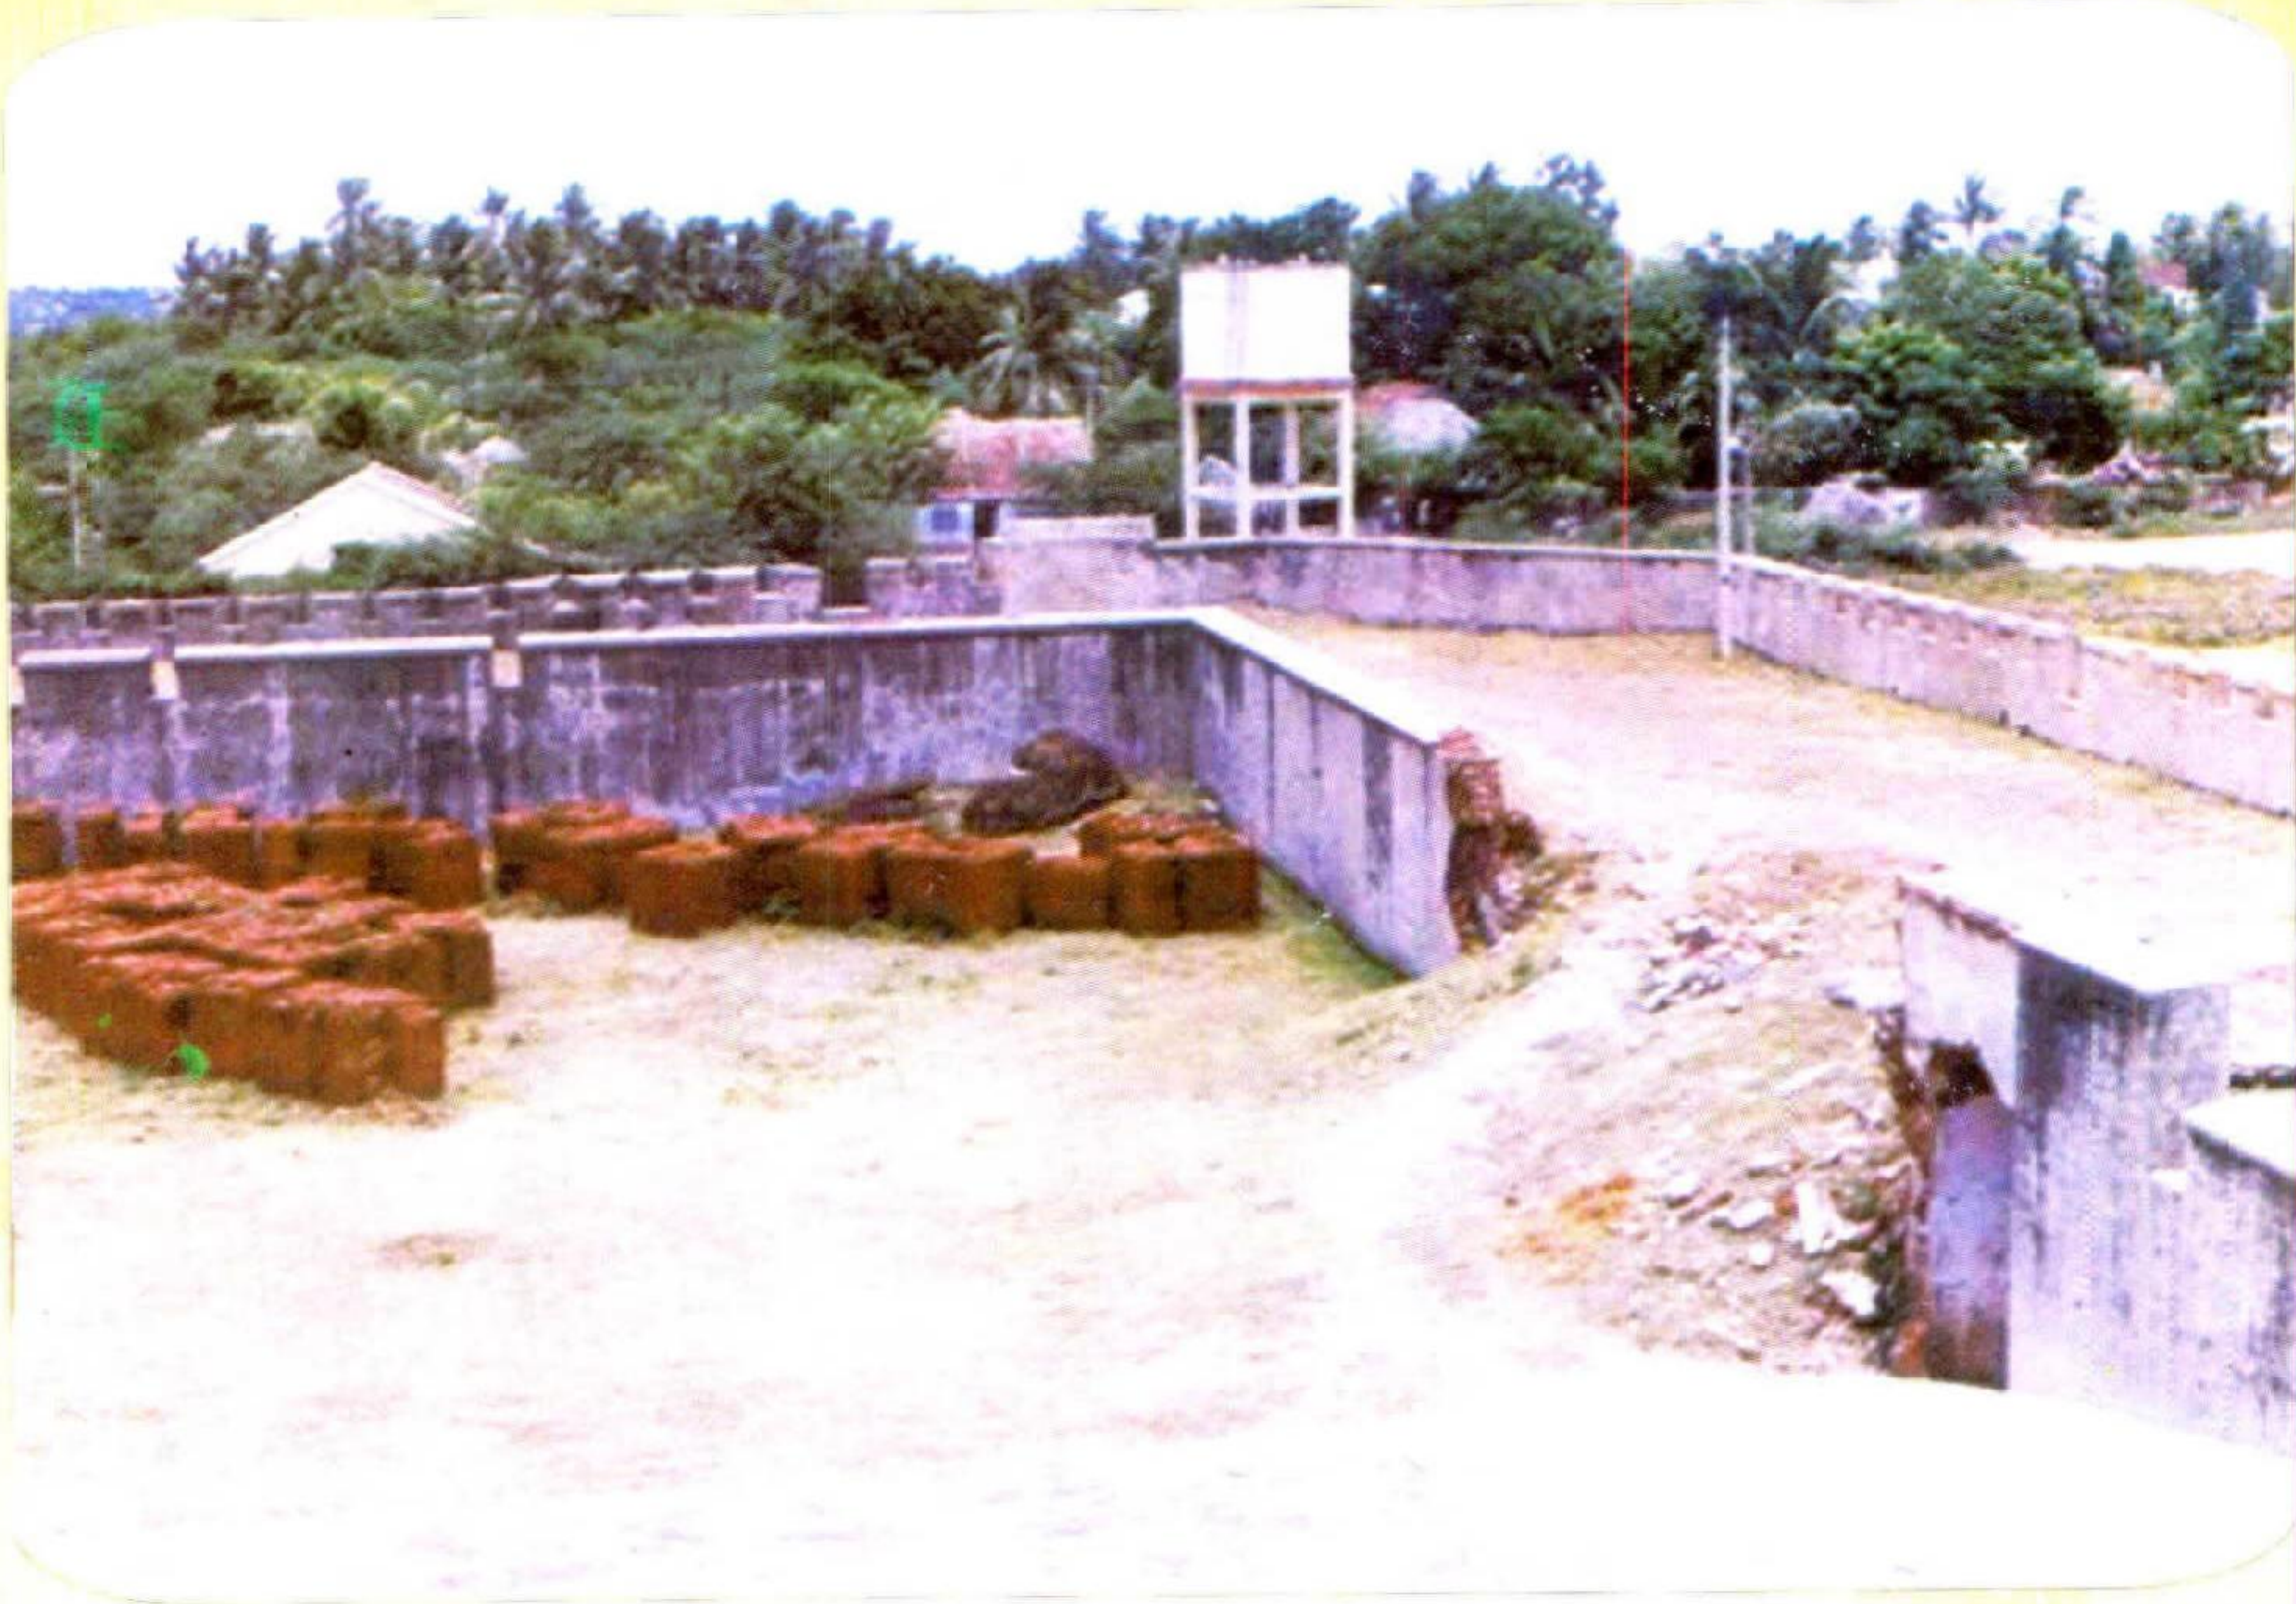
Rampart wall before conservation

The nature of the foundation was exposed. This helped to conserve the rampart wall and rebuild it using similar bricks and other bricks that had already been stocked at site since 1997 AD. They were used in the inner layer. In the outer layers, use was made of old bricks which were reused or new bricks made to the old dimensions. The rampart wall is now complete.

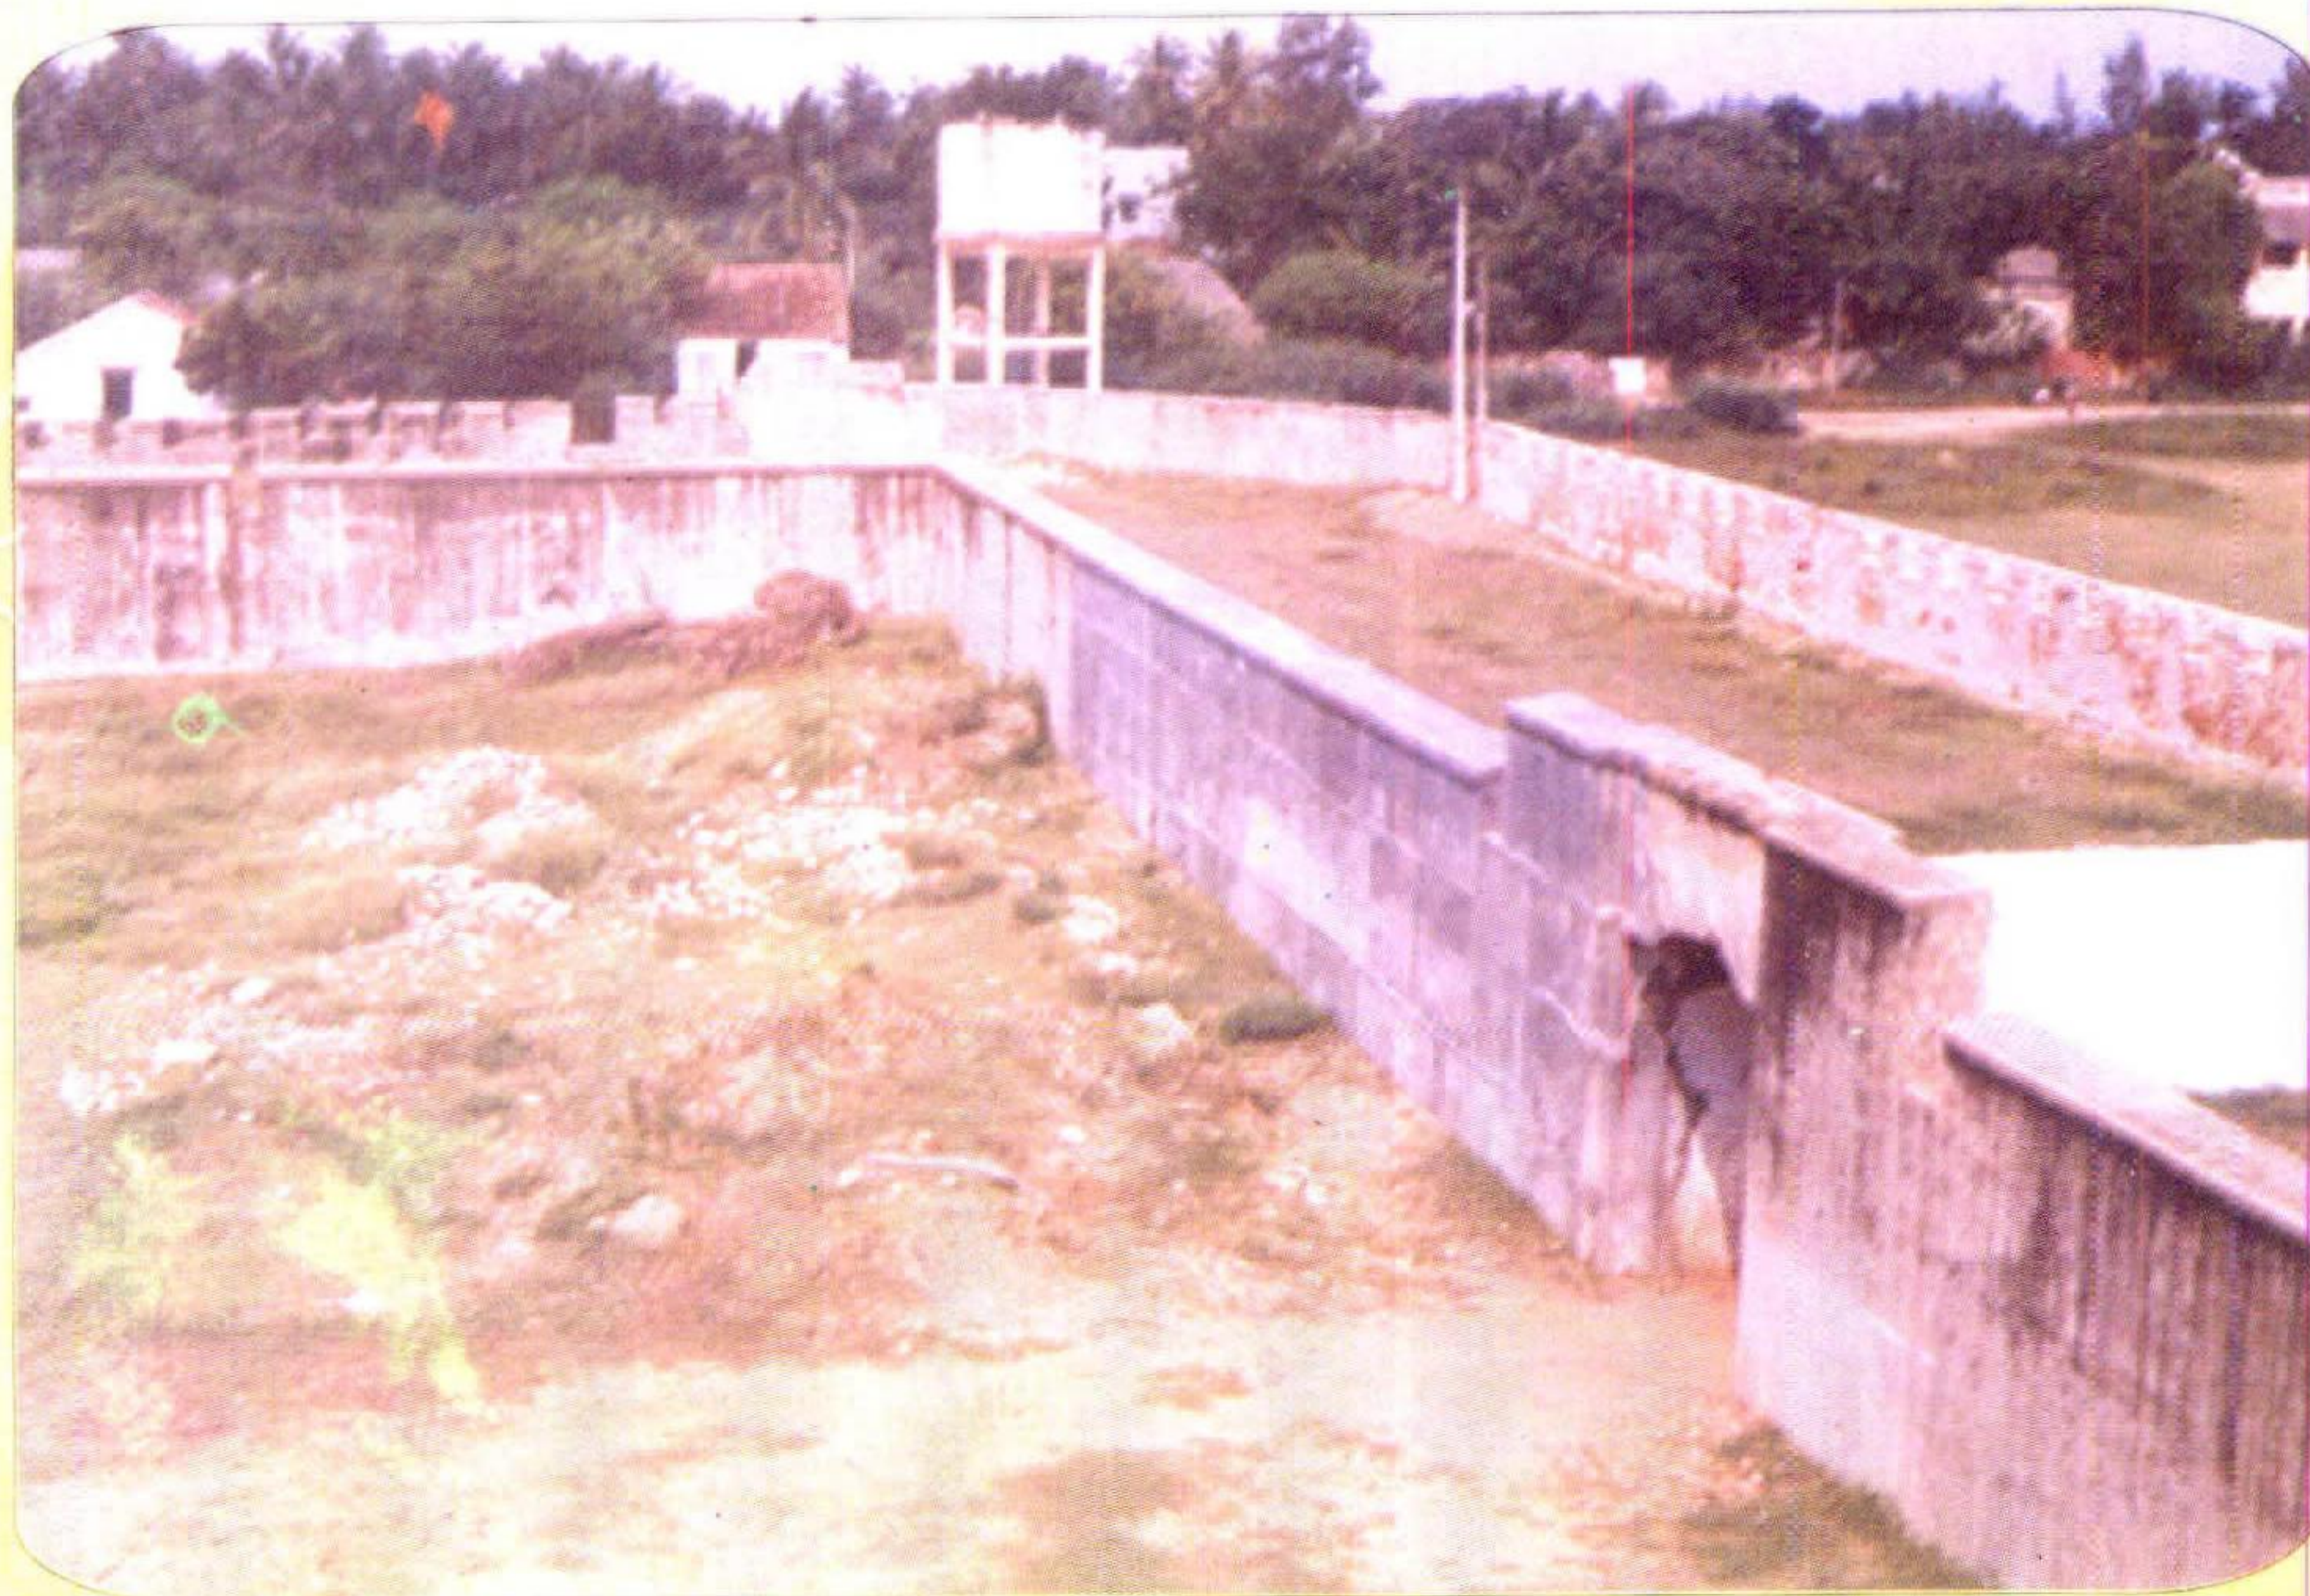
Rampart wall after conservation
