# **TARANGAMPADI (TRANQUEBAR) EXCAVATION & CONSERVATION REPORT**

**2001 - 2002**

Department of Archaeology,  
Government of Tamilnadu, Chennai - 600 113.

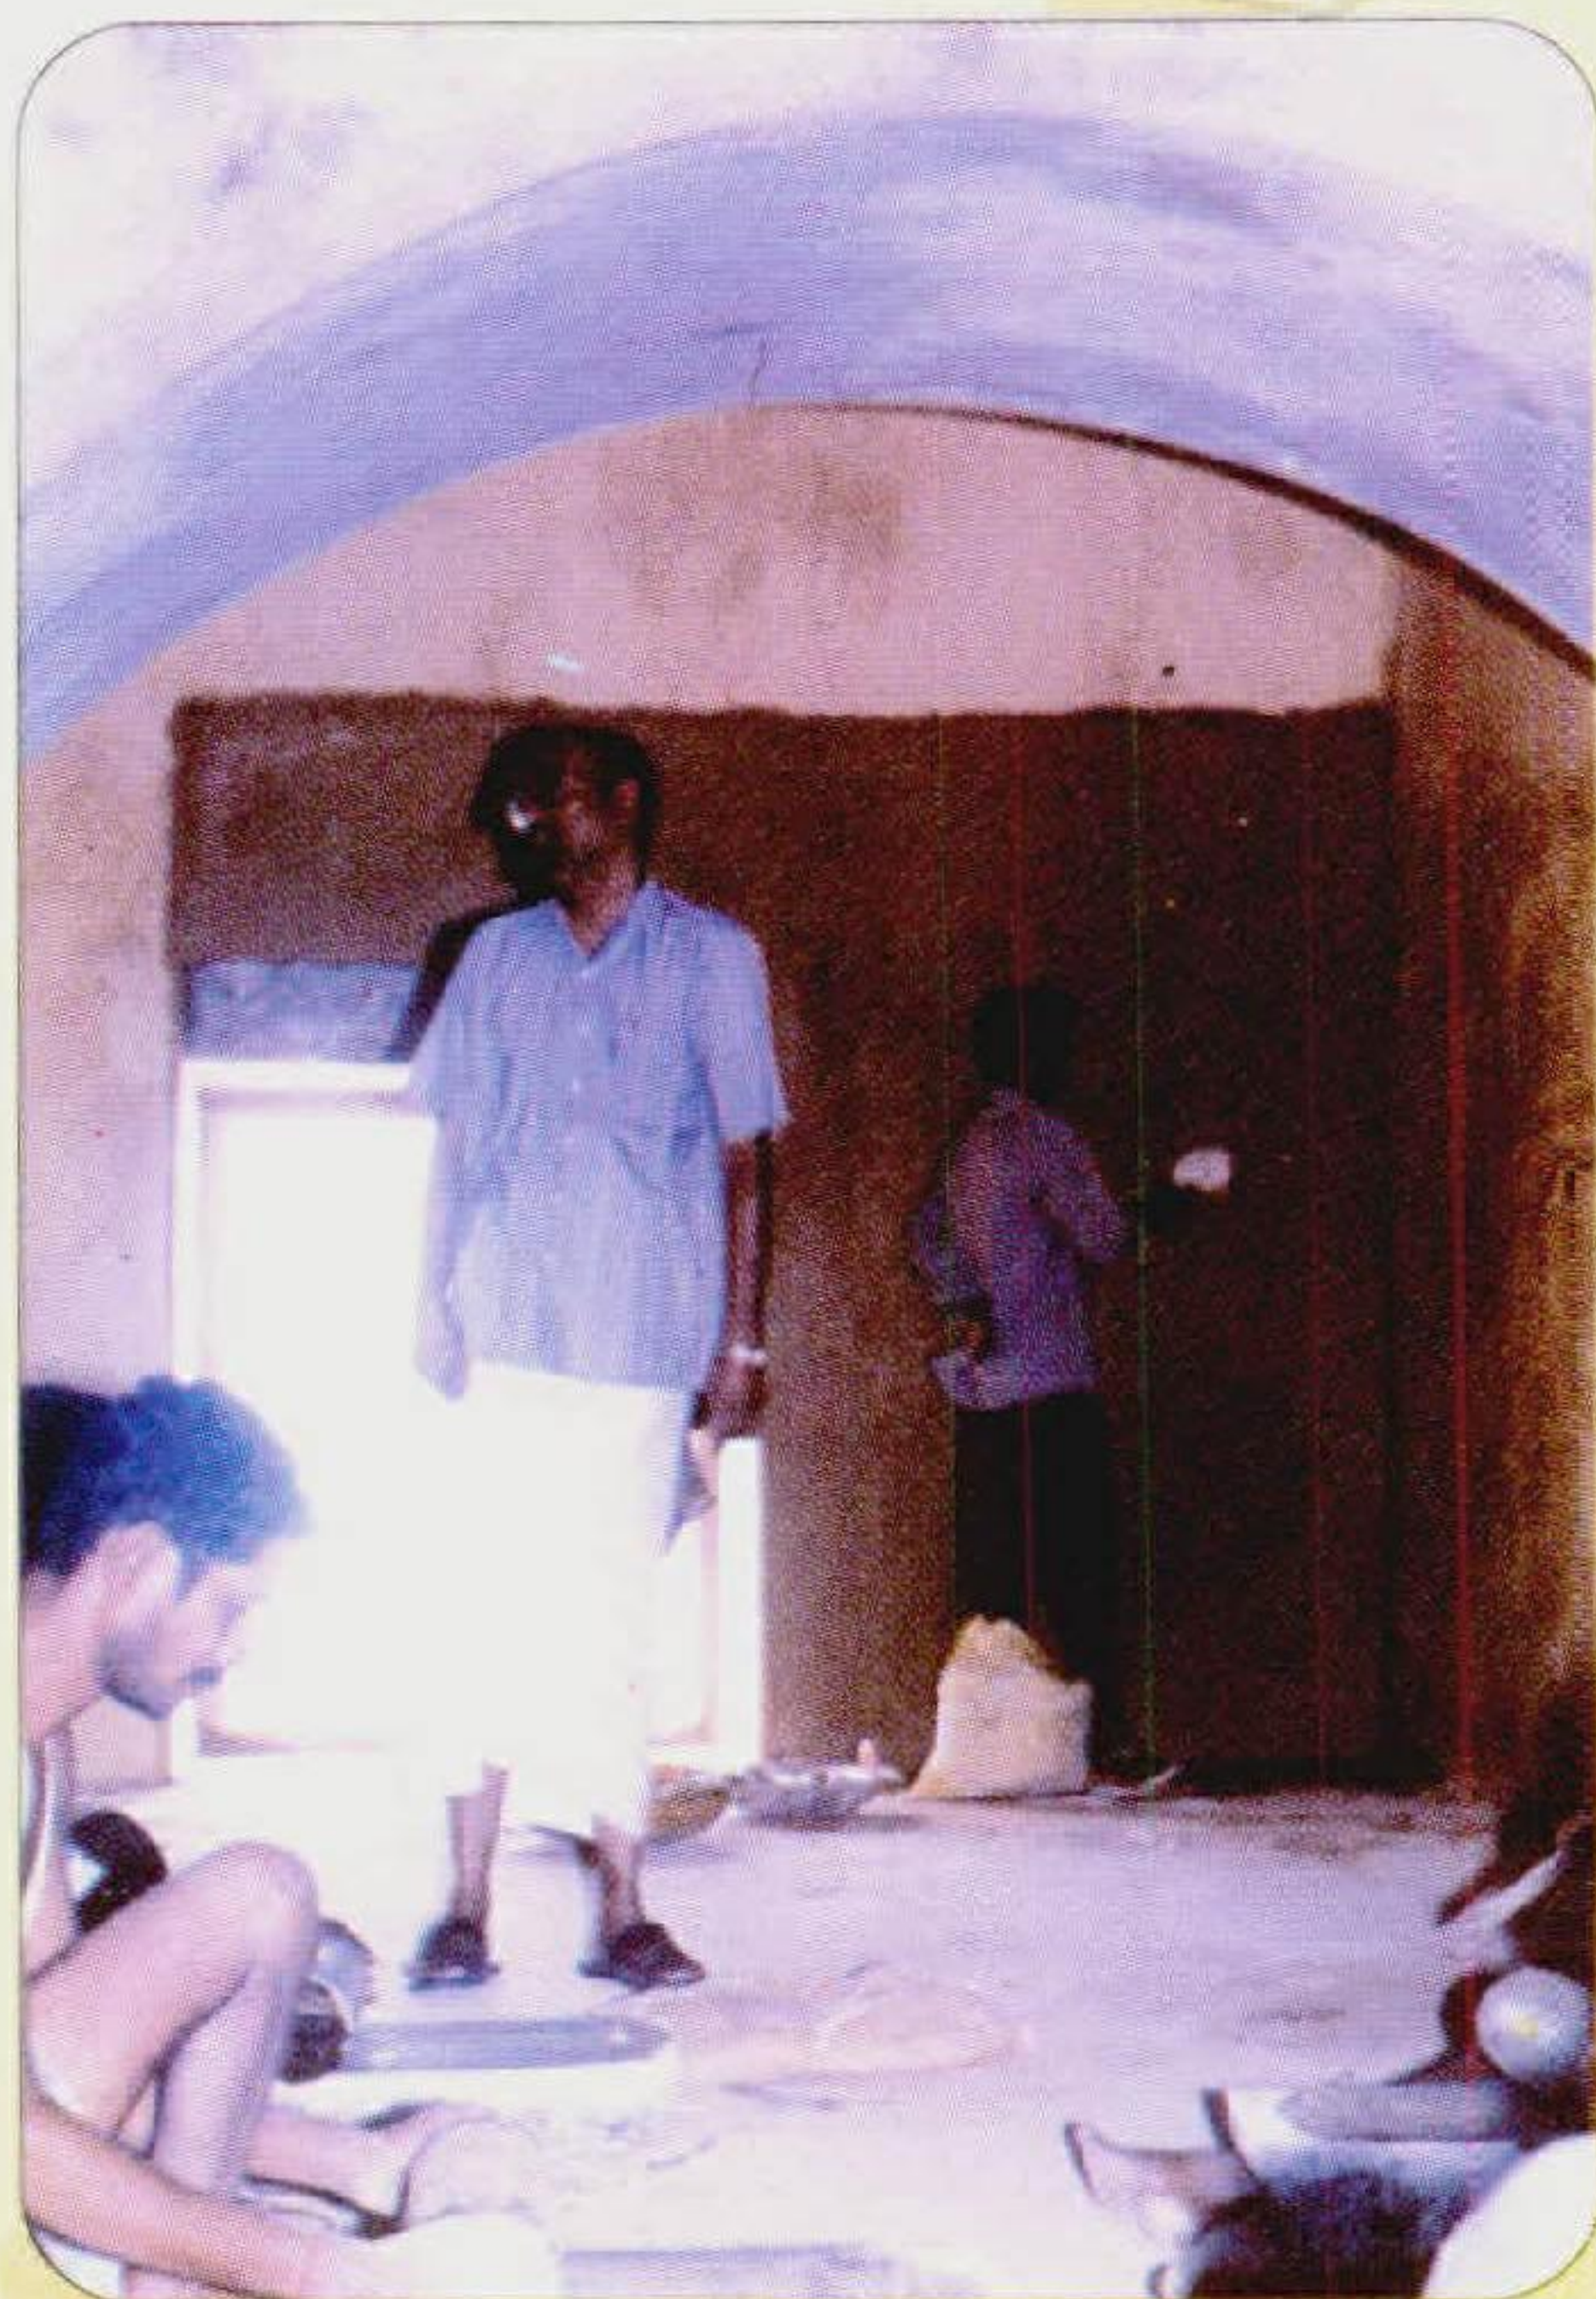
Plastering work in progress - lime being ground  
in traditional grinding stone - May - 2002

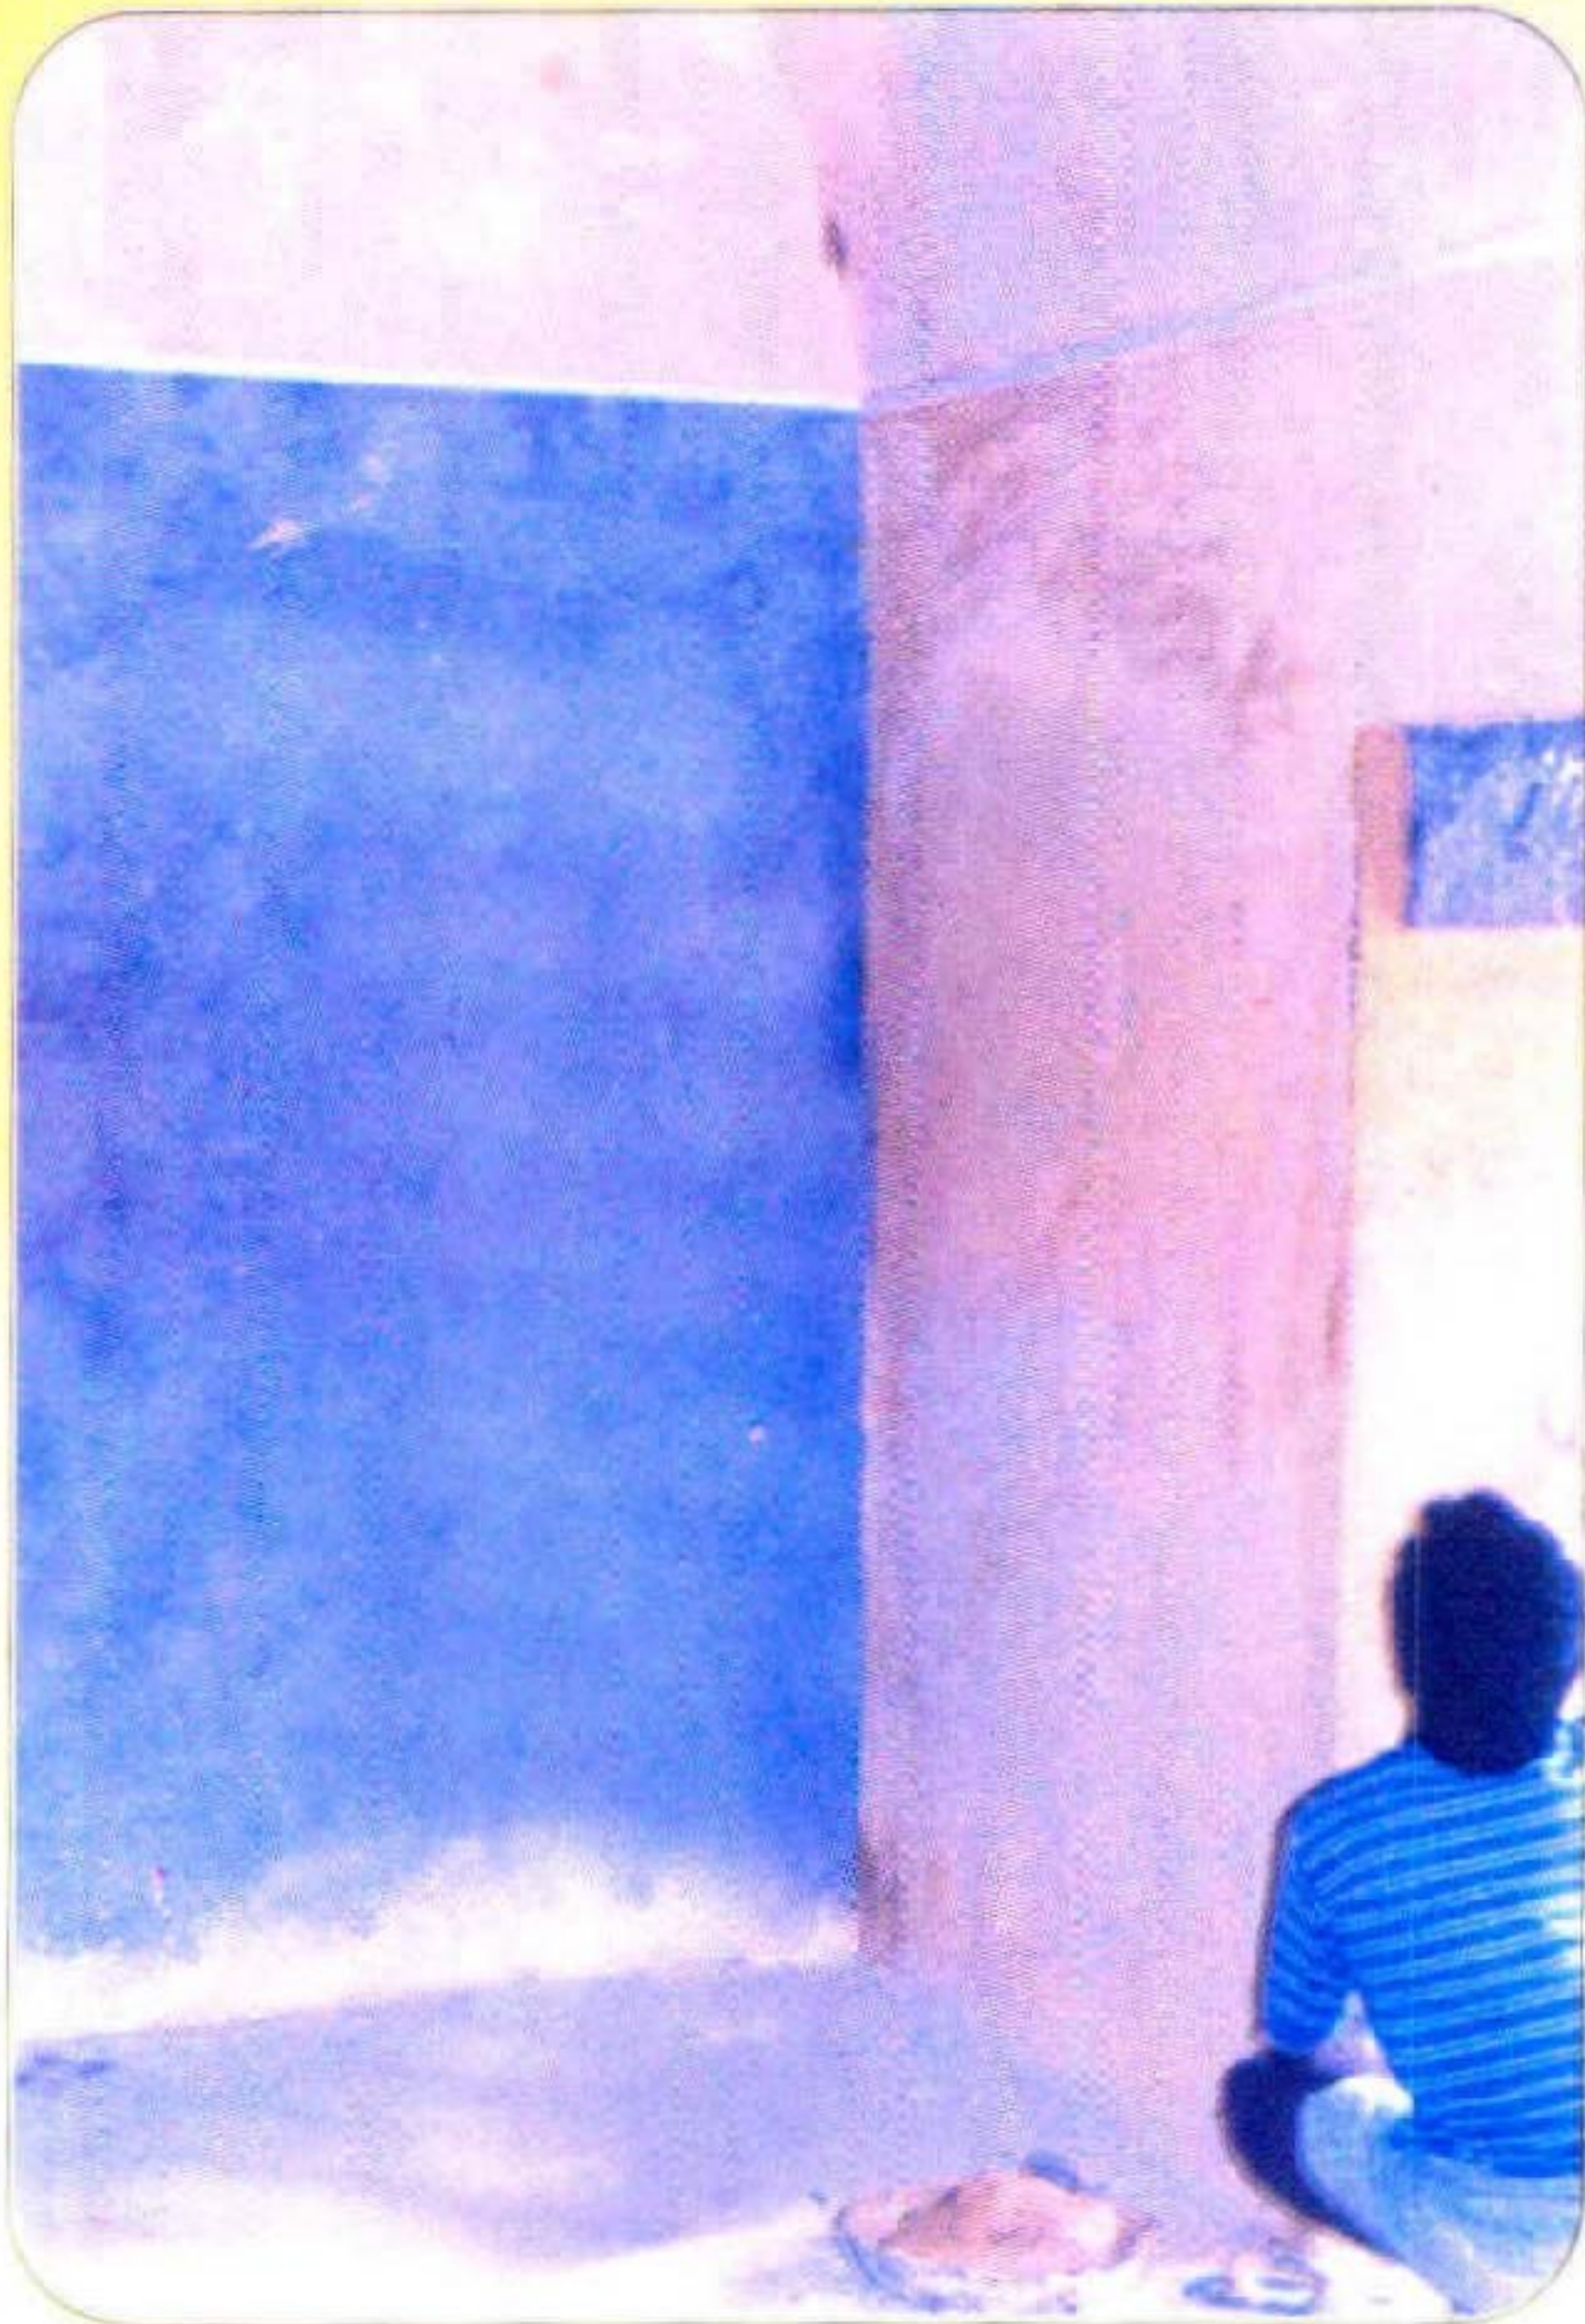
The fine polished plastering  
with yellow ochre finish  
(Moghul type plaster) in progress  
June 2002

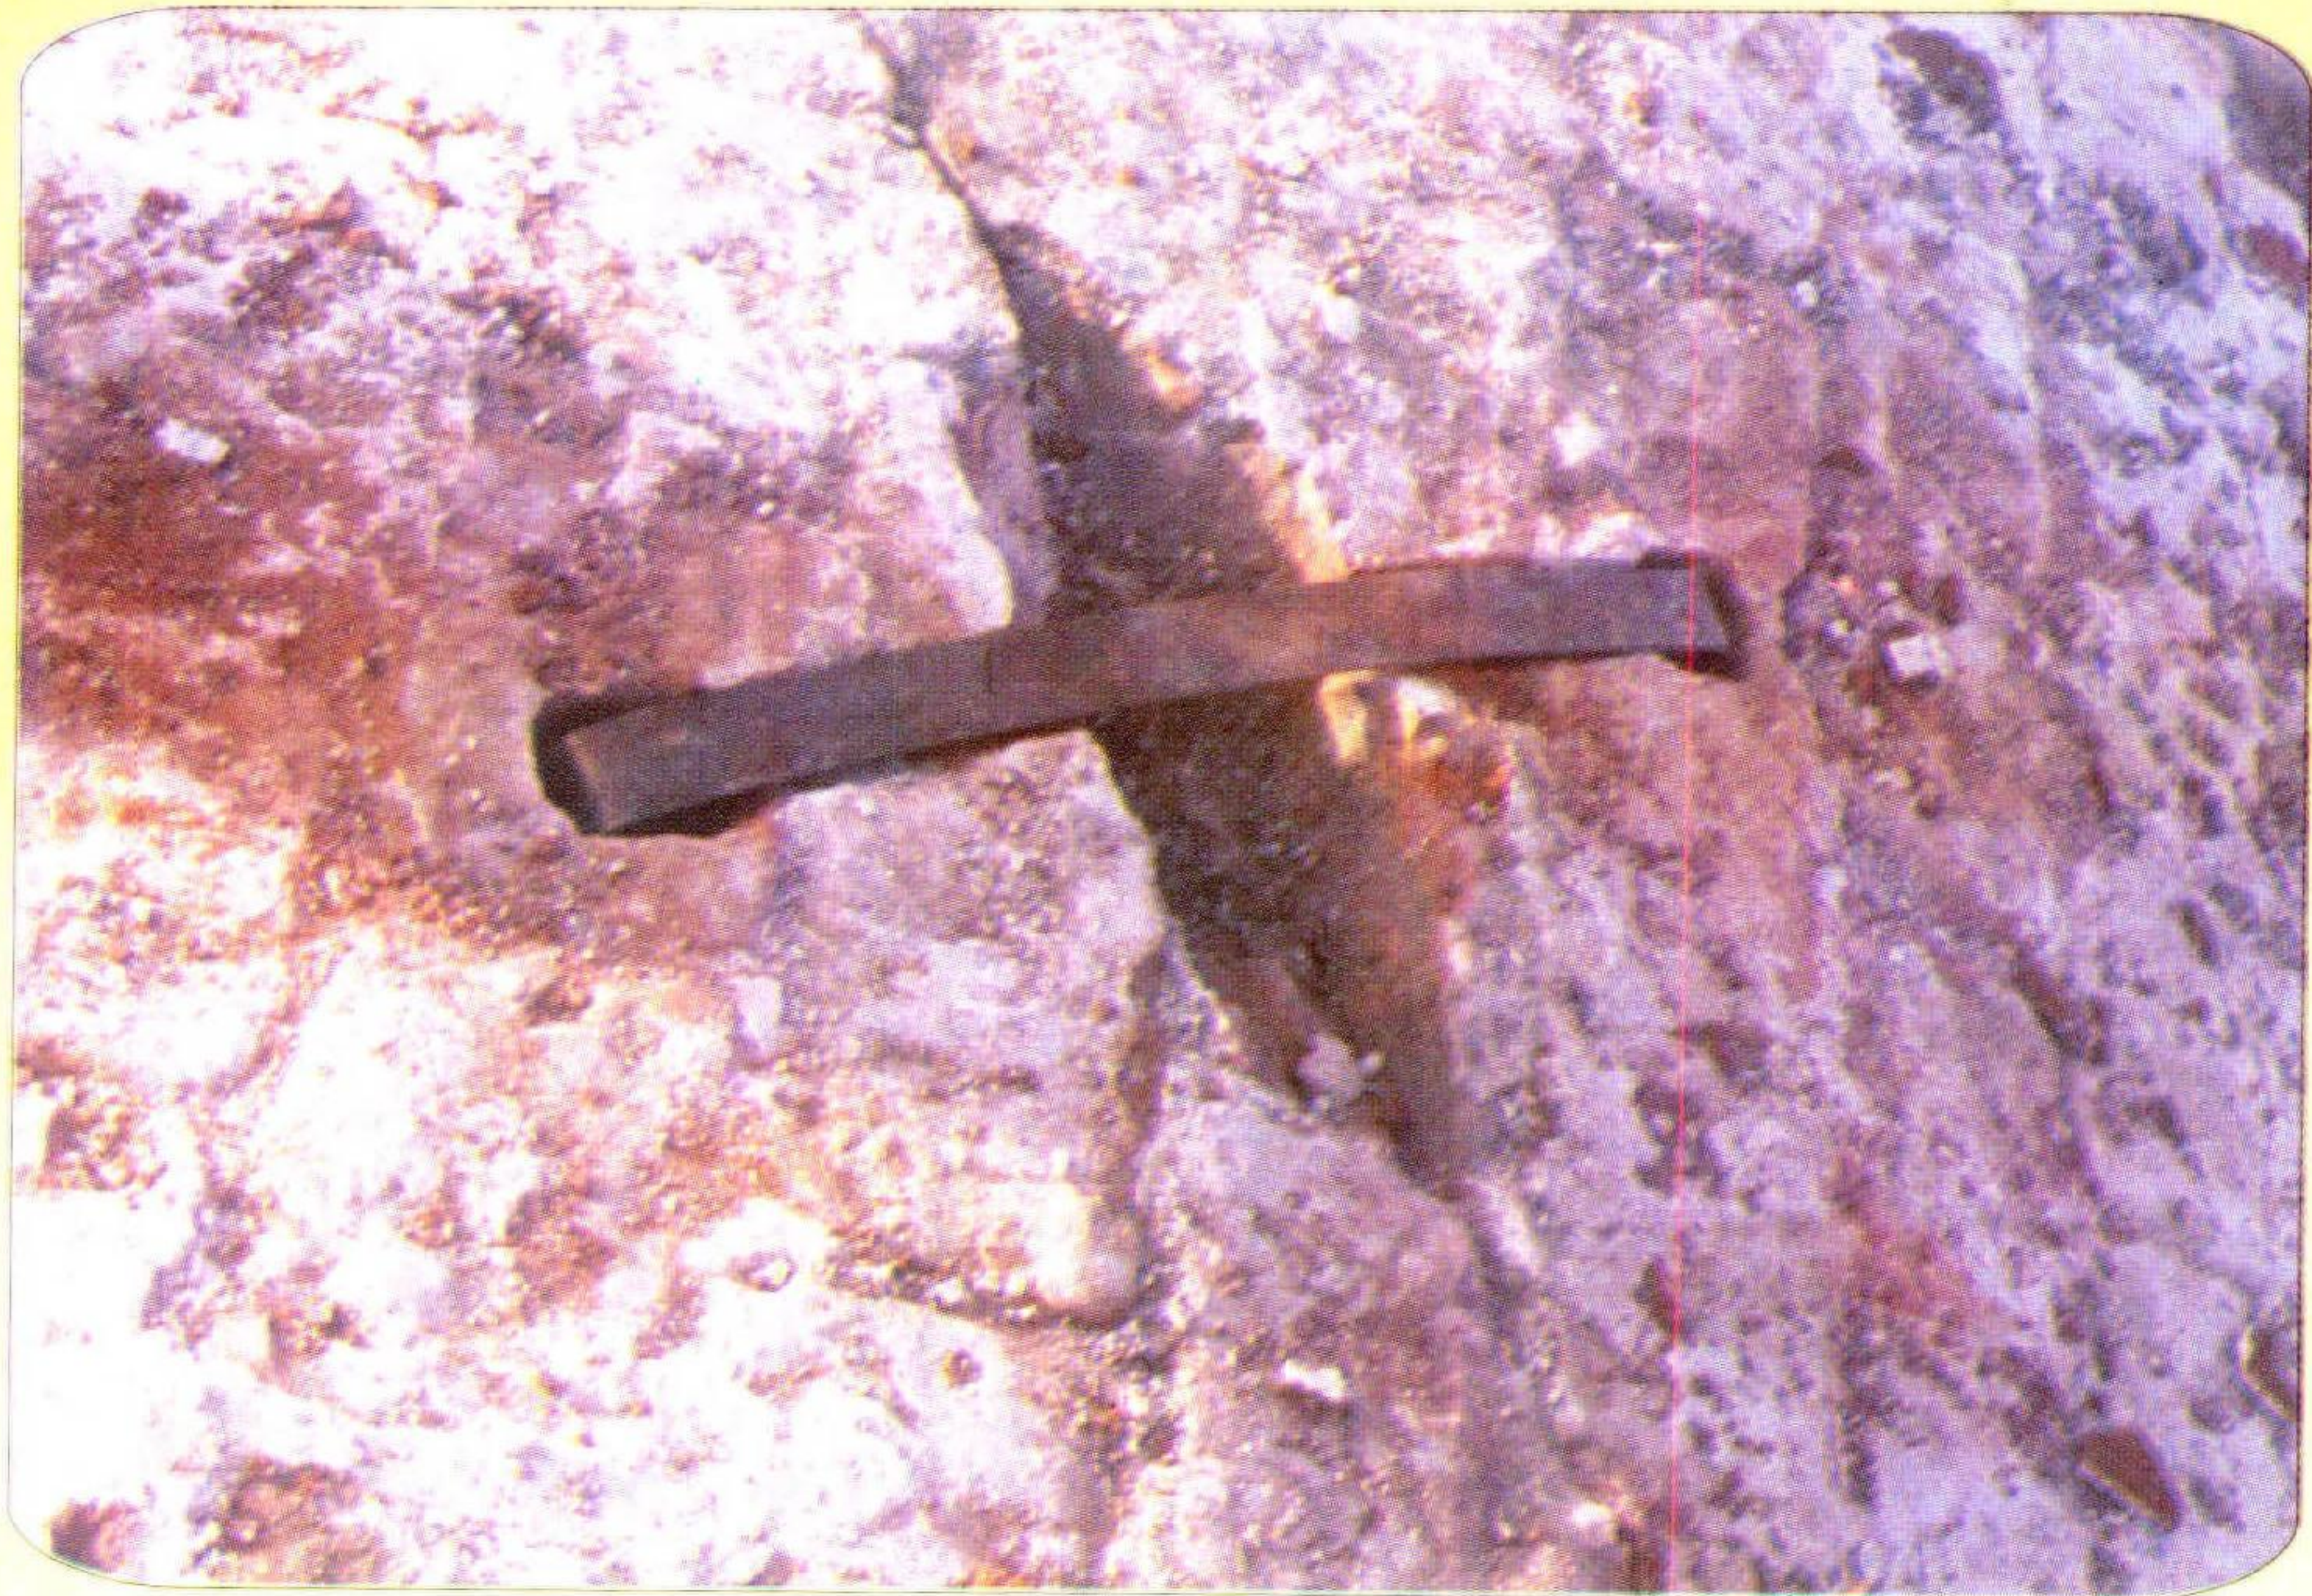
Crack in the arched portion being stitched with a copper clip.

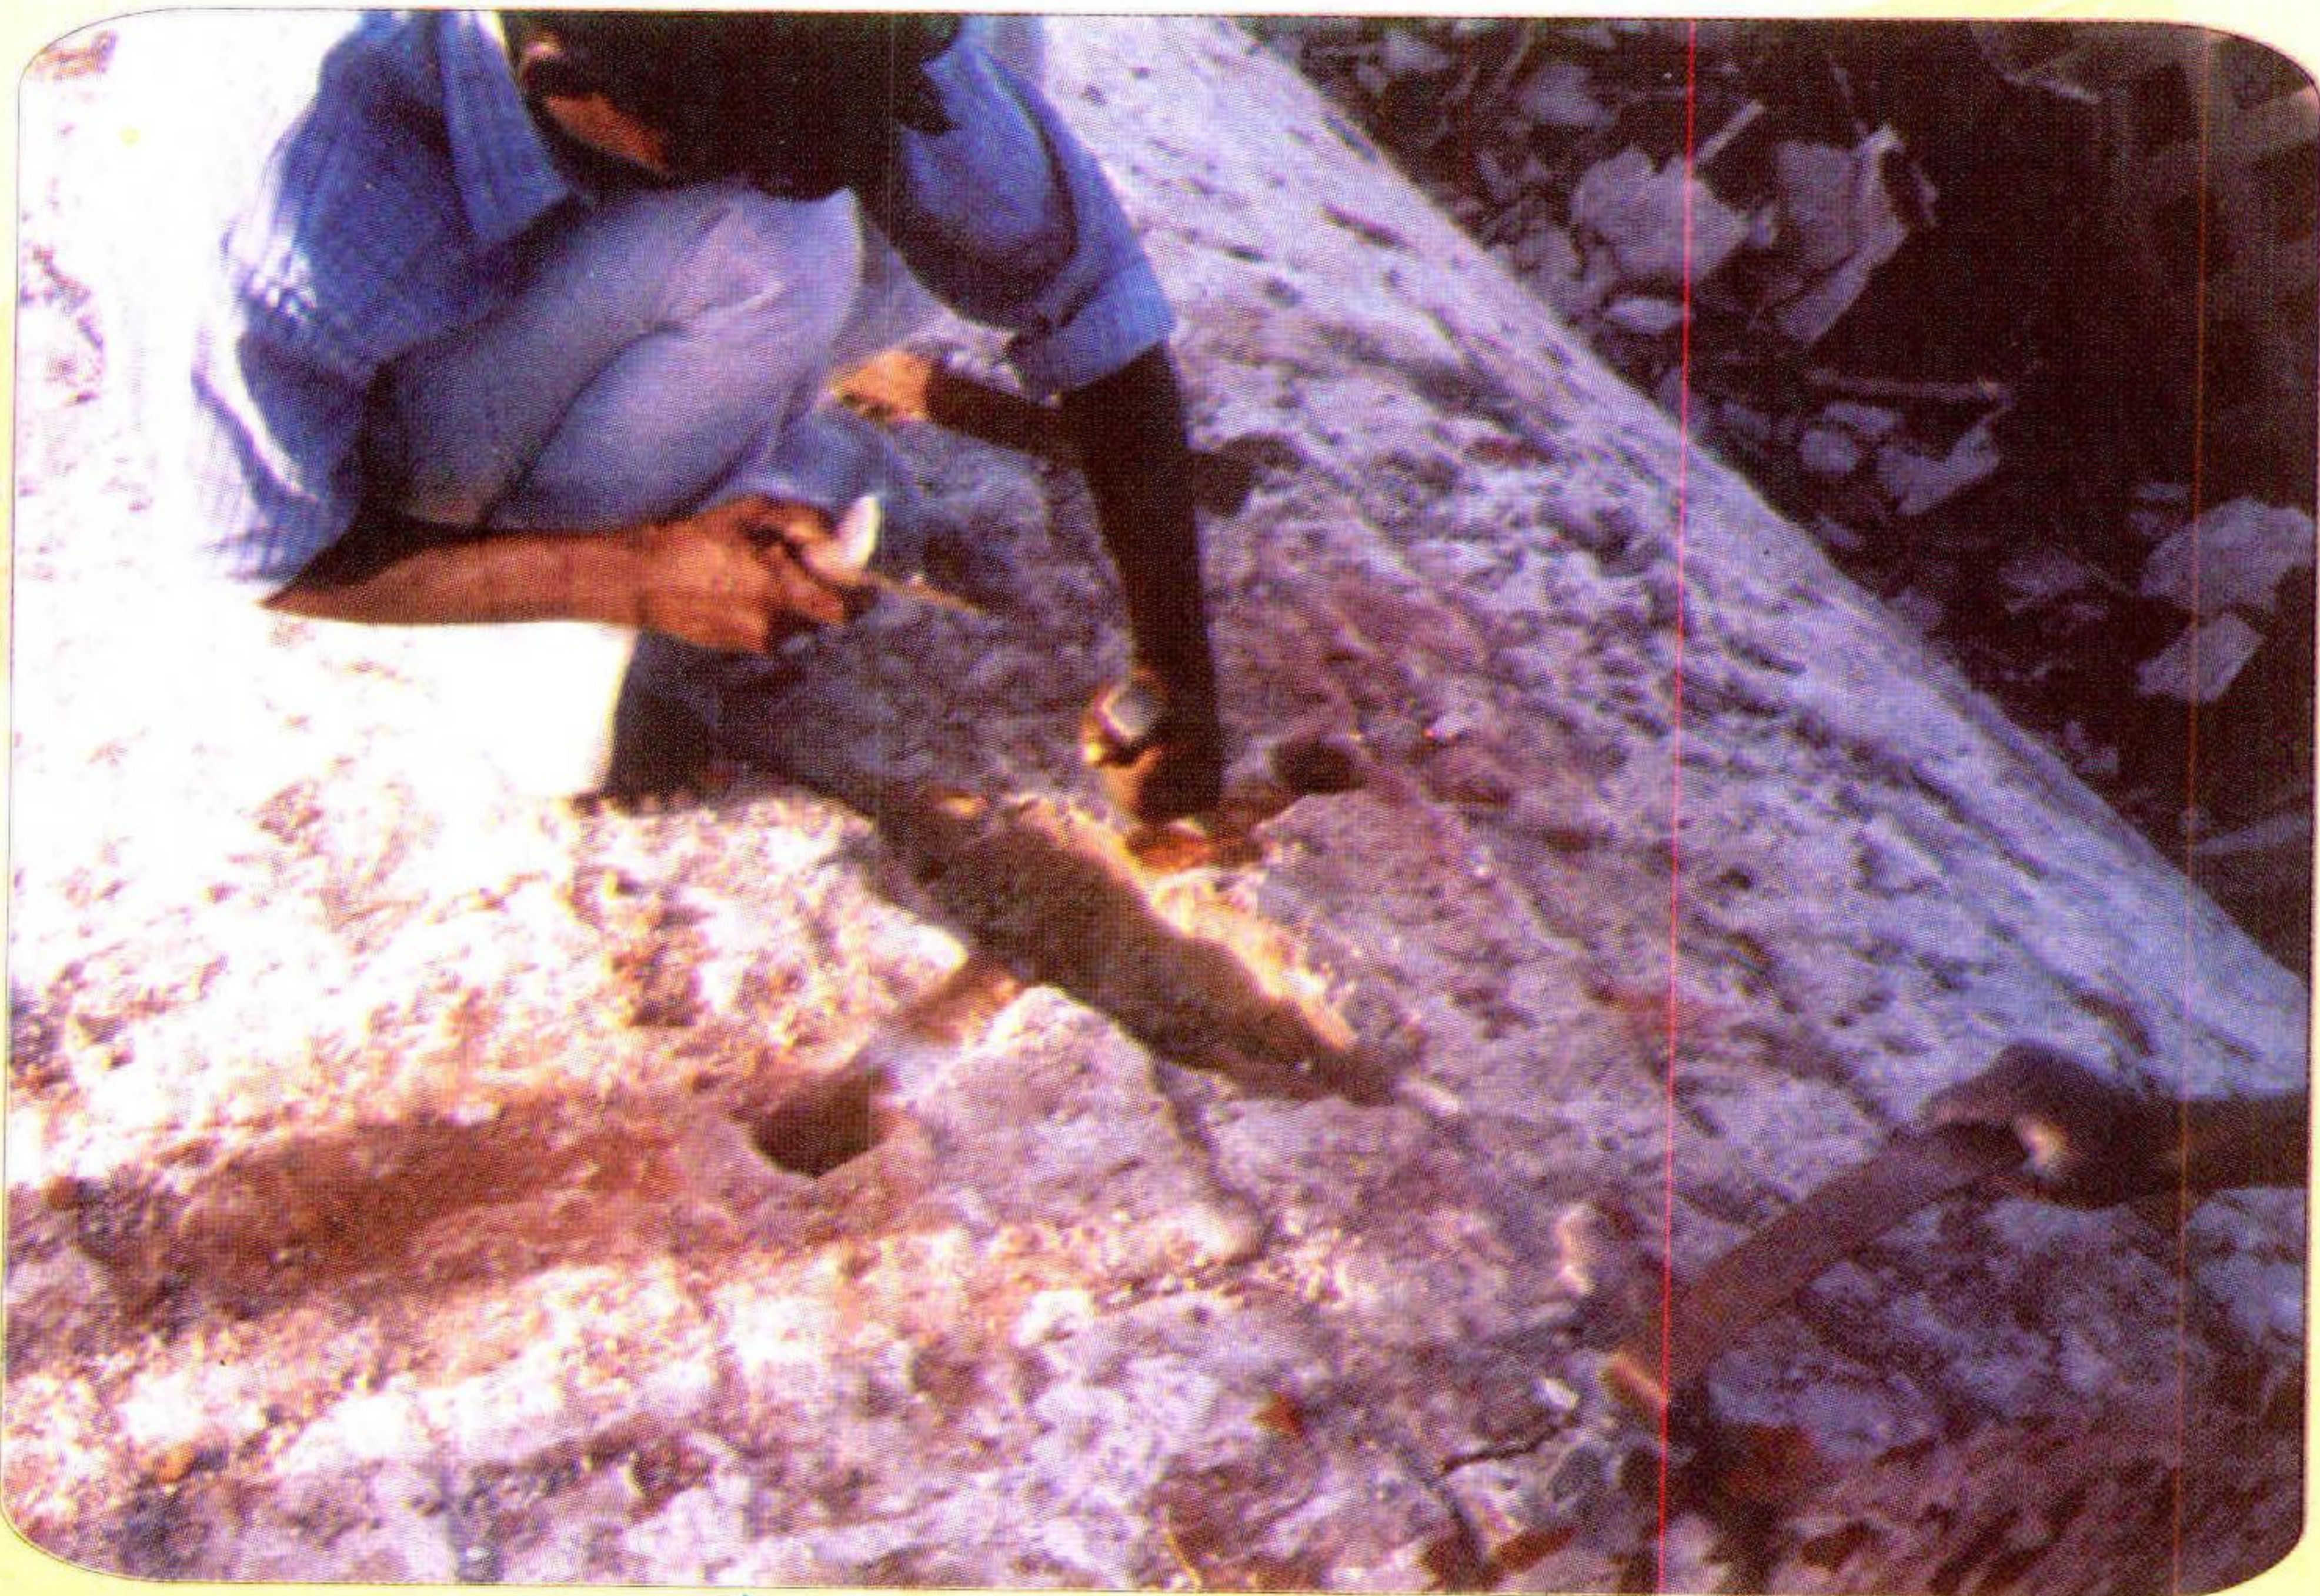
Making a groove to place the copper clip before pouring lead to stitch the cracked roof.

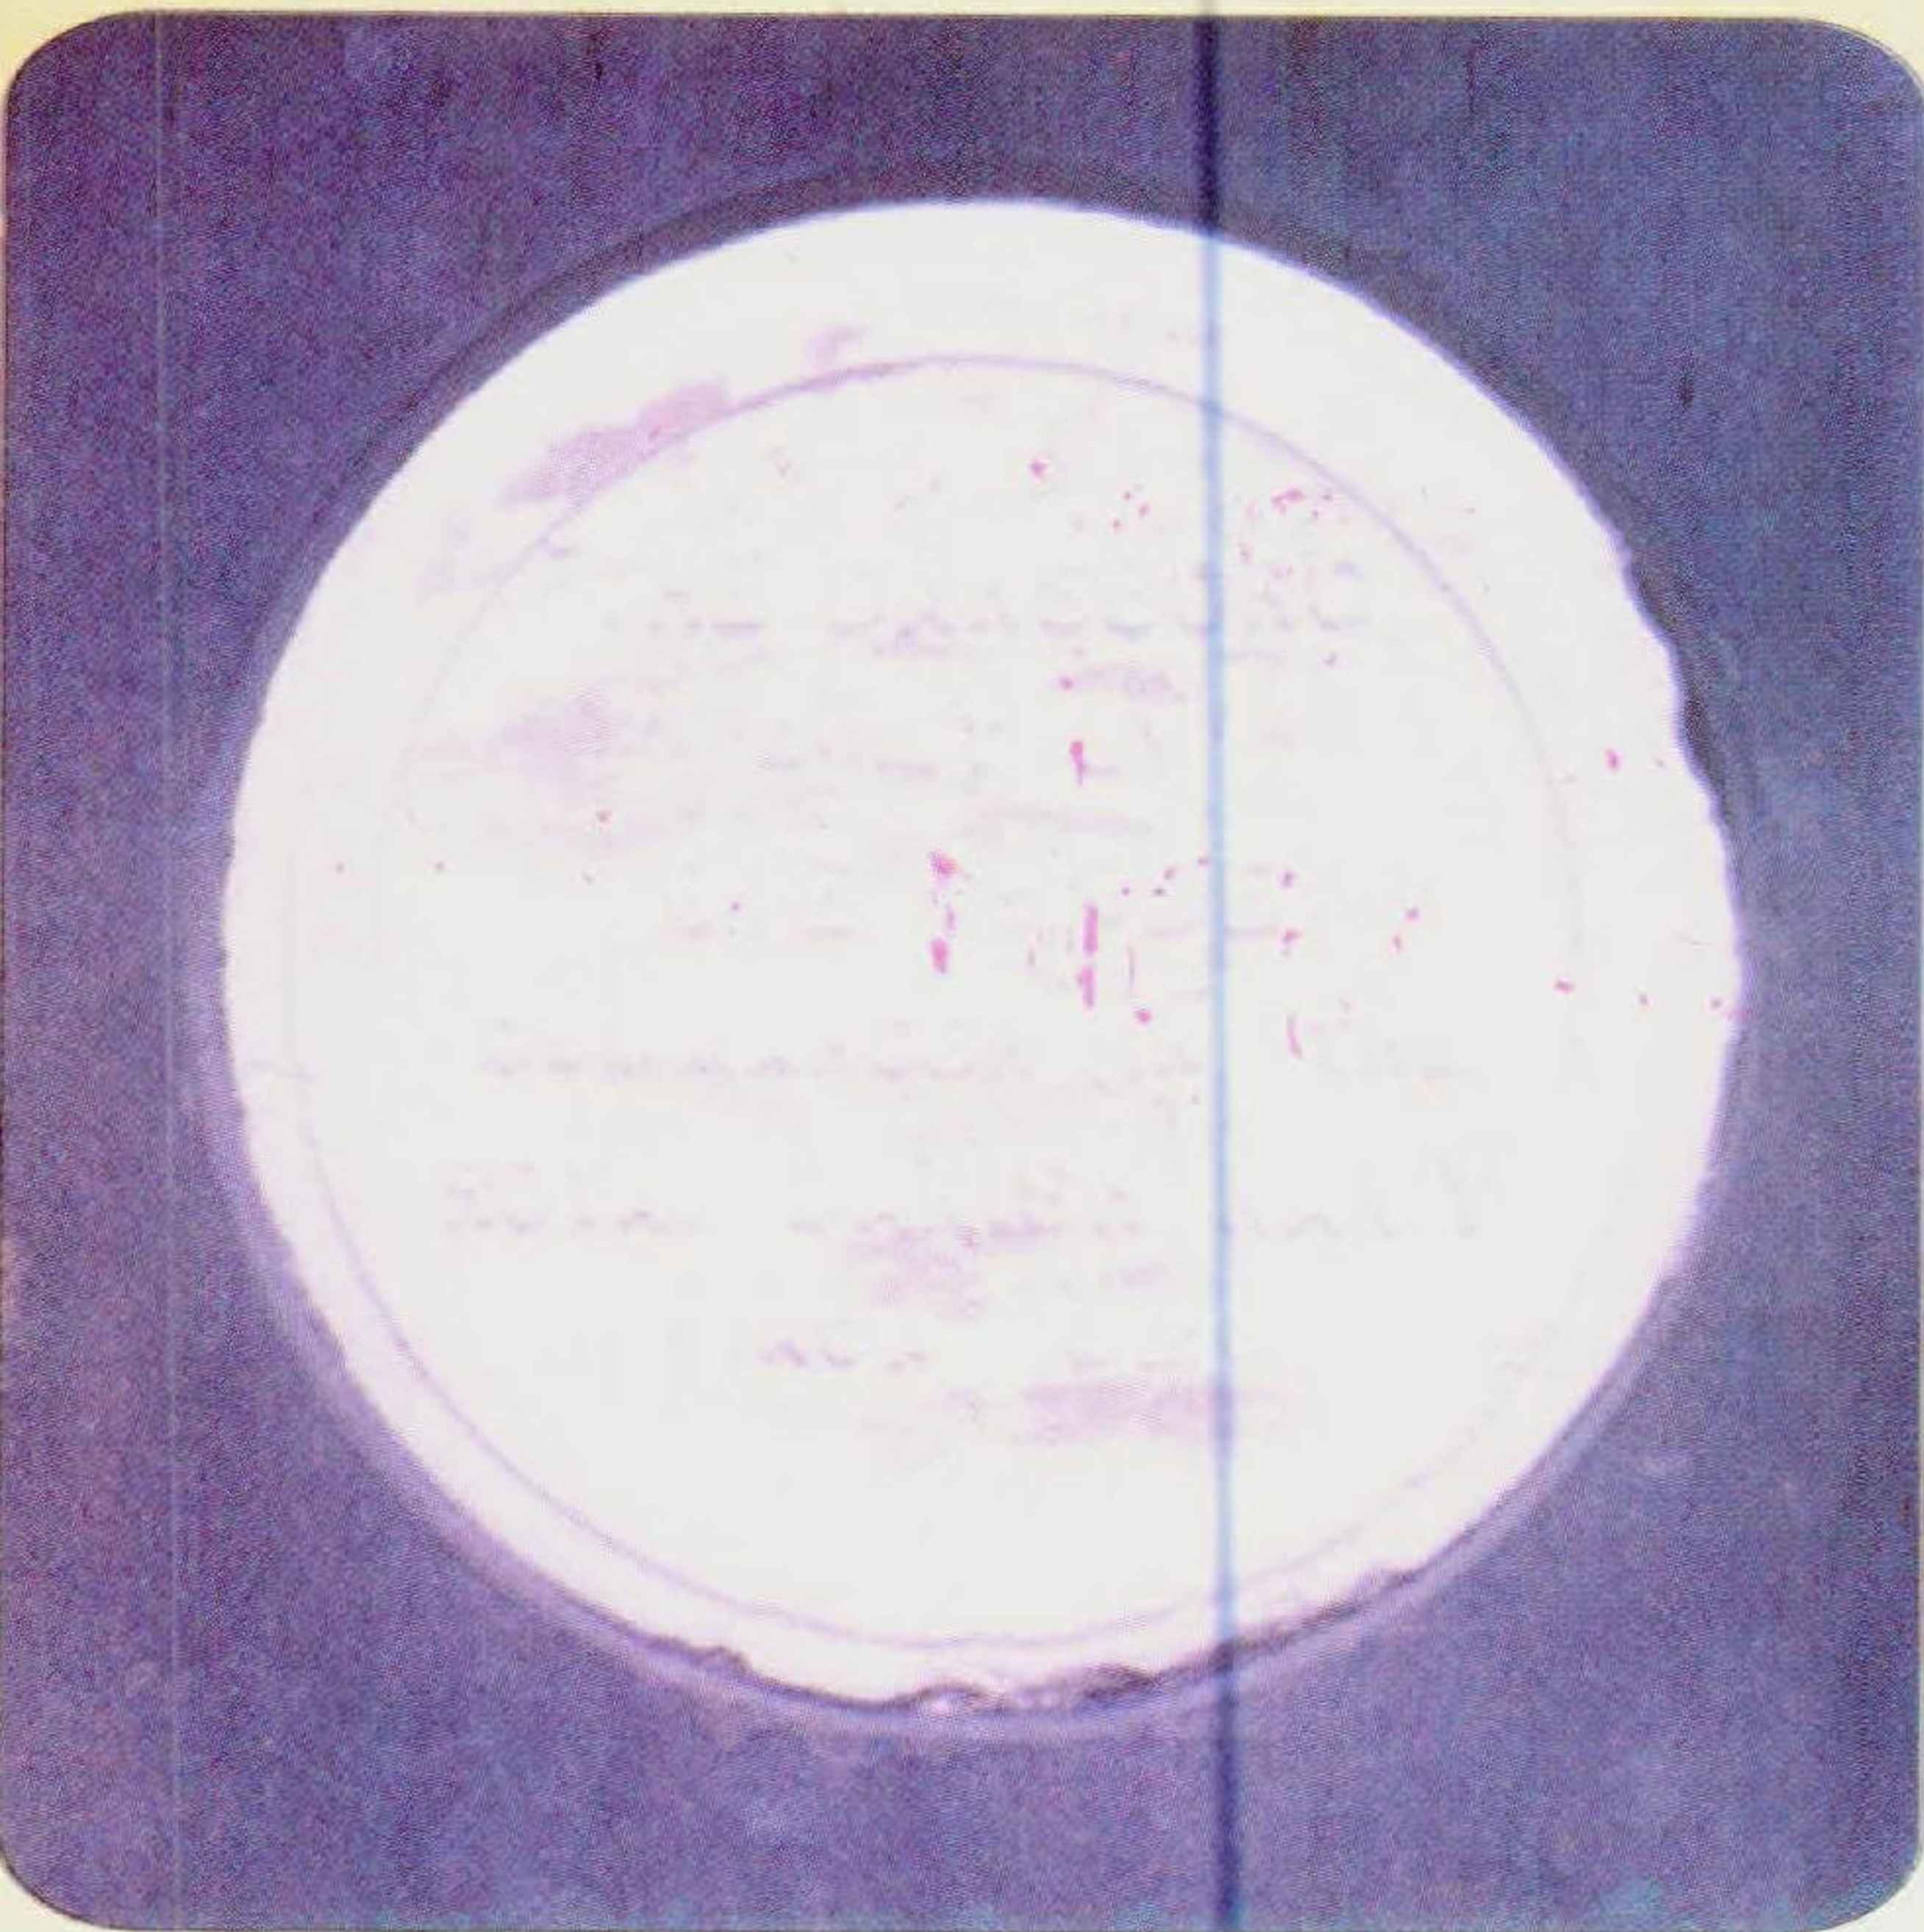
Commemoration tablet of  
Dansborg  
- before conservation

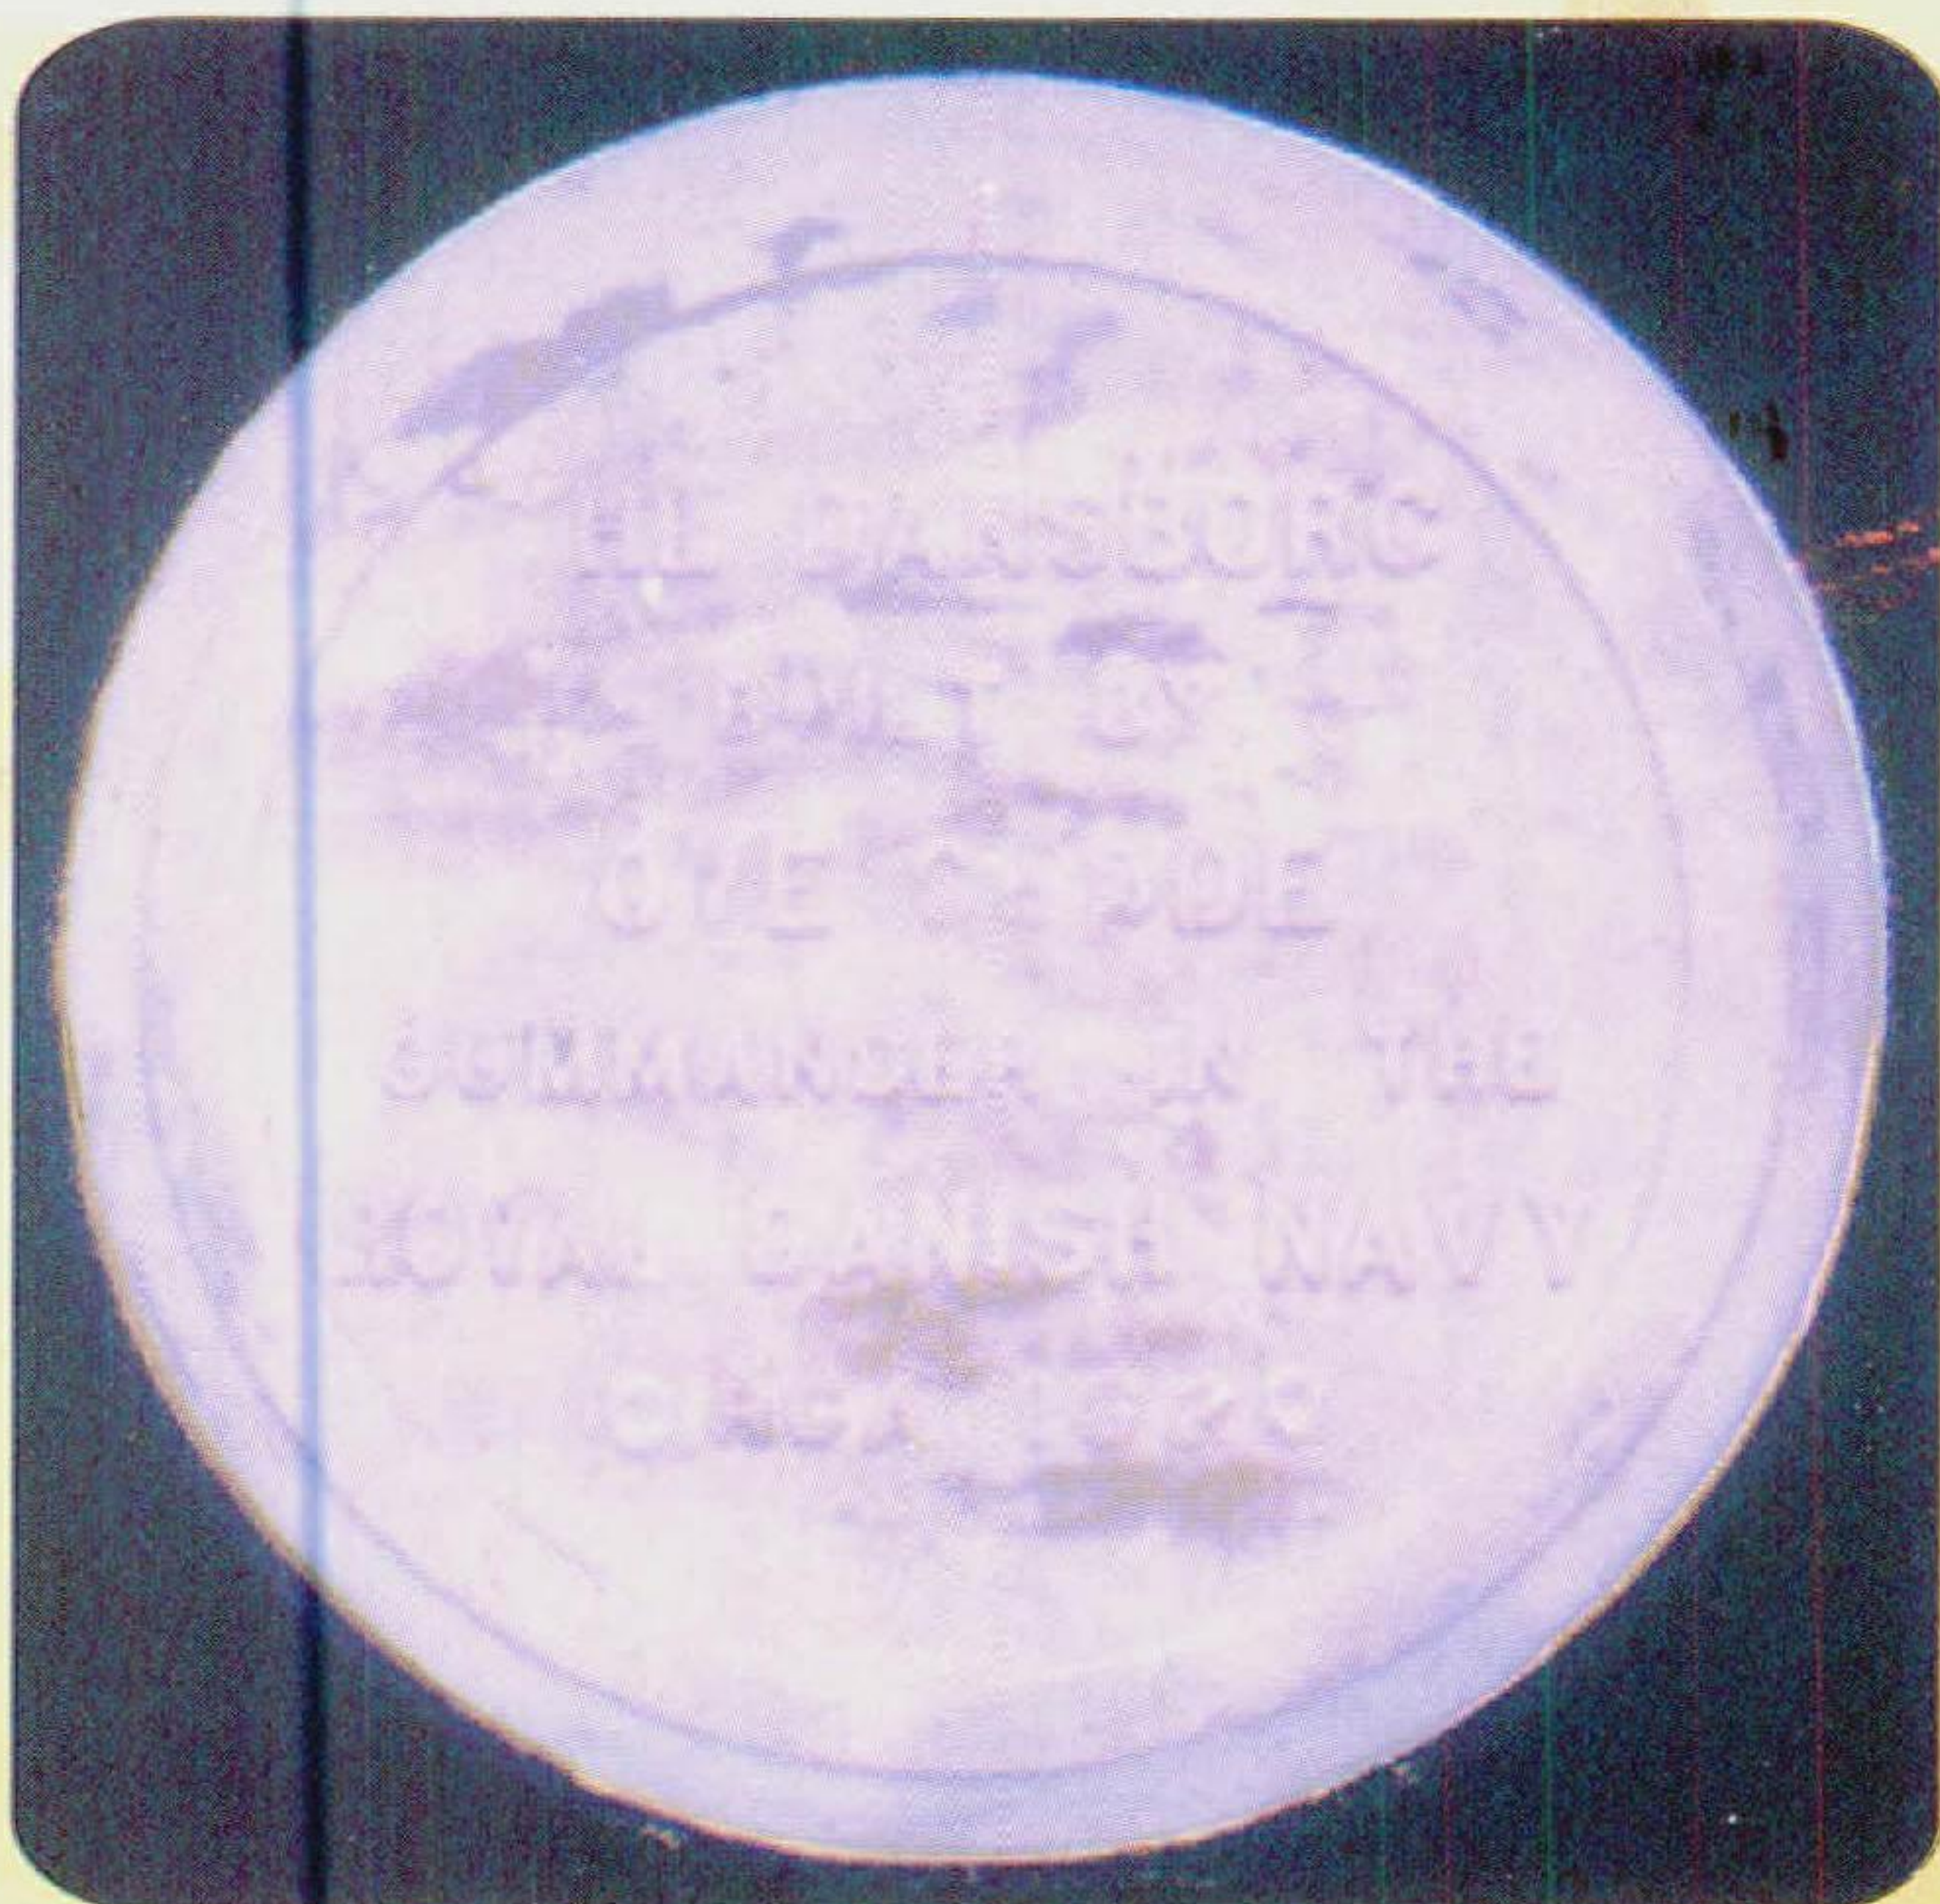
Commemoration tablet of  
Dansborg  
- After conservation
